# Commercial Vehicle Auctions Ltd.

MX69AVC

RENAULT MASTER LL35 2.3 DCI BUSINESS

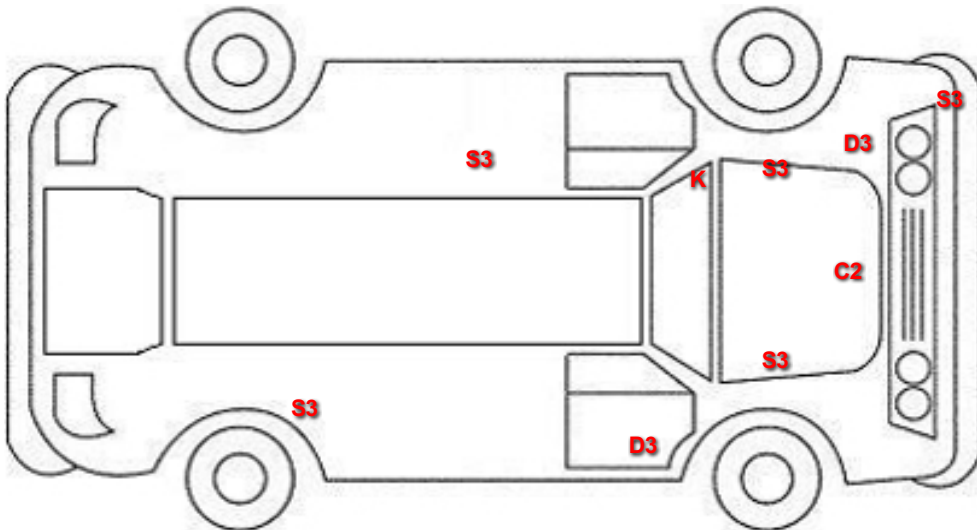
### Vehicle Splat

| Component | Condition | Severity | Repair |
|---|---|---|---|
| Bonnet | Scratched | Over 25mm Thru Paint | Refinish |
| Bonnet | Chipped | Multiple Chips | Refinish |
| Wing nsf | Dented | Over 30mm | Repair and Refinish |
| Wing nsf | Scratched | Over 25mm Thru Paint | Refinish |
| Bumper Front | Scratched | Over 100mm Thru Paint | Refinish |
| Door Mirror Assy nsf | Broken | Replace | Replace |
| Qtr Panel nsr | Scratched | Over 25mm Not Thru Paint | Machine Polish |
| Qtr Panel osr | Scratched | Over 25mm Not Thru Paint | Machine Polish |
| Door osf | Dented | Over 30mm | Repair and Refinish |
| Seat Base Cover osf | Holed | Over 3mm | Replace |
