## Commercial Vehicle Auctions Ltd.

DP19VUE

DAF LF 180 EURO 6 7.5 TONNE

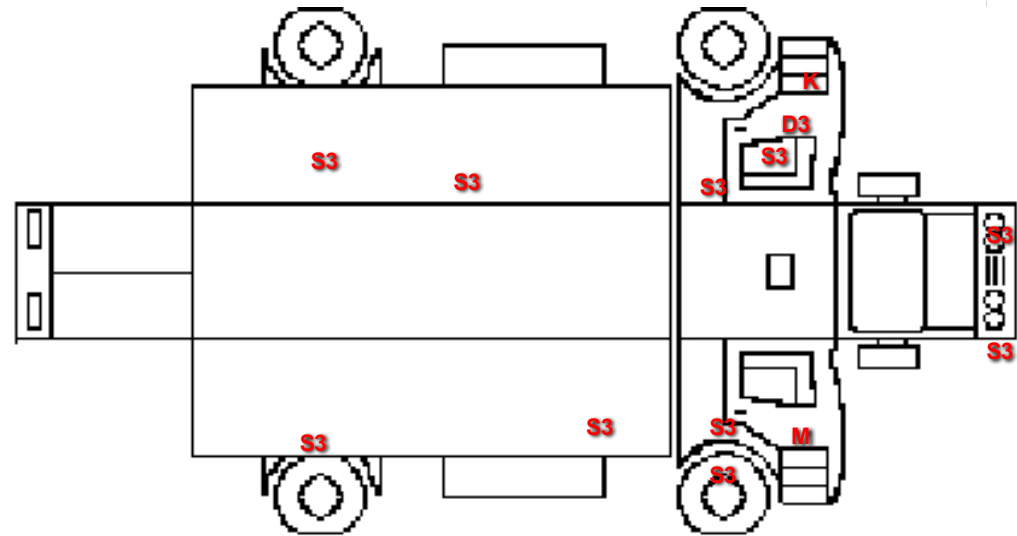
| Component | Condition | Severity | Repair |
|---|---|---|---|
| Qtr Panel osr | Scratched | Over 25mm Thru Paint | Refinish |
| Door osf | Scratched | Over 25mm Thru Paint | Refinish |
| Wing osf | Scratched | Over 25mm Thru Paint | Refinish |
| Door Moulding osf | Missing | Replace | Replace |
| Bumper Front | Scratched | Over 100mm Thru Paint | Refinish |
| Panel Front | Scratched | Over 25mm Thru Paint | Refinish |
| Door nsf | Scratched | Rusted | Refinish |
| Door nsf | Dented | Over 30mm | Repair and Refinish |
| Qtr Panel Trim ns | Scuffed | Over 25mm | Smart Repair |
