## Commercial Vehicle Auctions Ltd.

SY73NLC

MAXUS DELIVER 9 2.0 TD 150PS

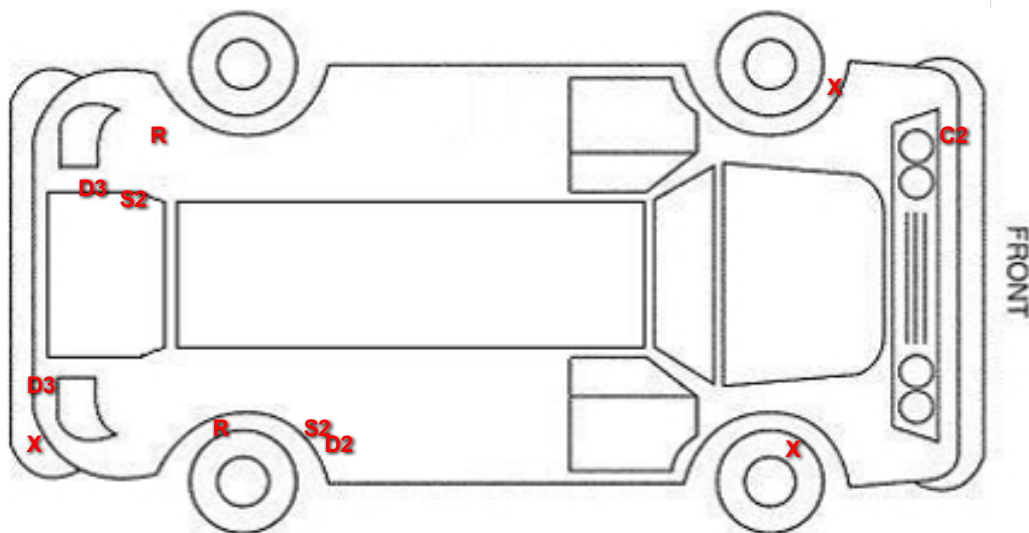
| Component | Condition | Severity | Repair |
|---|---|---|---|
| Wing Front Arch Extension os | Broken | Replace | Replace |
| Bumper Front | Chipped | Multiple Chips | Smart Repair |
| Bumper Front Moulding | Broken | Replace | Replace |
| Fuel Flap | Missing | Replace | Replace |
| Qtr Panel nsr | Rusted | Over 5mm | Refinish |
| Bumper Rear Moulding | Broken | Replace | Replace |
| Door nsr | Dented | With Paint Damage | Repair and Refinish |
| Boot Lid | Cracked | Replace | Replace |
| Qtr Panel osr | Rusted | Over 5mm | Refinish |
| Qtr Panel osr | Dented | With Paint Damage | Repair and Refinish |
