# Commercial Vehicle Auctions Ltd.

FJ19ZXA

CN: WF0YXXTTGYJR52532

FORD TRANSIT CUSTOM 280 2.0TDCI BASE  
130PS

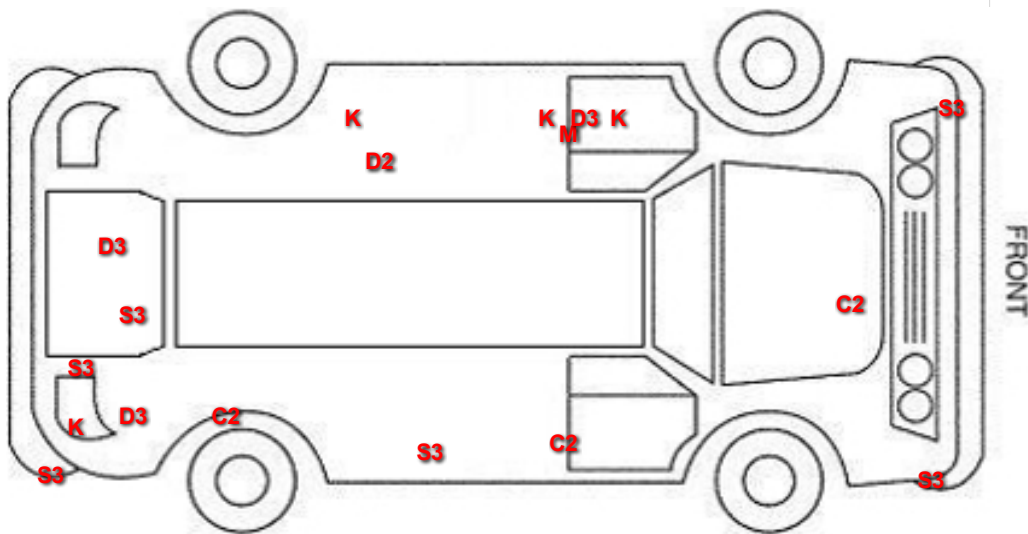
| Component | Condition | Severity | Repair |
|---|---|---|---|
| Bonnet | Chipped | Multiple Chips | Refinish |
| Bumper Front | Scratched | Over 100mm Thru Paint | Refinish |
| Door nsf | Dented | Over 30mm | Repair and Refinish |
| Fuel Flap | Missing | Replace | Replace |
| Door Moulding nsf | Broken | Replace | Replace |
| Qtr Panel nsr | Dented | Over 30mm | Repair and Refinish |
| Qtr Panel Trim ns | Broken | Replace | Replace |
| Door nsr | Dented | Over 30mm | Repair and Refinish |
| Door osr | Scratched | Over 25mm Thru Paint | Refinish |
| Bumper Rear Moulding | Scuffed (Unpainted) | Over 100mm | Smart Repair |
| Lamp osr | Broken | Replace | Replace |
| Qtr Panel osr | Dented | Over 30mm | Repair and Refinish |
| Qtr Panel osr | Chipped | Multiple Chips | Refinish |
| Qtr Panel osr | Scratched | Over 25mm Thru Paint | Refinish |
| Door osf | Chipped | Multiple Chips | Refinish |
