# Commercial Vehicle Auctions Ltd.

MX19DYT

RENAULT MASTER LL35 2.3 DCI BUSINESS

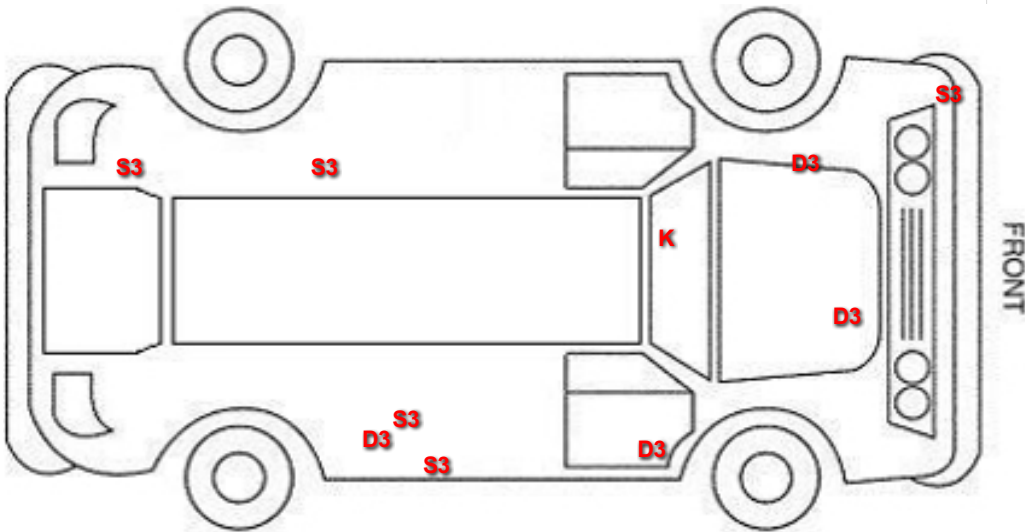
#### Vehicle Splat

| Component | Condition | Severity | Repair |
|---|---|---|---|
| Bonnet | Dented | Over 30mm | Repair and Refinish |
| Wing nsf | Dented | Over 30mm | Repair and Refinish |
| Bumper Front | Scratched | Over 100mm Thru Paint | Refinish |
| Qtr Panel nsr | Scratched | Over 25mm Thru Paint | Refinish |
| Qtr Panel osr | Scratched | Over 25mm Thru Paint | Refinish |
| Qtr Panel osr | Dented | Over 30mm | Repair and Refinish |
| Door osf | Dented | Over 30mm | Repair and Refinish |
| Seat Base Cover osf | Holed | Over 3mm | Replace |
| Screen Front | Cracked | Replace | Replace |
| Seat Base Cover nsf | Soiled | Heavy | Replace |
