# Commercial Vehicle Auctions Ltd.

DL70MGO

CN: VXEVFAHKKM7803927

VAUXHALL VIVARO 3100 2.0 DYNAMIC 120PS

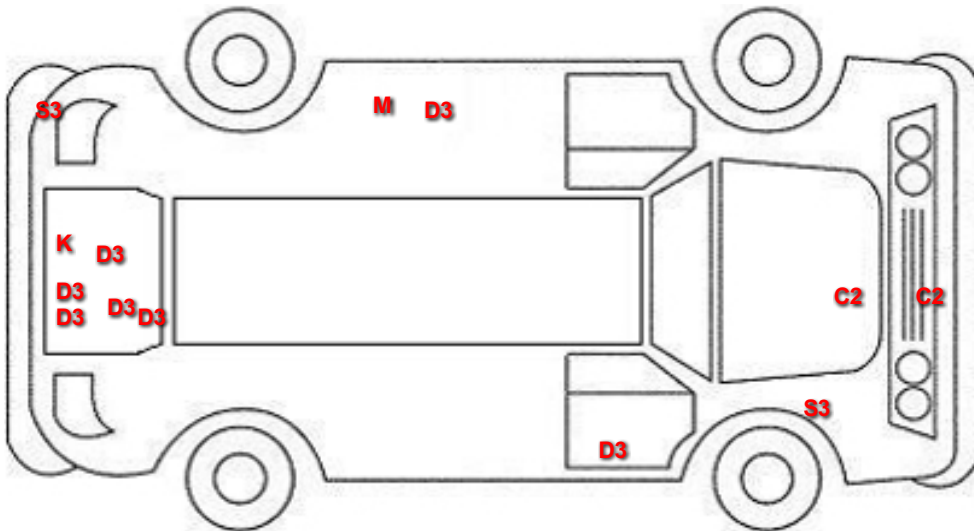
| Component | Condition | Severity | Repair |
|---|---|---|---|
| Bonnet | Chipped | Multiple Chips | Refinish |
| Panel Front | Chipped | Multiple Chips | Refinish |
| Qtr Panel Moulding ns | Missing | Replace | Replace |
| Qtr Panel nsr | Dented | Over 30mm | Repair and Refinish |
| Door nsr | Dented | Over 30mm | Repair and Refinish |
| Bumper Rear | Scratched | Over 100mm Thru Paint | Refinish |
| Door Moulding nsr | Broken | Replace | Replace |
| Door osr | Dented | Over 30mm | Repair and Refinish |
| Door osf | Dented | Over 30mm | Repair and Refinish |
| Wing osf | Scratched | Over 25mm Thru Paint | Refinish |
