Commercial Vehicle Auctions Ltd.

YV68BVJ

FORD RANGER 2.2 TDCI
 Vat Status: Commercial (plus Vat)

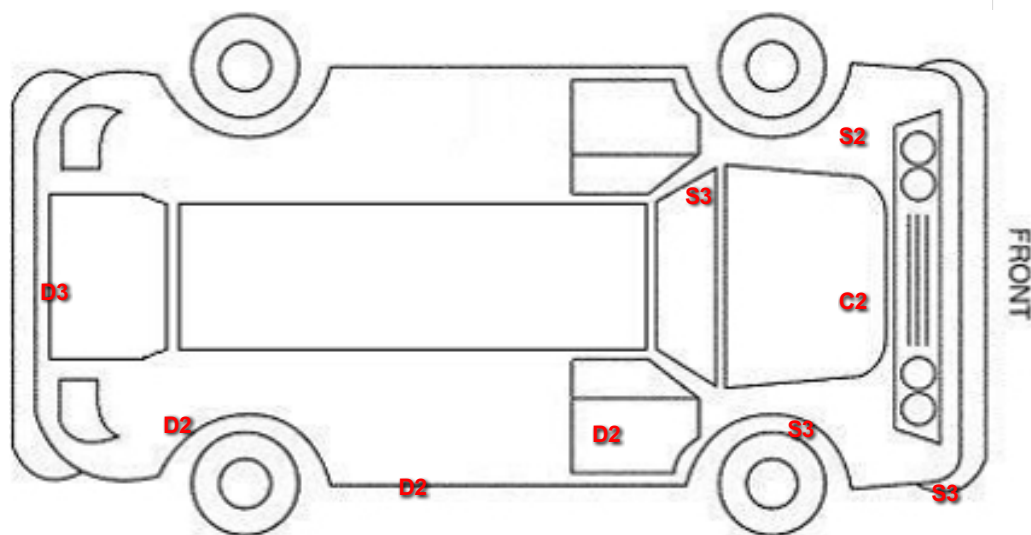
Vehicle Splat

Component	Condition	Severity	Repair
Bonnet	Chipped	Multiple Chips	Refinish
Bumper Front	Scratched	25 to 100mm Thru Paint	Smart Repair
Door Mirror Assy nsf	Scuffed (Unpainted)	Over 100mm	Smart Repair
Tailgate	Dented	Over 30mm	Repair and Refinish
Qtr Panel osr	Dented	Over 30mm	Repair and Refinish
Sill os	Dented	Over 30mm	Repair and Refinish
Door osf	Dented	Over 30mm	Repair and Refinish
Door Pad osr	Scuffed	Over 25mm	Smart Repair
Wing osf	Scratched	Over 25mm Not Thru Paint	Machine Polish
Bumper Front	Scratched	Over 100mm Thru Paint	Refinish
Door Pad nsf	Soiled	Heavy	Replace
Seat Base Cover osf	Soiled	Heavy	Replace
