# Commercial Vehicle Auctions Ltd.

PO19ZZD

CN: WDB9076332P089390

MERCEDES-BENZ SPRINTER 316 CDI

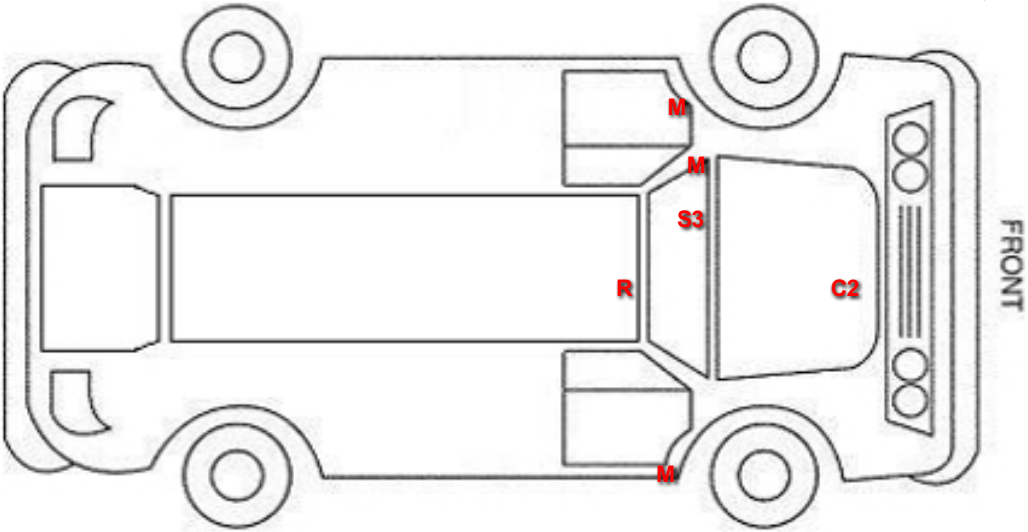
| Damage Lines | | | |
|---|---|---|---|
| Bonnet | Chipped | Multiple Chips | Refinish |
| Roof | Rusted | Over 5mm | Refinish |
| Door Moulding nsf | Missing | Replace | Replace |
| Door Moulding osf | Missing | Replace | Replace |

| Vehicle Splat | Splat Key |
|---|---|
| | <p><b>S3</b><br/>Scratch/Paint defect 100m +</p> <p><b>C2</b><br/>Multiple Chips</p> <p><b>M</b><br/>Missing</p> <p><b>R</b><br/>Rust</p> |
