# Commercial Vehicle Auctions Ltd.

YB12DAO

TOYOTA HILUX 2.5 D-4D 144PS

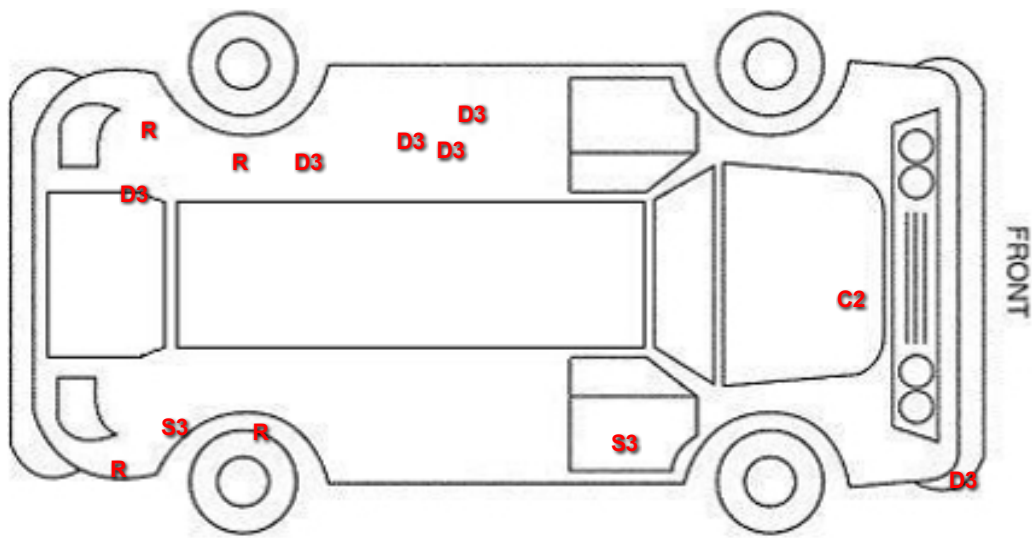
#### Vehicle Splat

| Component | Condition | Severity | Repair |
|---|---|---|---|
| Bonnet | Chipped | Multiple Chips | Refinish |
| Door nsr | Dented | Over 30% Of Panel | Replace |
| C Post ns | Dented | Over 30mm | Repair and Refinish |
| Qtr Panel nsr | Dented | Over 30mm | Repair and Refinish |
| Qtr Panel nsr | Rusted | Over 5mm | Refinish |
| Qtr Panel osr | Scratched | Over 25mm Thru Paint | Refinish |
| Qtr Panel osr | Rusted | Over 5mm | Refinish |
| Door osf | Scratched | Over 25mm Thru Paint | Refinish |
| Bumper Front | Dented | Over 30mm | Repair and Refinish |
