Commercial Vehicle Auctions Ltd.

CN: WF0XXXTTGXHE68292

FORD TRANSIT 350 2.0 TDCI 130PS Vat Status: Commercial (plus Vat)

Damage Assessment

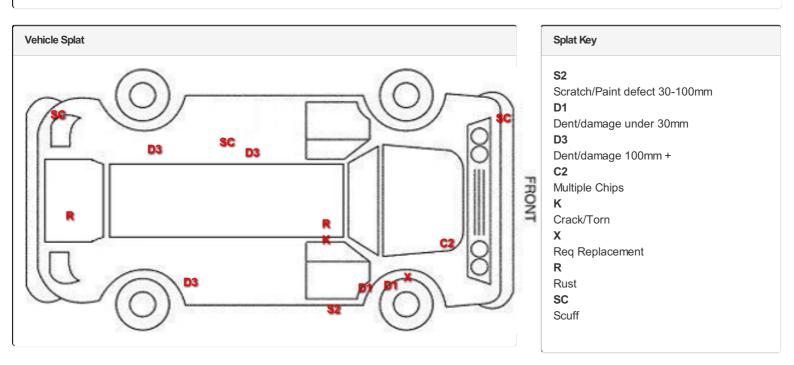
- Component Sill os Seat Base Cover osf Roof Bonnet Bumper Front Moulding Wing osf Wing Front Arch Extension os Door osf Qtr Panel osr Tailgate Bumper Rear Moulding Qtr Panel nsr
- Condition Scratched Torn Rusted Chipped Scuffed (Unpainted) Dented Dented Dented Rusted Scuffed (Unpainted) Dented

Severity Over 25mm Thru Paint Over 3mm Over 5mm 1 To 5 Over 100mm With Paint Damage With Paint Damage With Paint Damage Over 5mm Over 100mm With Paint Damage

Sill os Scratched

> Over 25mm Thru Paint Refinish

Seat Base Cover osf

Torn

Over 3mm

Roof Rusted Over 5mm Refinish

Qtr Panel osr Dented With Paint Damage Repair and Refinish

Qtr Panel nsr Dented With Paint

Tailgate Rusted Over 5mm Refinish

ADD BLUE WARNING LIGHT

Repair Refinish Replace Refinish Smart Repair Smart Repair Repair and Refinish Replace Repair and Refinish Repair and Refinish Refinish Smart Repair Scuffed (Unpainted) Dented
