# Commercial Vehicle Auctions Ltd.

PJ20GXG

MERCEDES-BENZ SPRINTER 314 CDI

Damage Assessment

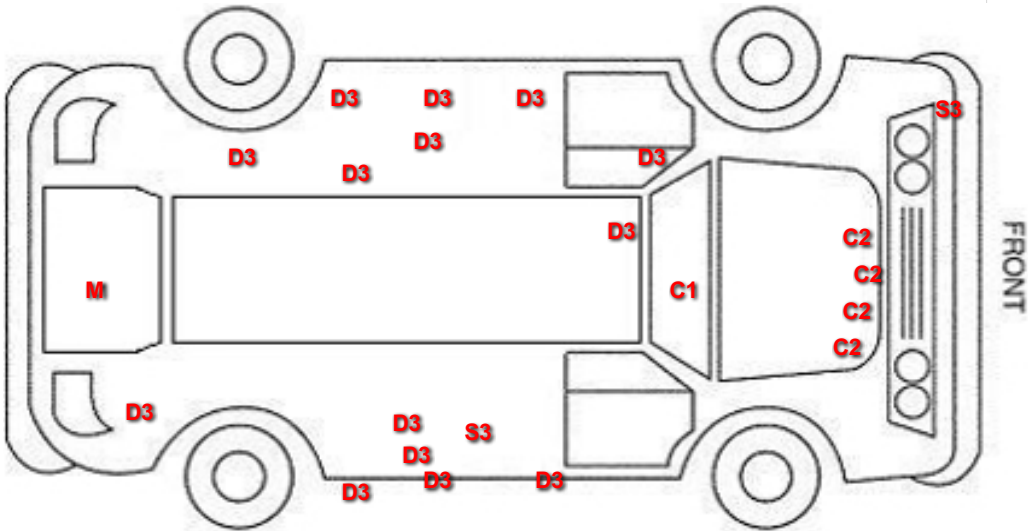
Vehicle Splat

| Component | Condition | Severity | Repair |
|---|---|---|---|
| Bonnet | Chipped | Multiple Chips | Refinish |
| Bumper Front | Scratched | Over 100mm Thru Paint | Refinish |
| Door nsf | Dented | Over 30mm | Repair and Refinish |
| Roof | Dented | Over 30mm | Repair and Refinish |
| Qtr Panel nsr | Dented | Over 30mm | Repair and Refinish |
| Badgedecal Rear | Missing | Replace | Replace |
| Qtr Panel osr | Dented | Over 30mm | Repair and Refinish |
| Qtr Panel osr | Cracked | Replace | Replace |
| Qtr Panel Moulding os | Scuffed (Unpainted) | Over 100mm | Smart Repair |
| Screen Front | Chipped | Over 10mm | Replace |
