## Commercial Vehicle Auctions Ltd.

PK20UXU

MERCEDES-BENZ SPRINTER 314 CDI

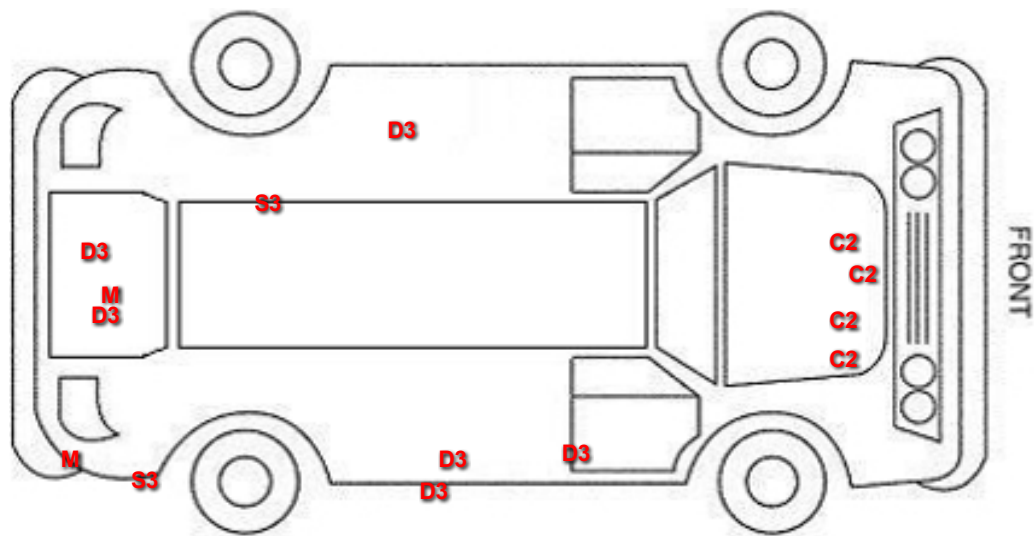
| Component | Condition | Severity | Repair |
|---|---|---|---|
| Bonnet | Chipped | Multiple Chips | Refinish |
| Qtr Panel nsr | Dented | Over 30mm | Repair and Refinish |
| Qtr Panel nsr | Scratched | Over 25mm Thru Paint | Refinish |
| Door nsr | Dented | Over 30mm | Repair and Refinish |
| Door osr | Dented | Over 30mm | Repair and Refinish |
| Badgedecal Rear | Missing | Replace | Replace |
| Bumper Rear Moulding | Missing | Replace | Replace |
| Qtr Panel Moulding os | Scuffed (Unpainted) | Over 100mm | Smart Repair |
| Qtr Panel osr | Dented | Over 30mm | Repair and Refinish |
| Door osf | Dented | Over 30mm | Repair and Refinish |
