# VEHICLE INSPECTION REPORT

**KU21ZFV**

## Mercedes-Benz Sprinter 314 CDI

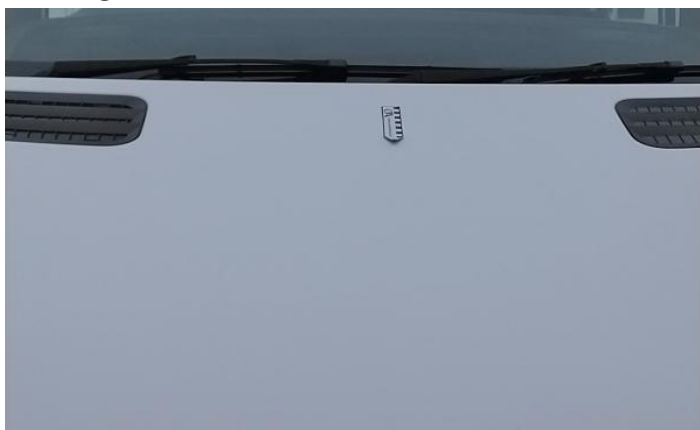
1: Bonnet  
Chipped  
Multiple Chips

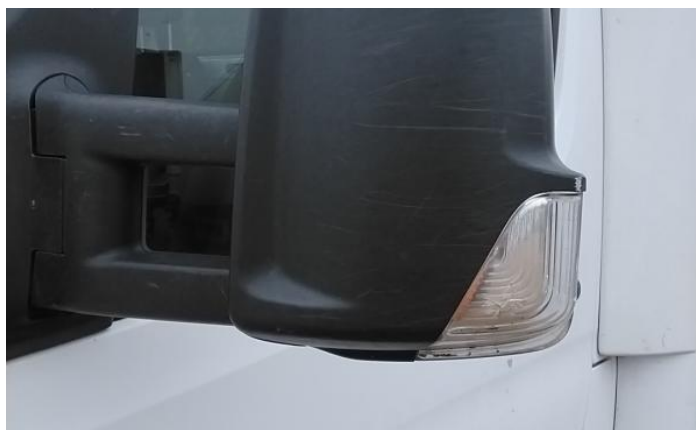
2: Door Mirror Assy nsf  
Scuffed (Unpainted)  
Over 100mm

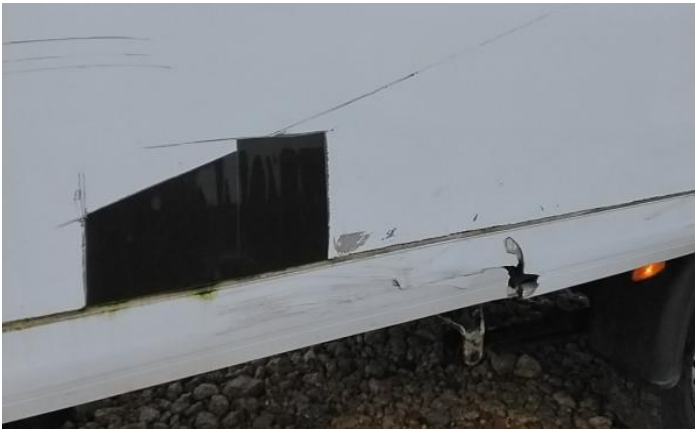
3: Qtr Panel nsr  
Hole  
Over 10mm

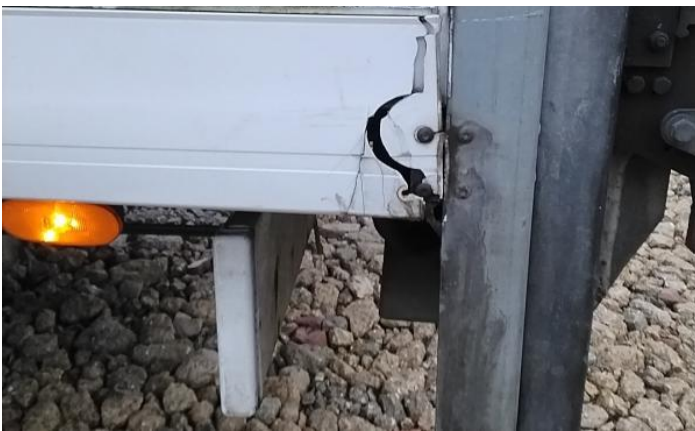
5: Qtr Panel nsr  
Hole  
Over 10mm

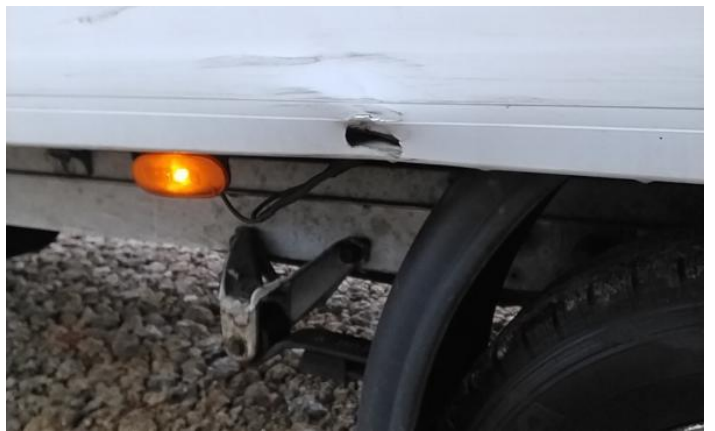
6: Qtr Panel nsr  
Hole  
Over 10mm

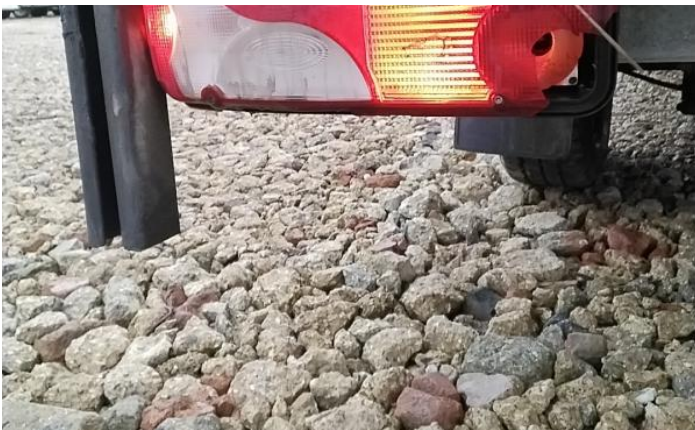
7: Lamp nsr  
Broken  
Replace

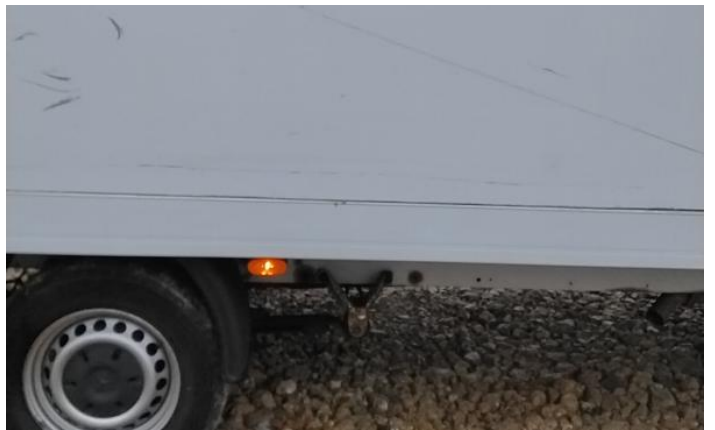
8: Qtr Panel osr  
Scratched  
Over 25mm Not Thru Paint

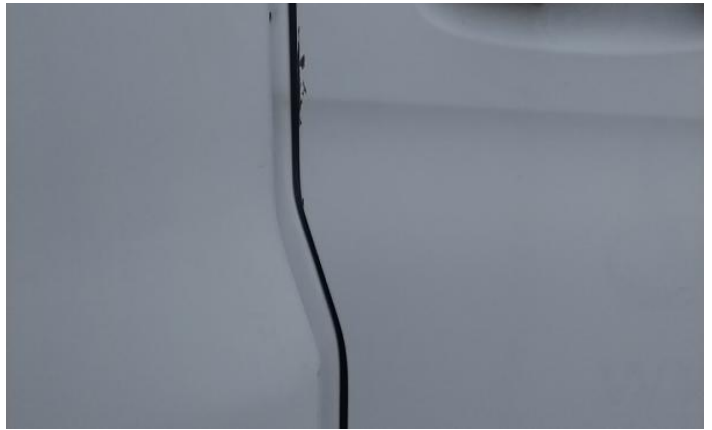
10: Door osf  
Scratched  
Over 25mm Thru Paint

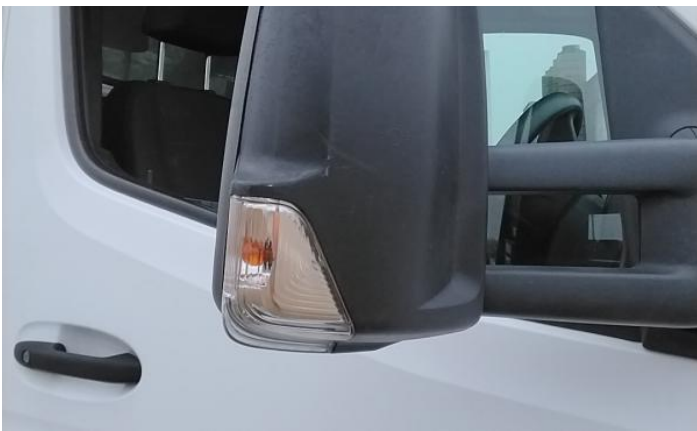
11: Door Mirror Assy osf  
Scuffed (Unpainted)  
Over 100mm
