# VEHICLE INSPECTION REPORT

**BJ22KHY**

## Nissan Interstar TEKNA 2.3 DCI 135PS

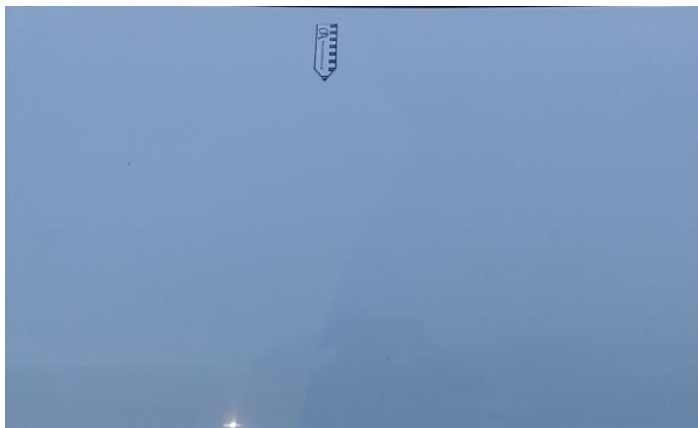
1: Bonnet  
Chipped  
Multiple Chips

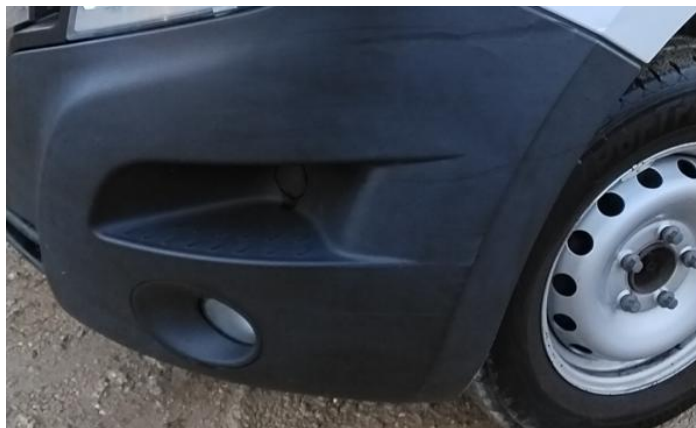
2: Bumper Front Moulding  
Scuffed (Unpainted)  
Over 100mm

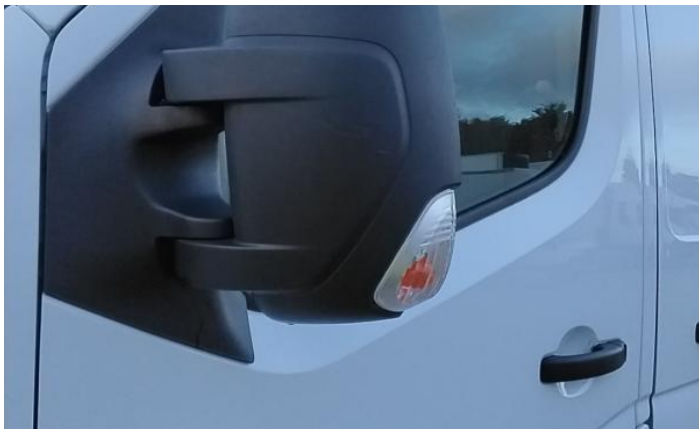
3: Door Mirror Assy nsf  
Scuffed (Unpainted)  
Over 100mm

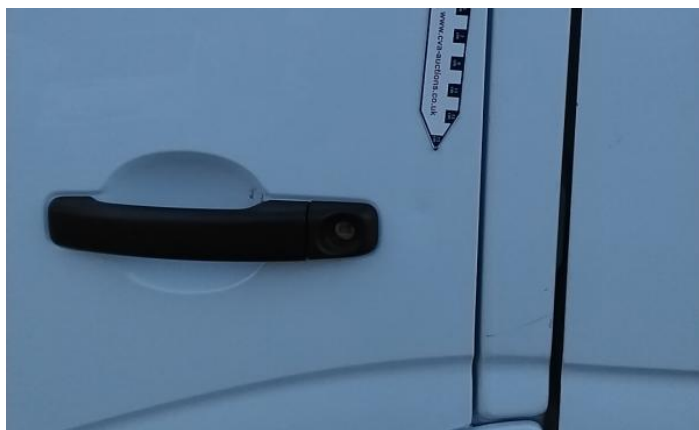
6: Door nsf  
Dented  
Over 2 UpTo 10mm

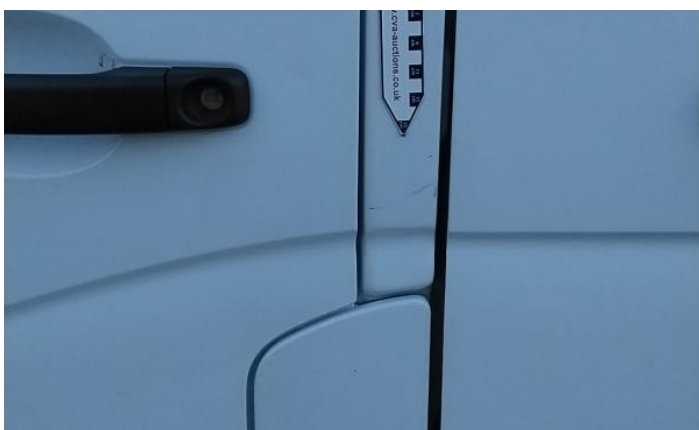
7: B Post ns  
Scratched  
UpTo 25mm Not Thru Paint

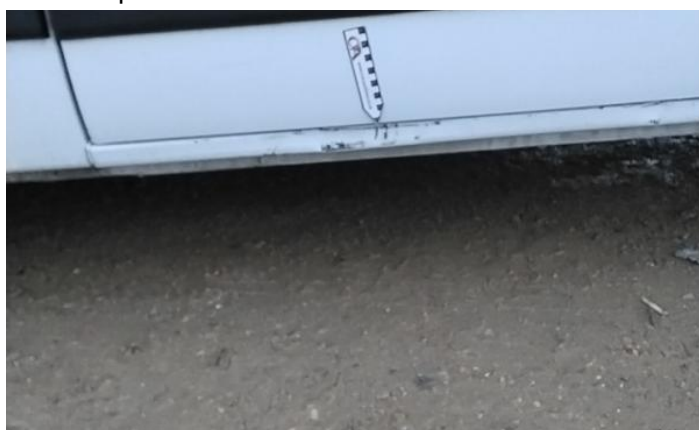
8: Sill ns  
Dented  
With Paint Damage

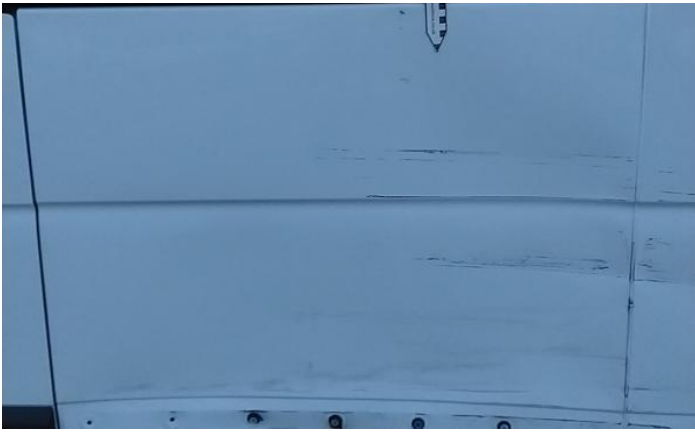
9: Qtr Panel nsr  
Dented  
With Paint Damage

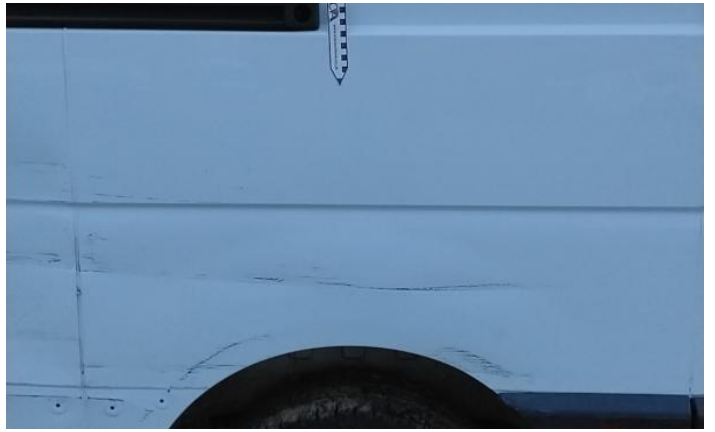
10: Qtr Panel nsr  
Dented  
With Paint Damage

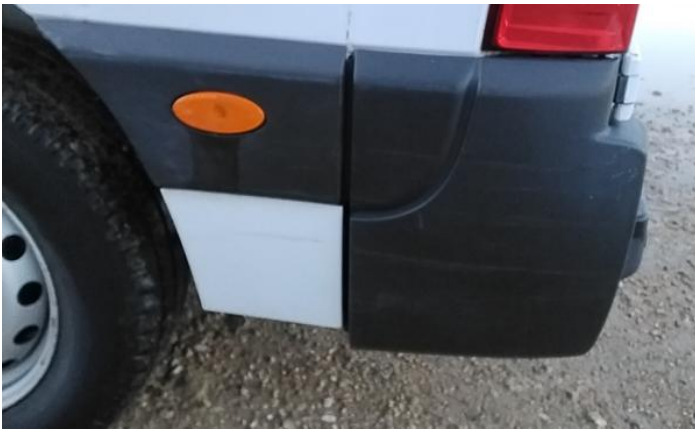
11: Qtr Panel Moulding ns  
Scuffed (Unpainted)  
Over 100mm

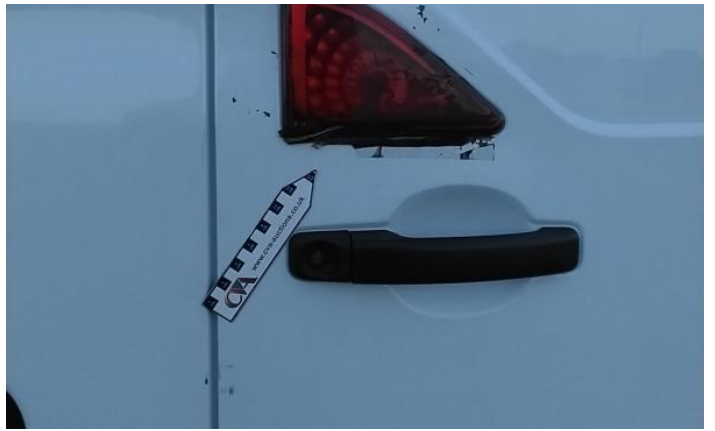
12: Lamp osr  
Broken  
Replace

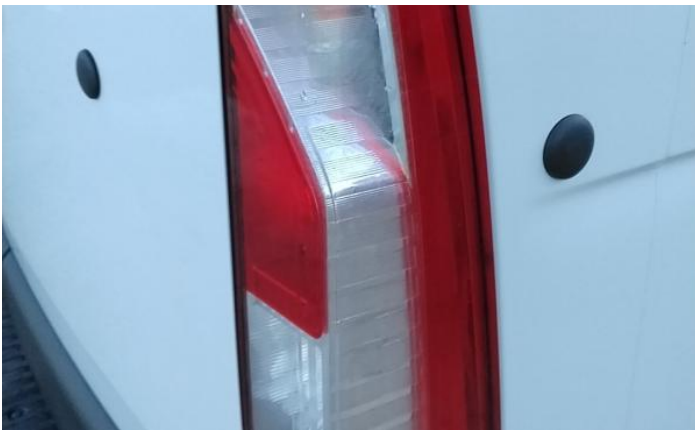
13: Lamp osr  
Broken  
Replace

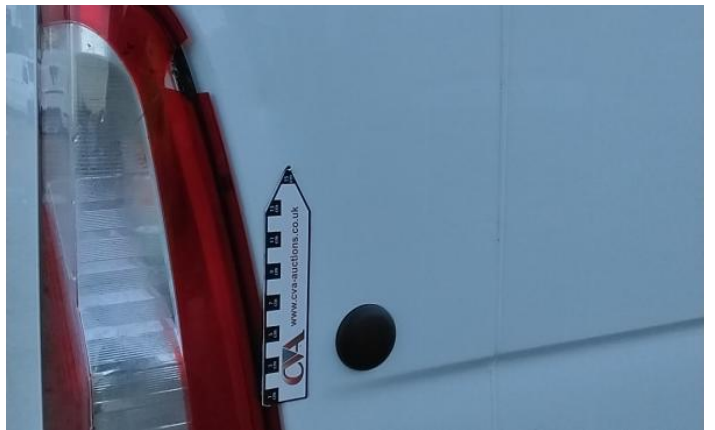
14: Qtr Panel osr  
Dented  
Between 10mm + 30mm

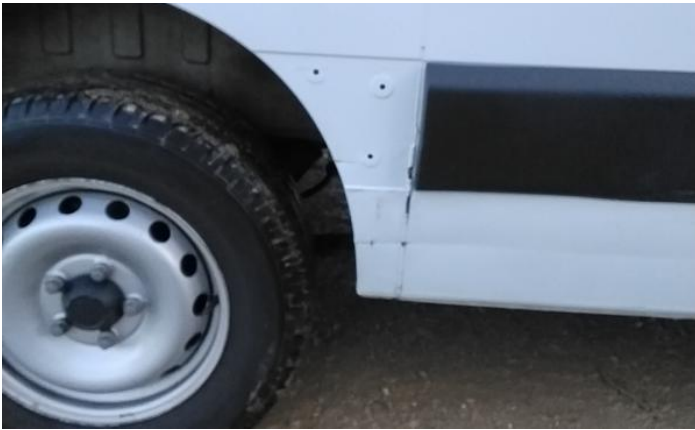
15: Qtr Panel Moulding os  
Missing  
Replace

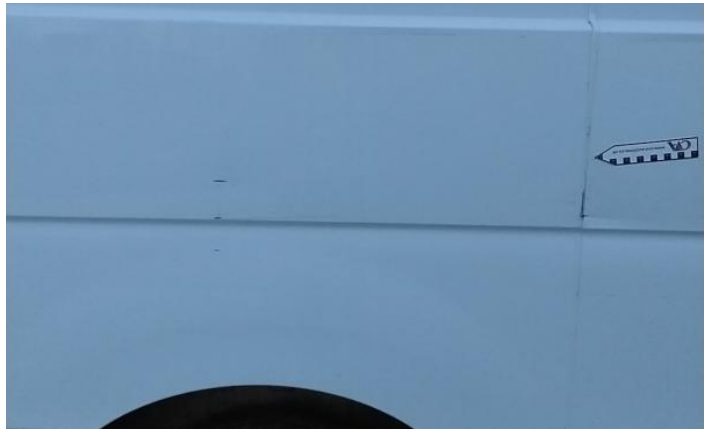
16: Qtr Panel osr  
Scratched  
Over 25mm Not Thru Paint

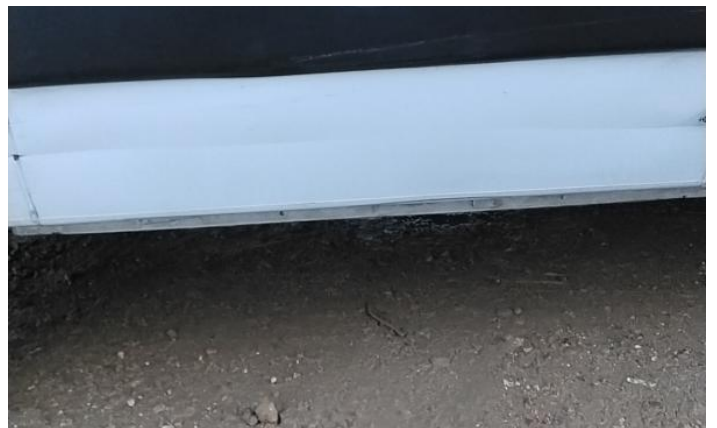
18: Qtr Panel osr  
Dented  
Over 30mm

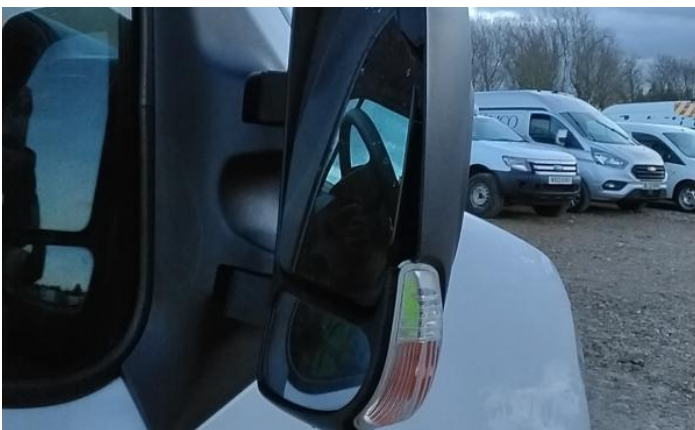
19: Door Mirror Assy osf  
Broken  
Replace
