# VEHICLE INSPECTION REPORT

**PO13DZL**

## Daf LF 45.140

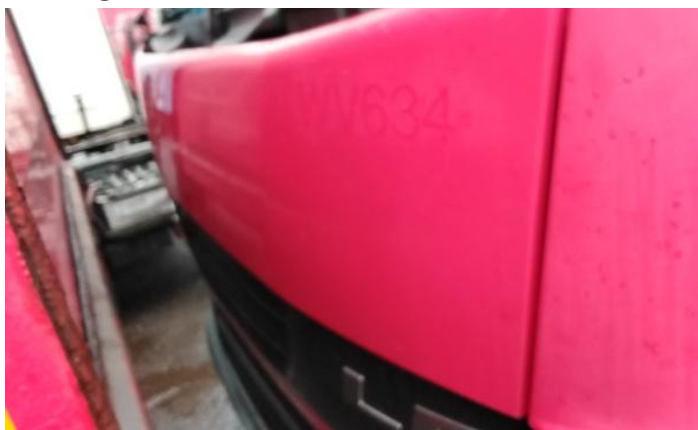
1: Bonnet  
Chipped  
Multiple Chips

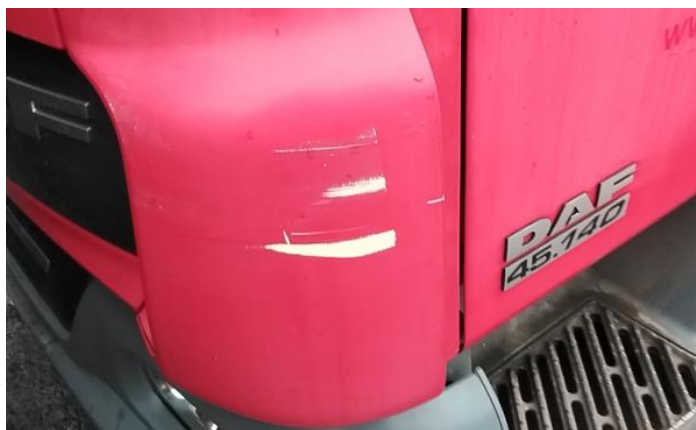
2: Panel Front  
Scratched  
Over 25mm Thru Paint

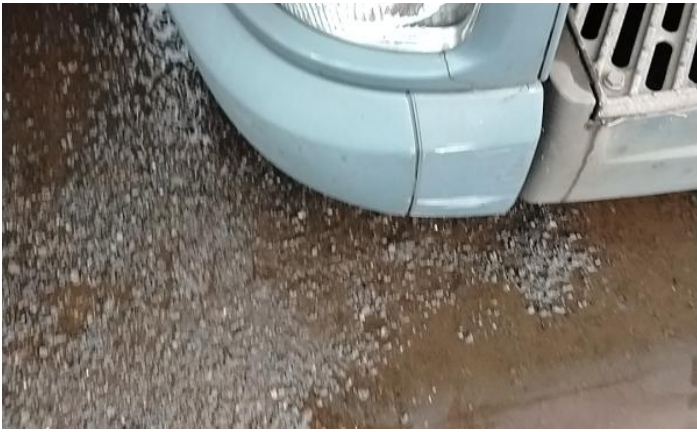
3: Bumper Front  
Scratched  
Over 100mm Thru Paint

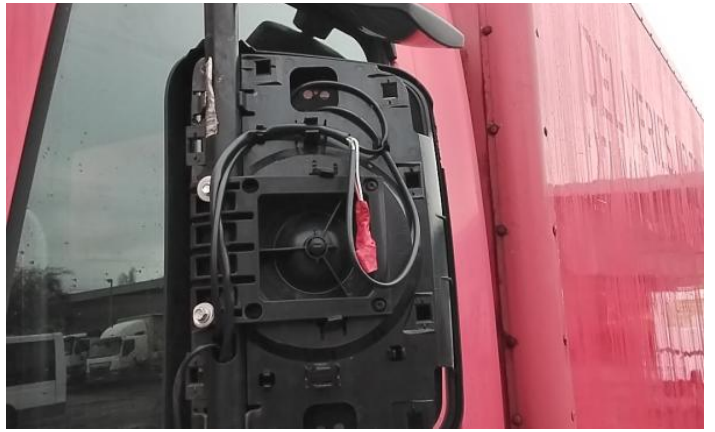
4: Door Mirror Assy nsf  
Broken  
Replace

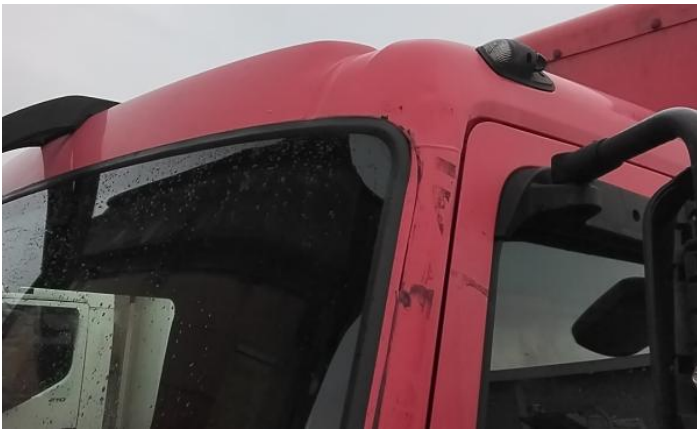
5: Roof  
Dented  
With Paint Damage

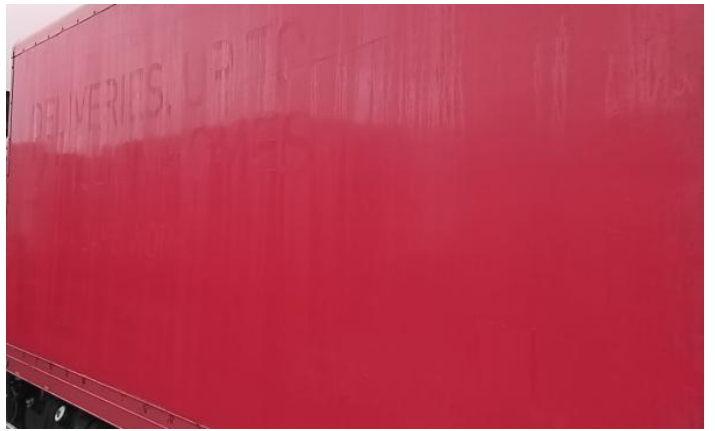
6: Qtr Panel nsr  
Scratched  
Over 25mm Not Thru Paint

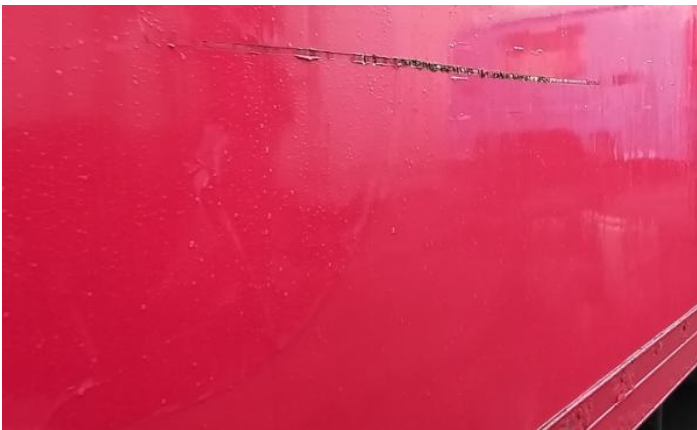
7: Qtr Panel osr  
Scratched  
Over 25mm Thru Paint

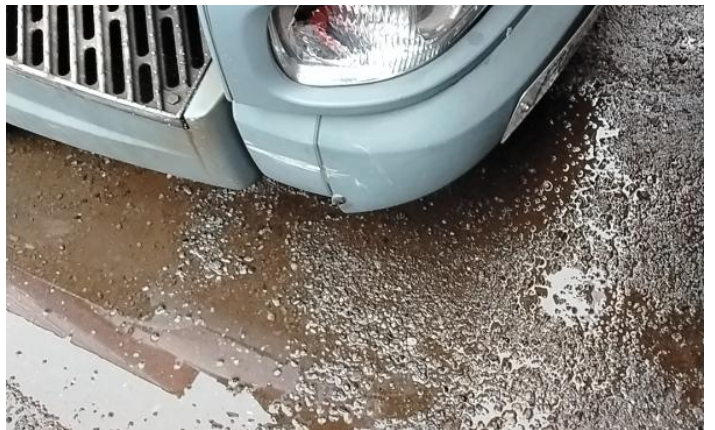
8: Bumper Front  
Dented  
With Paint Damage

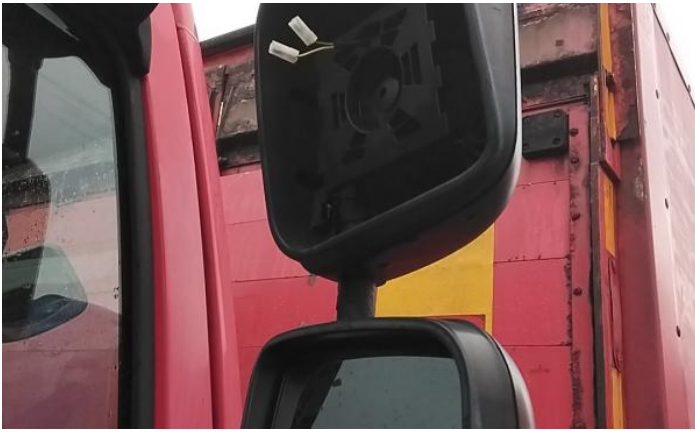
9: Door Mirror Glass os  
Missing  
Replace

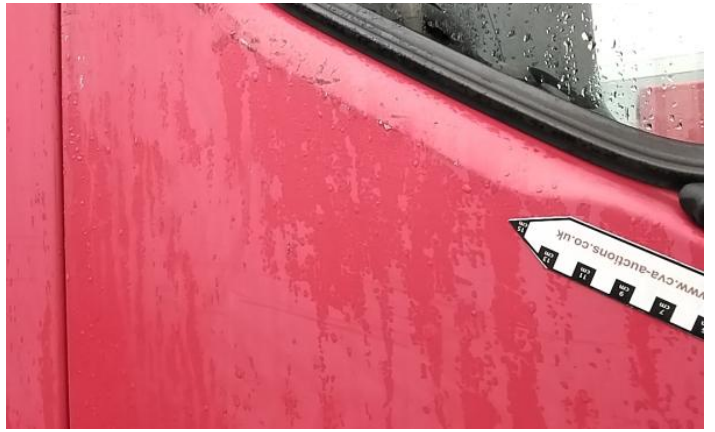
10: Door osf  
Scratched  
Over 25mm Thru Paint

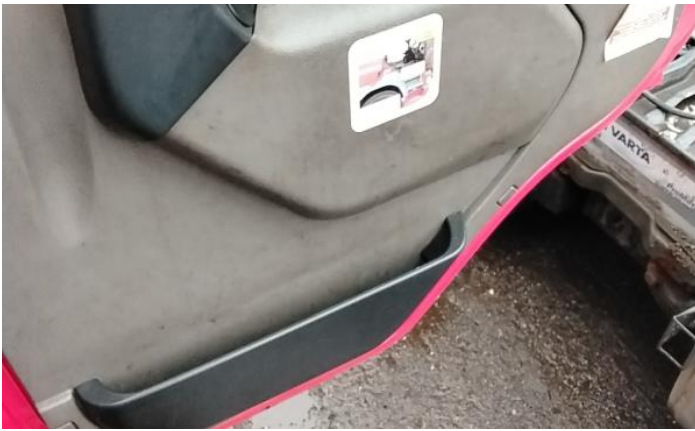
11: Door Pad osf  
Soiled  
Heavy

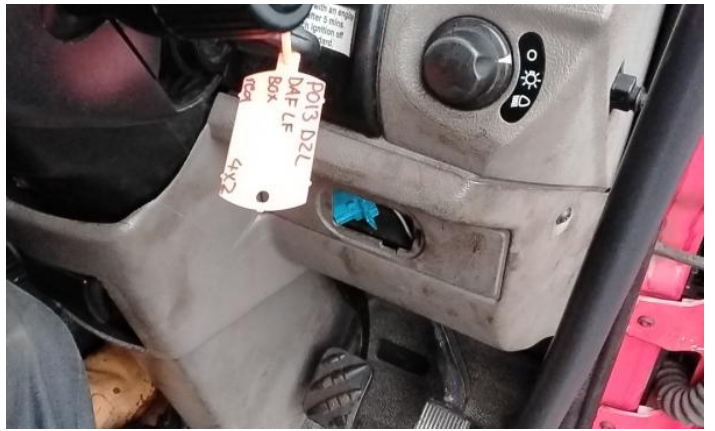
12: Fascia Panel  
Soiled  
Heavy

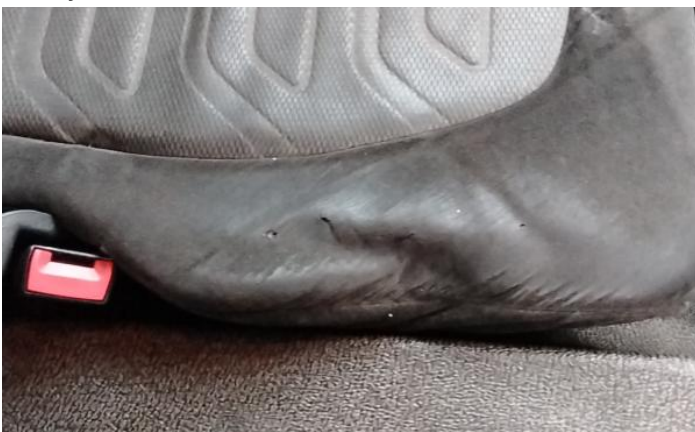
13: Seat Base Cover nsf  
Burn  
Over 3mm
