# VEHICLE INSPECTION REPORT

**PE17HRM**

## Daf CF 440

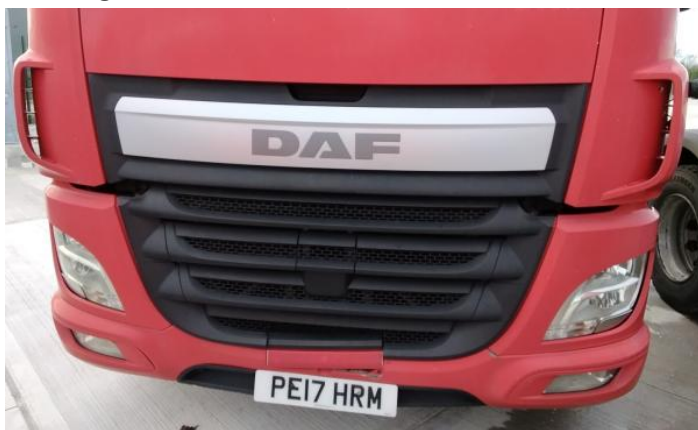
1: Bonnet  
Chipped  
Multiple Chips

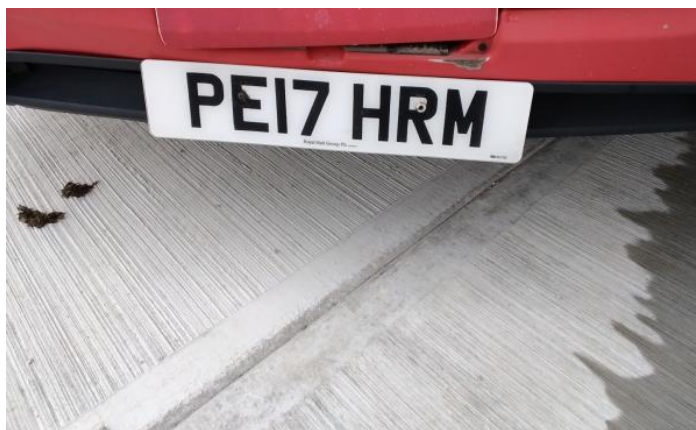
2: Bumper Front Moulding  
Broken  
Replace

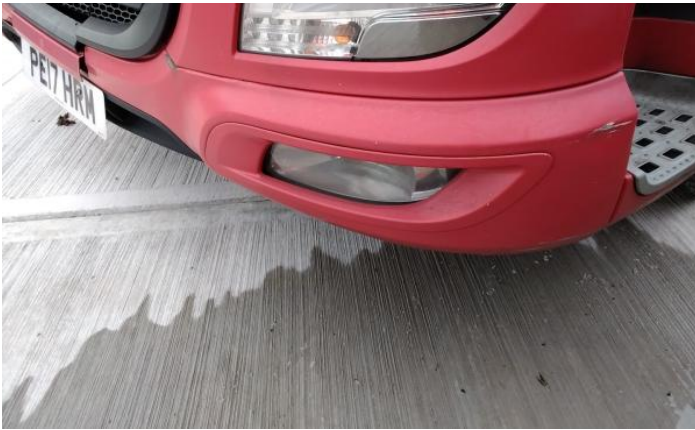
3: Bumper Front  
Dented  
With Paint Damage

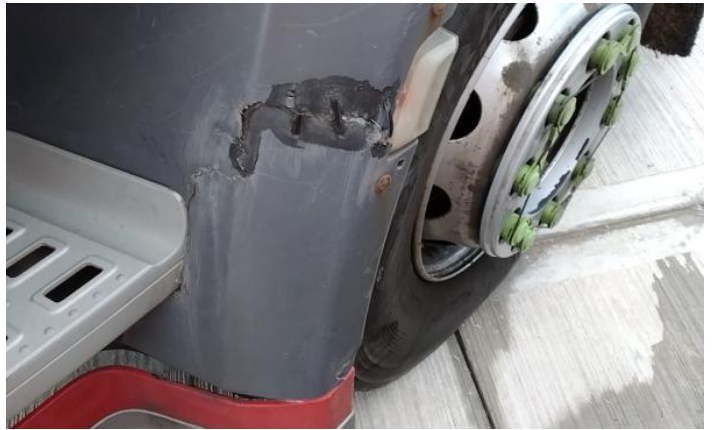
4: Wing nsf  
Cracked  
Replace

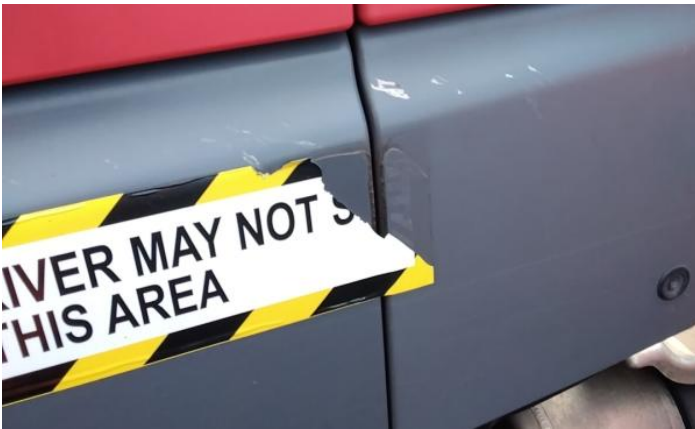
5: Qtr Panel Moulding ns  
Scratched (Painted)  
Over 25mm Thru Paint

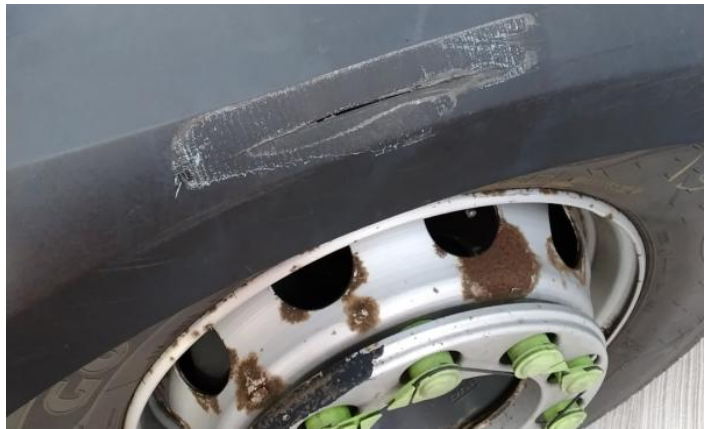
6: Qtr Panel Moulding os  
Broken  
Replace

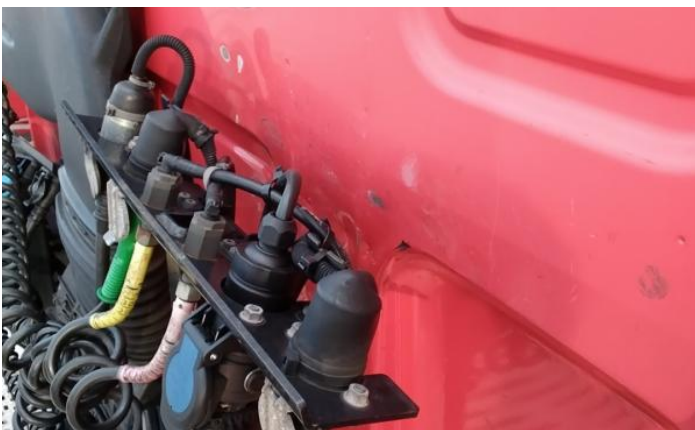
7: Panel Rear  
Dented  
With Paint Damage

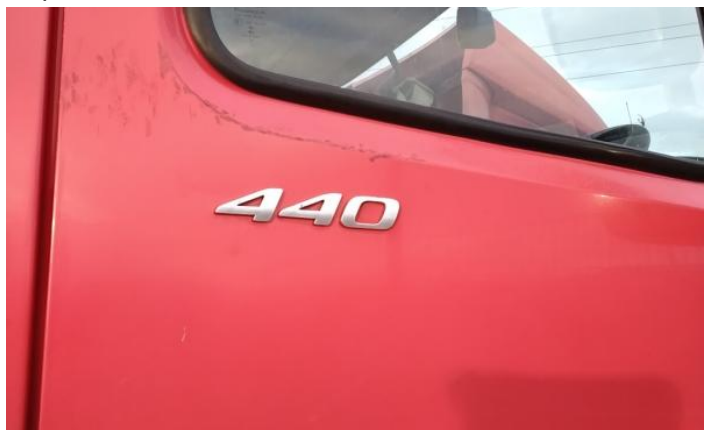
8: Door osf  
Dented  
With Paint Damage

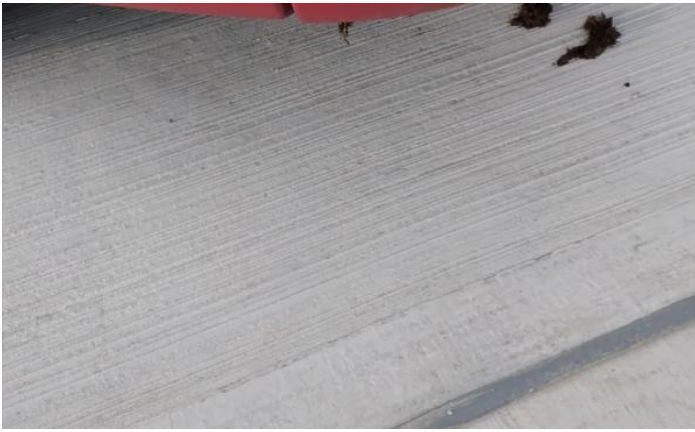
9: Bumper Front  
Dented  
With Paint Damage

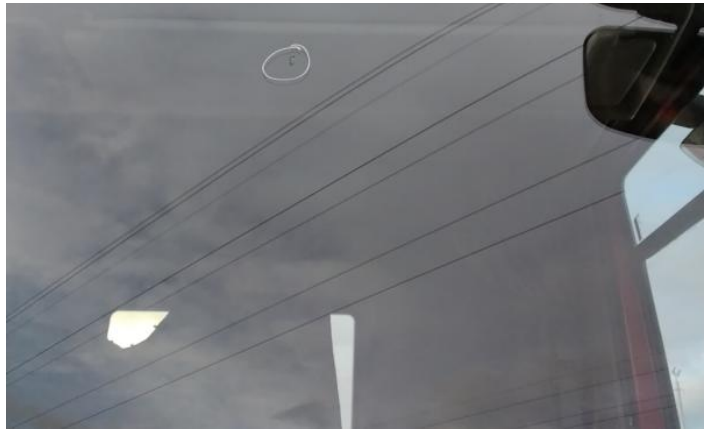
10: Screen Front  
Chipped  
UpTo 10mm

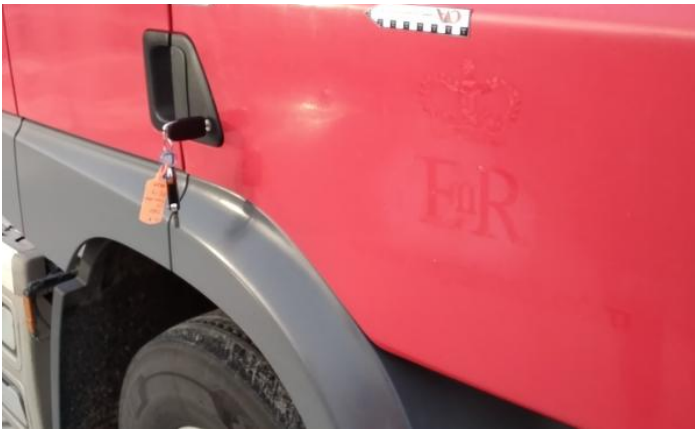
11: Door osf  
Dented  
Over 30mm

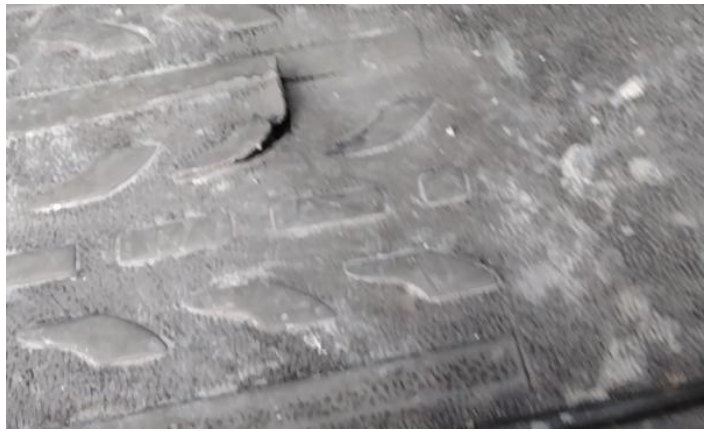
12: Carpets Front  
Holed  
Over 3mm

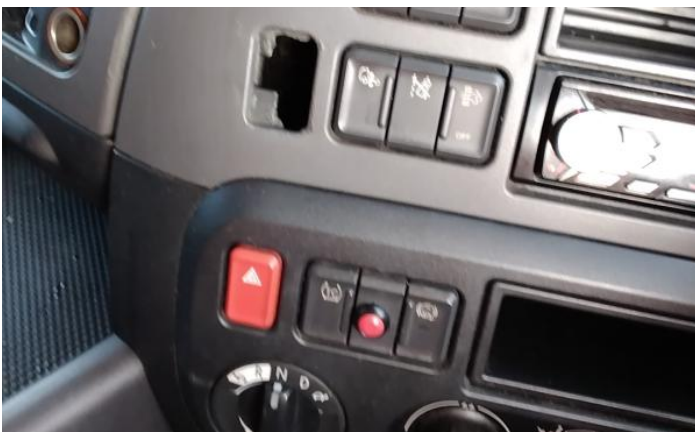
13: Switches And Controls  
Missing  
Replace
