# VEHICLE INSPECTION REPORT

**PE63MYT**

## Daf LF 45.140

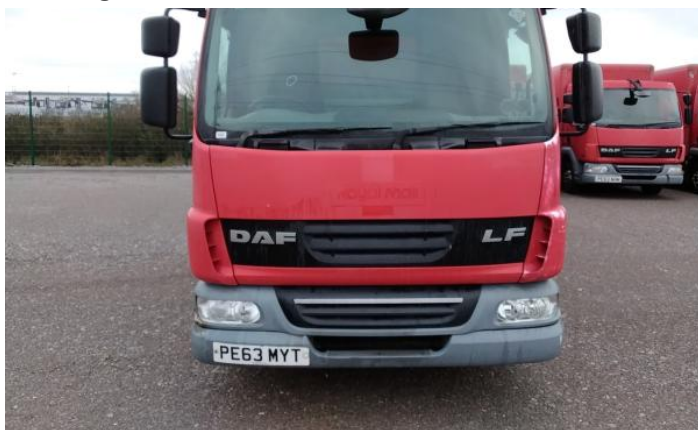
1: Bonnet  
Chipped  
Multiple Chips

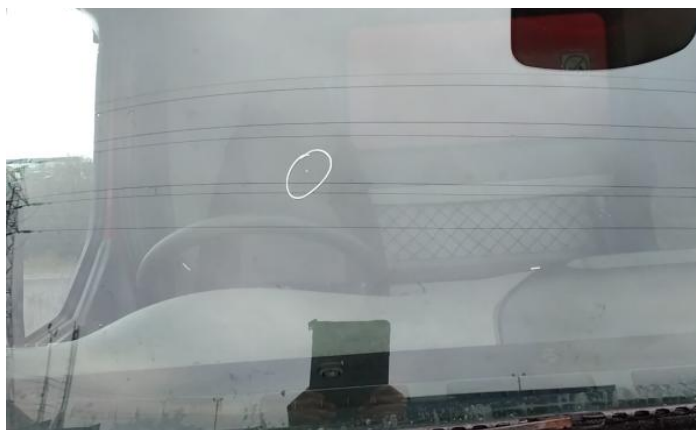
2: Screen Front  
Chipped  
UpTo 10mm

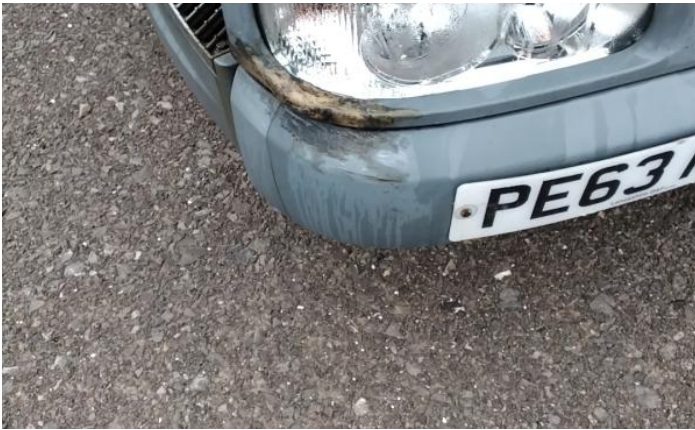
3: Bumper Front  
Cracked  
Over 25mm

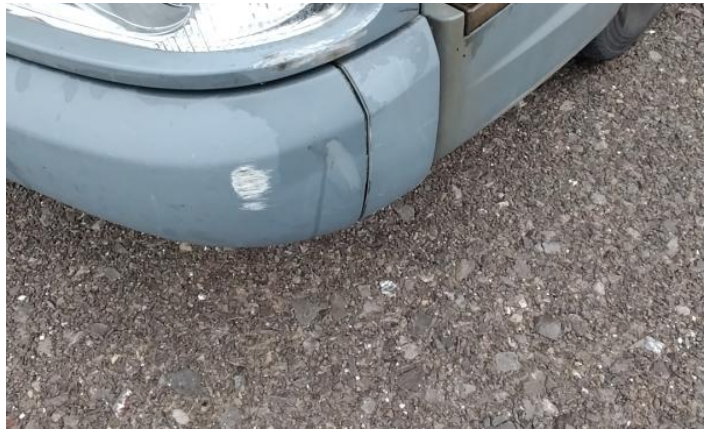
4: Bumper Front  
Scratched  
Over 100mm Thru Paint

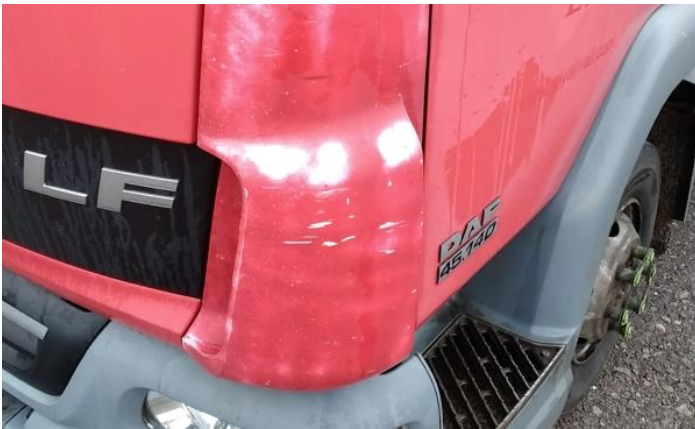
5: Bumper Front Moulding  
Scratched (Painted)  
Over 25mm Thru Paint

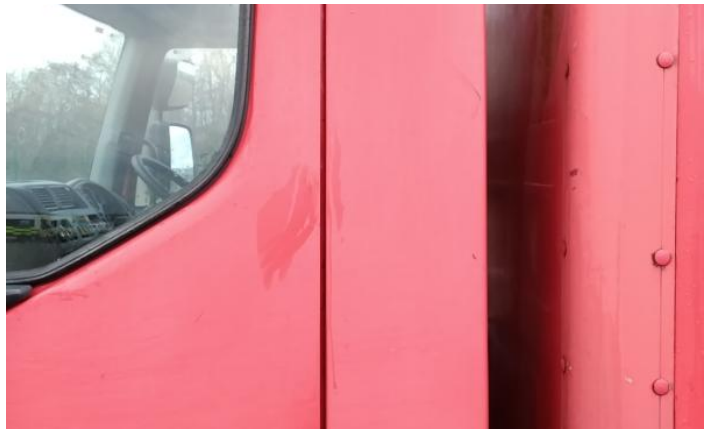
6: Qtr Panel nsr  
Scratched  
Over 25mm Not Thru Paint

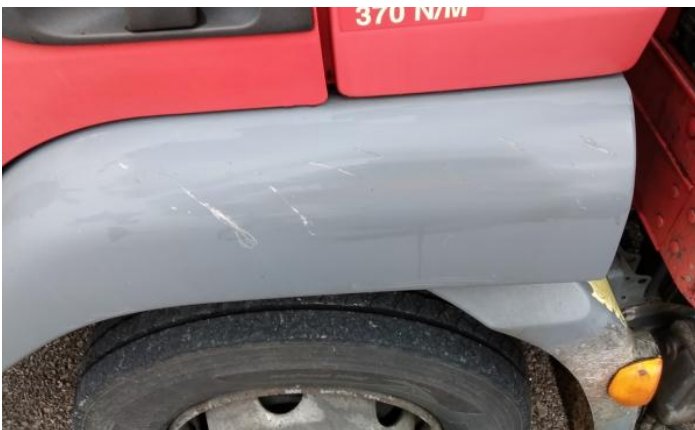
7: Moulding nsf Wing  
Scratched (Painted)  
Over 25mm Thru Paint

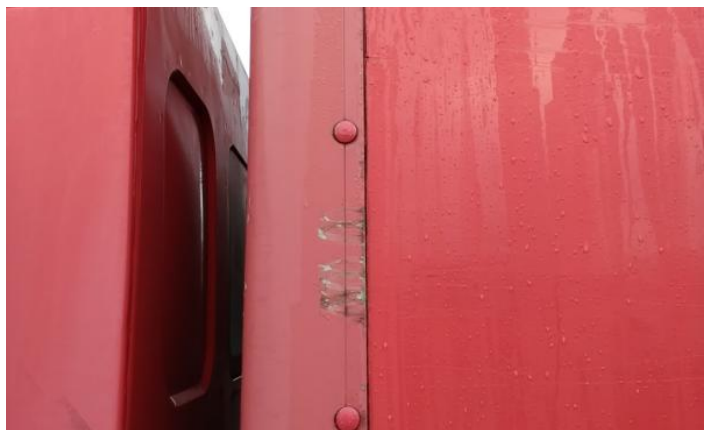
8: Qtr Panel nsr  
Scratched  
Over 25mm Thru Paint

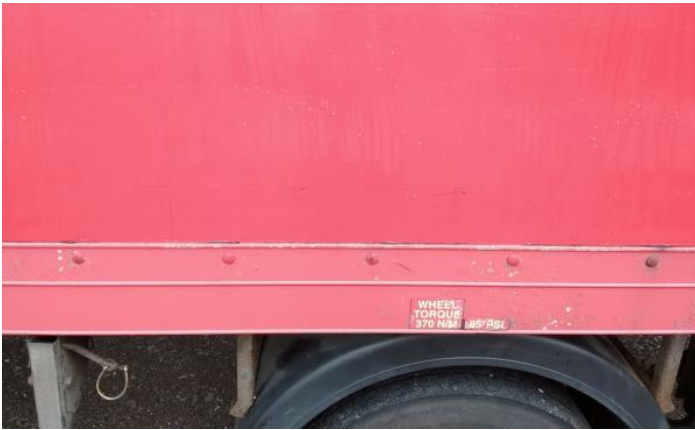
9: Qtr Panel nsr  
Scratched  
Over 25mm Thru Paint

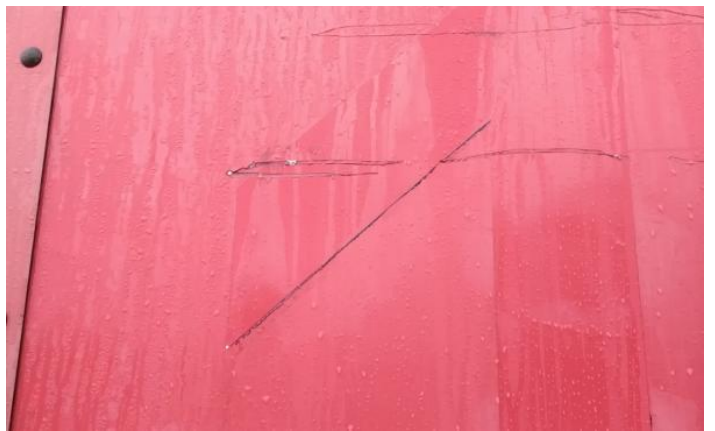
12: Qtr Panel osr  
Cracked  
Replace

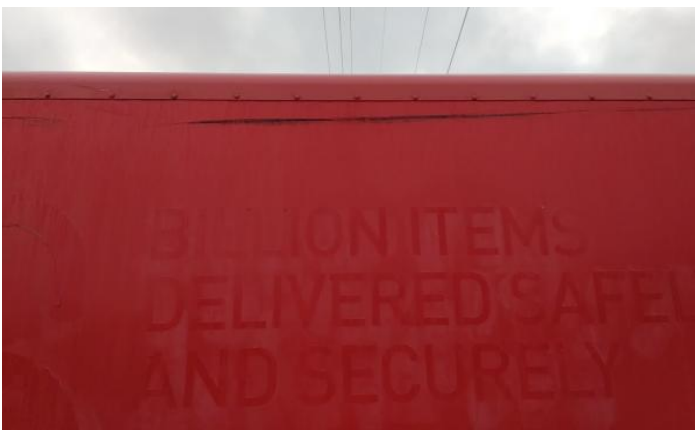
13: Qtr Panel osr  
Scratched  
Over 25mm Thru Paint

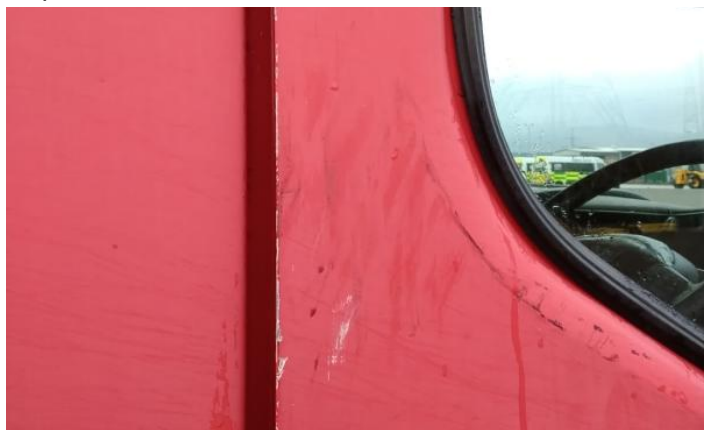
14: Door osf  
Chipped  
Edge Chip

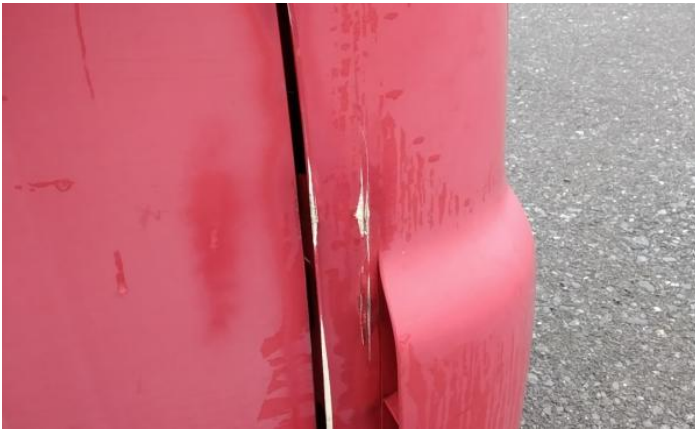
15: Moulding of Wing  
Broken  
Replace

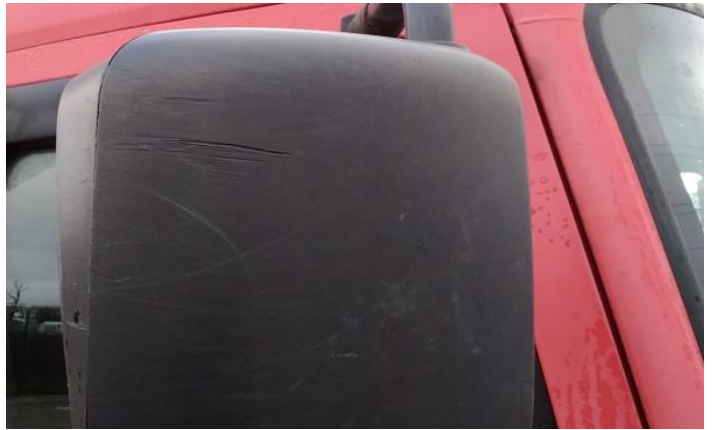
16: Door Mirror Assy of  
Scratched (Painted)  
Over 25mm Thru Paint

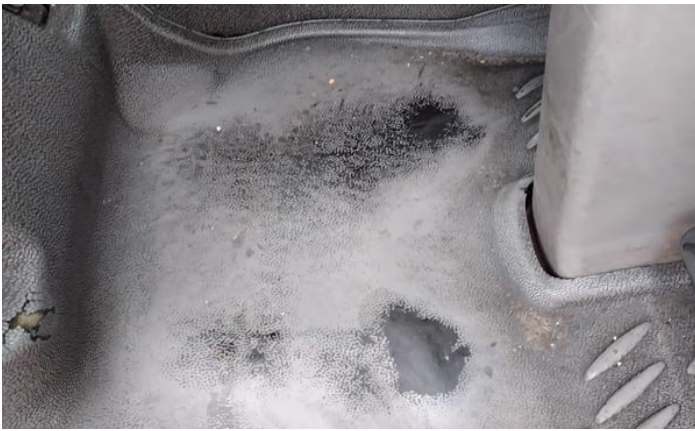
17: Carpets Front  
Holed  
Over 3mm

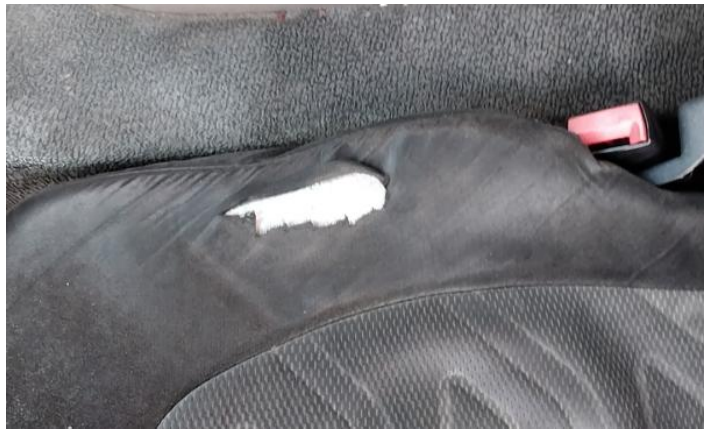
18: Seat Base Cover of  
Holed  
Over 3mm

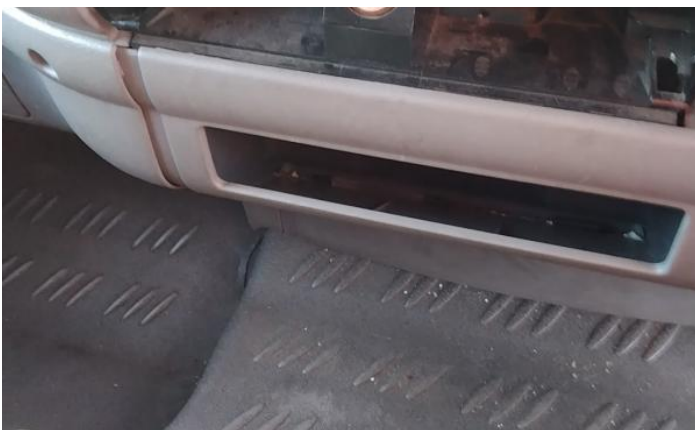
19: Switches And Controls  
Missing  
Replace

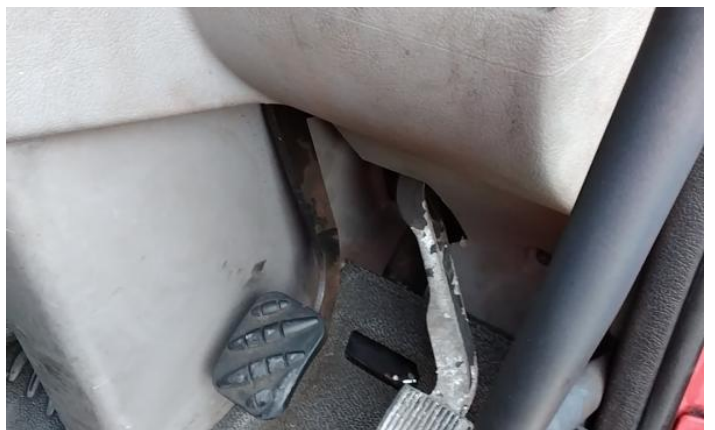
20: Switches And Controls  
Missing  
Replace

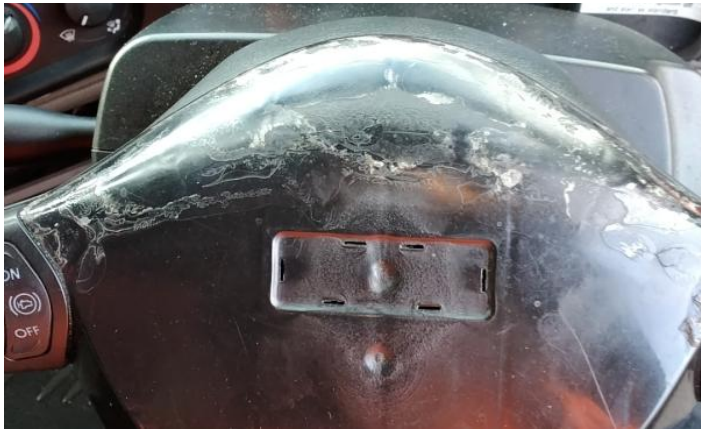
21: Steering Wheel  
 Damaged  
 Replace
