# VEHICLE INSPECTION REPORT

**PE17HSJ**

## Daf CF 440

VIN XLRTGM4100G150646

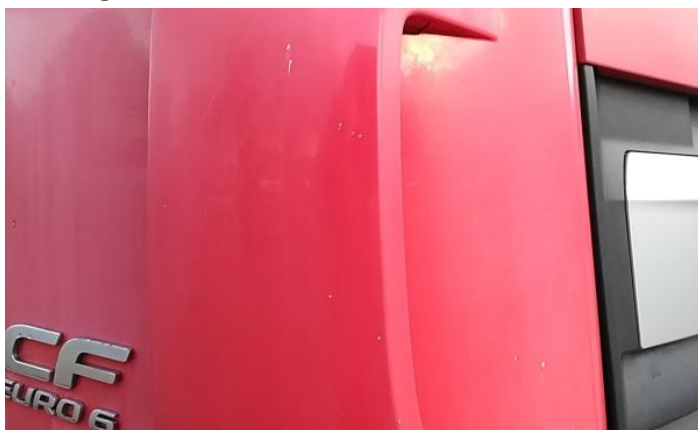
1: Wing osf  
Chipped  
Multiple Chips

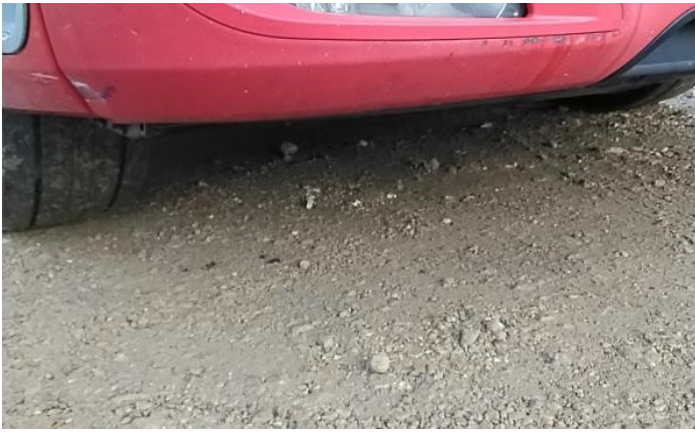
3: Fog Lamp Surround os  
Scratched (Painted)  
Over 25mm Thru Paint

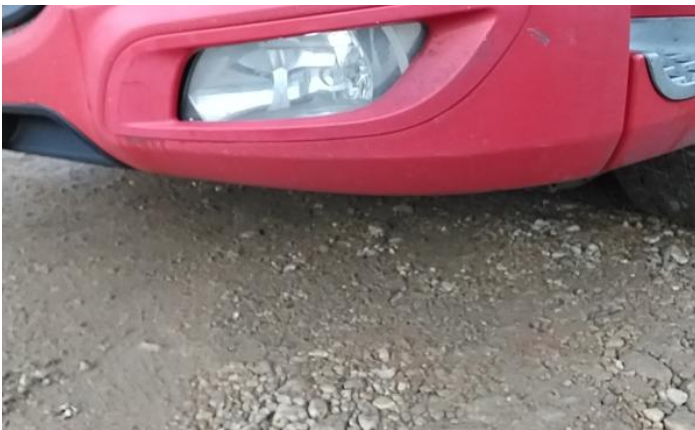
6: Bumper Front  
Chipped  
Multiple Chips

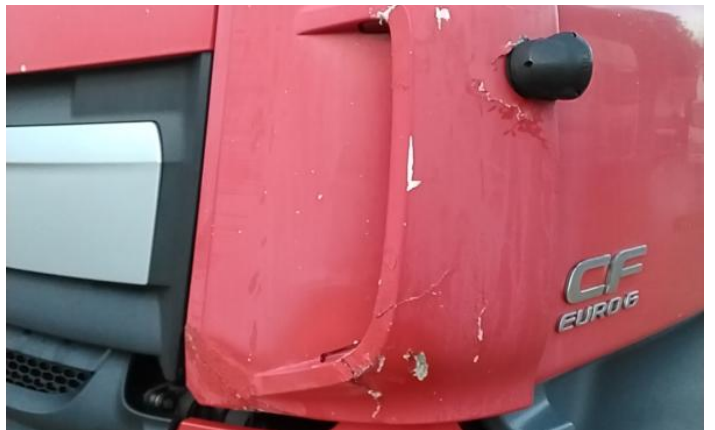
7: Fog Lamp Surround ns  
Scratched (Painted)  
Over 25mm Thru Paint

8: Wing nsf  
Cracked  
Replace

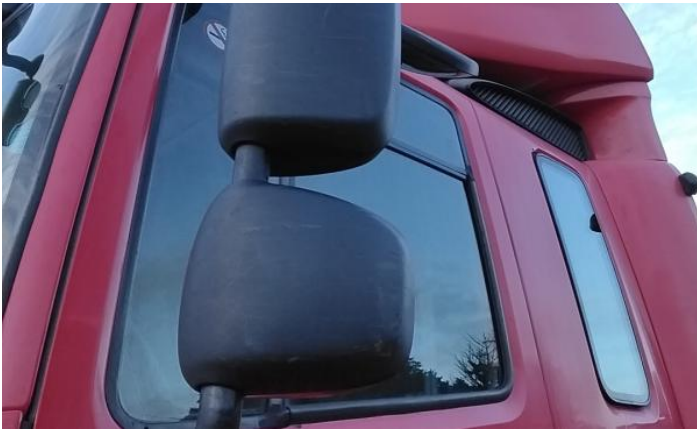
9: Door Mirror Assy nsf  
Scuffed (Unpainted)  
Over 100mm

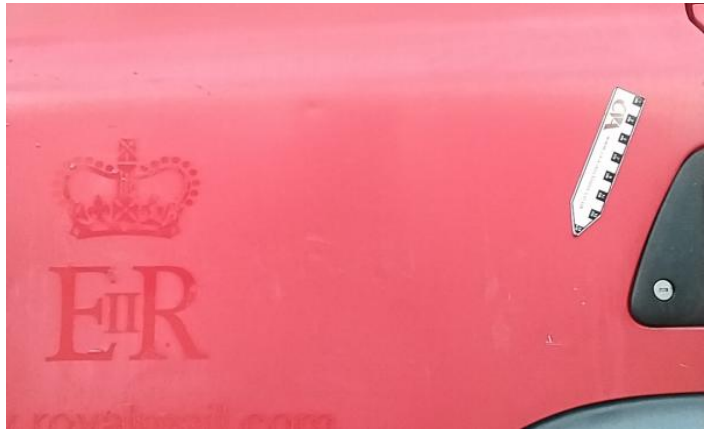
10: Door nsf  
Scratched  
Over 25mm Thru Paint

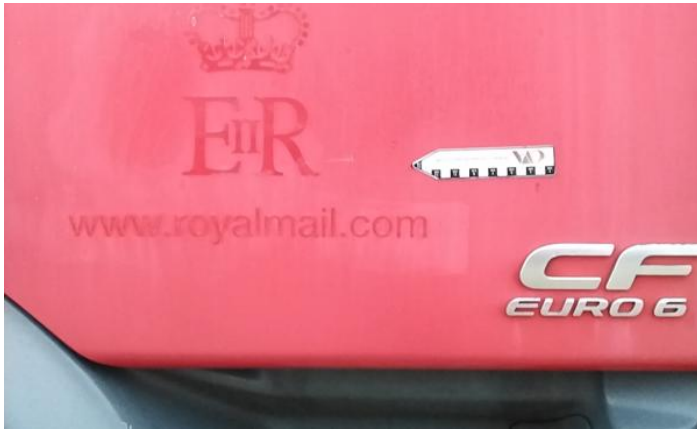
15: Door osf  
 Scratched  
 UpTo 25mm Thru Paint

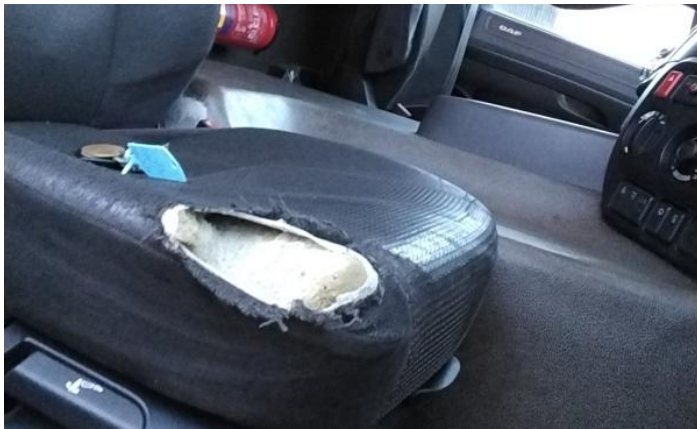
17: Seat Base Cover osf  
 Holed  
 Over 3mm
