# VEHICLE INSPECTION REPORT

**PE63NHN**

## Daf LF 45.140

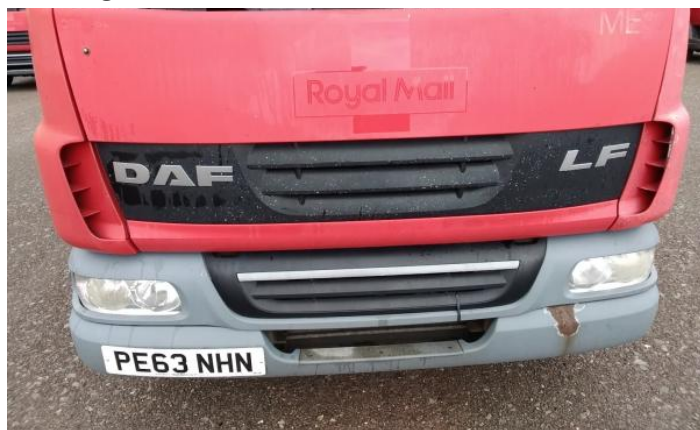
1: Bonnet  
Chipped  
Multiple Chips

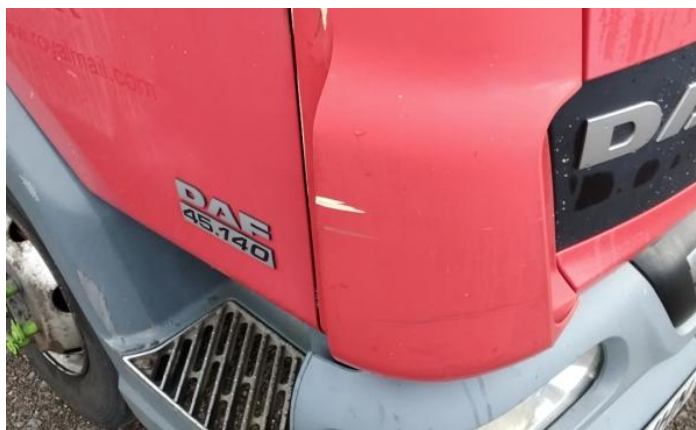
2: Moulding on Wing  
Broken  
Replace

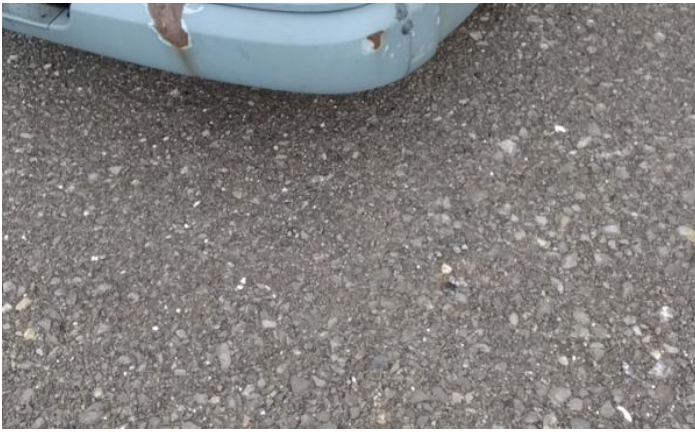
3: Bumper Front  
Rusted  
Over 5mm

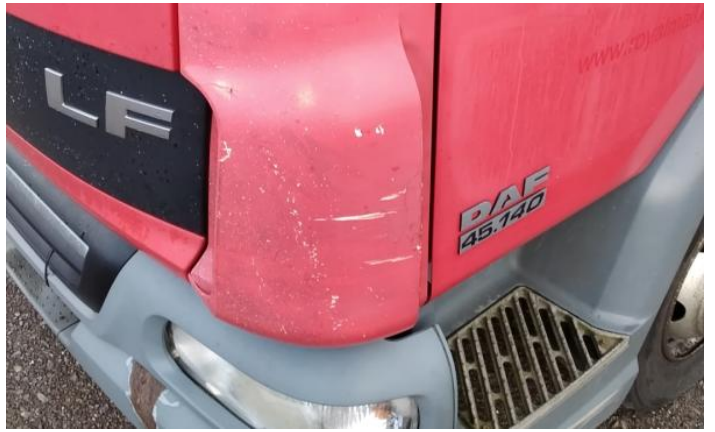
4: Moulding nsf Wing  
Broken  
Replace

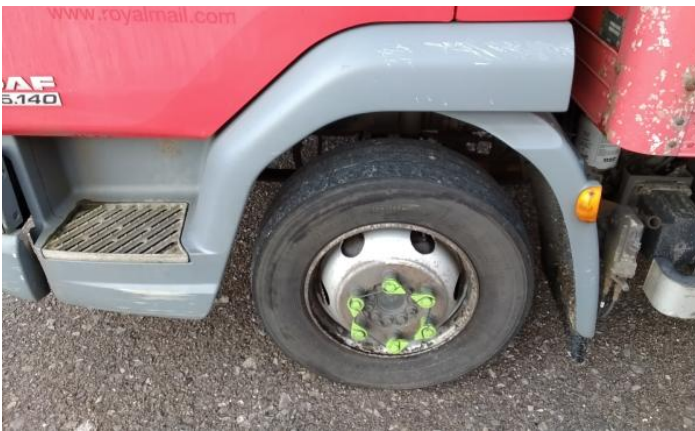
5: Moulding nsf Wing  
Scratched (Painted)  
Over 25mm Thru Paint

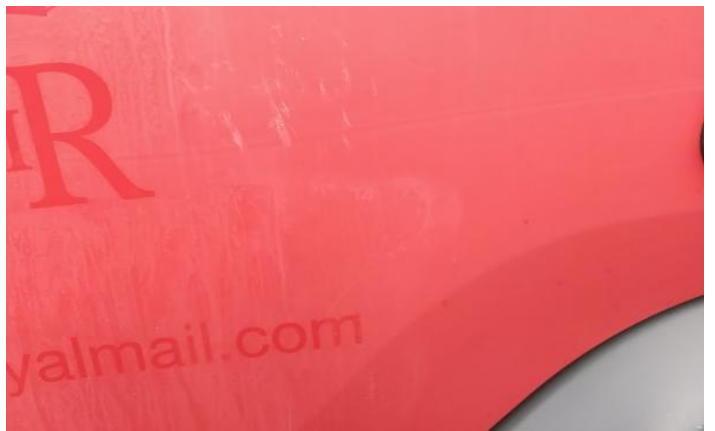
6: Door nsf  
Scratched  
Over 25mm Thru Paint

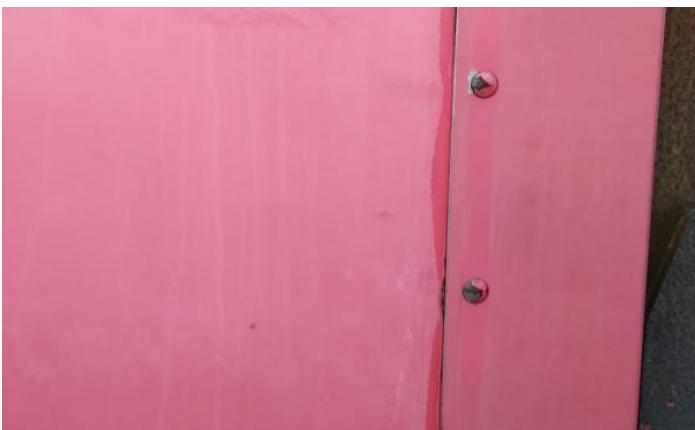
7: Qtr Panel nsr  
Scratched  
Over 25mm Thru Paint

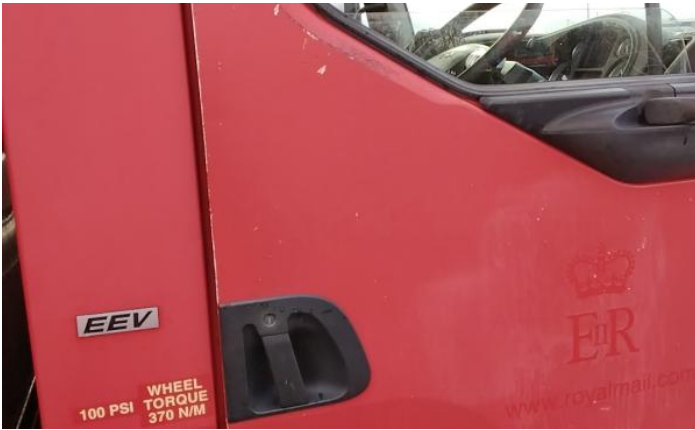
9: Door osf  
Chipped  
Multiple Chips

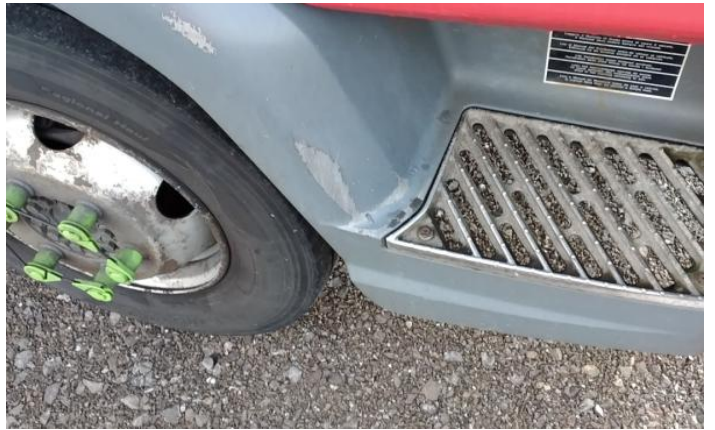
10: Moulding osf Wing  
Scratched (Painted)  
Over 25mm Thru Paint

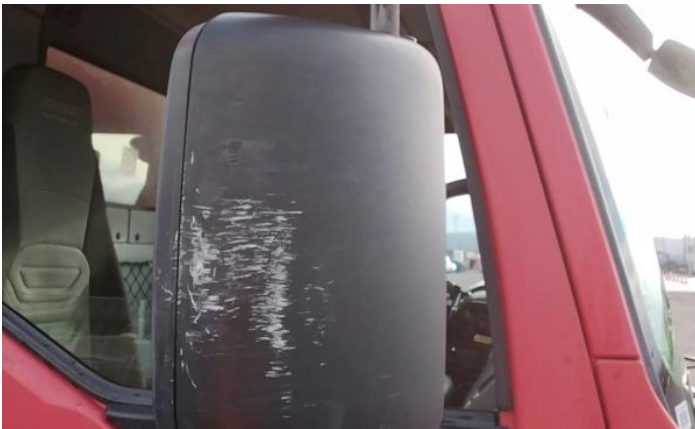
11: Door Mirror Assy osf  
Scuffed (Unpainted)  
Over 100mm

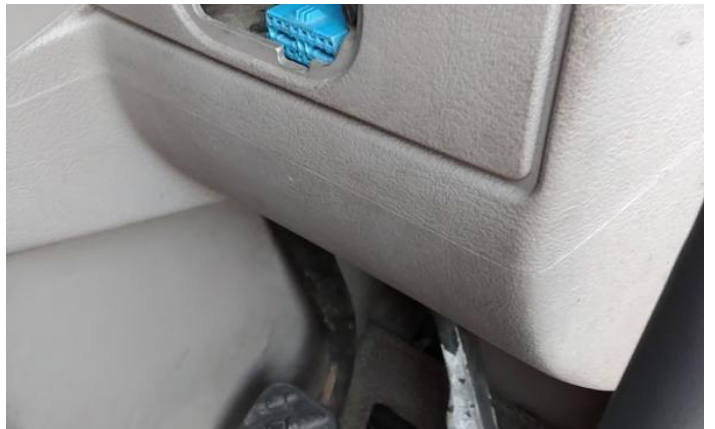
12: Switches And Controls  
Missing  
Replace

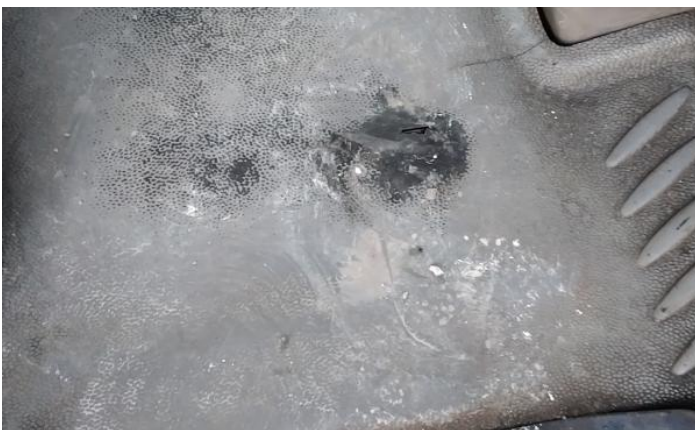
13: Carpets Front  
Holed  
Over 3mm
