# VEHICLE INSPECTION REPORT

**SJ65GCV**

## Fuso Canter 7C18

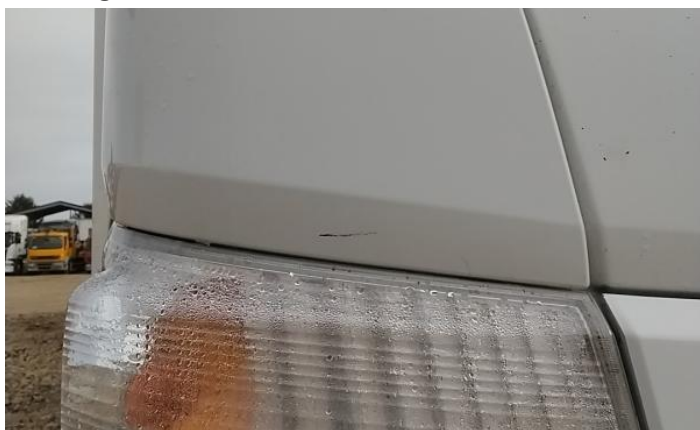
1: Wing osf  
Scratched  
UpTo 25mm Thru Paint

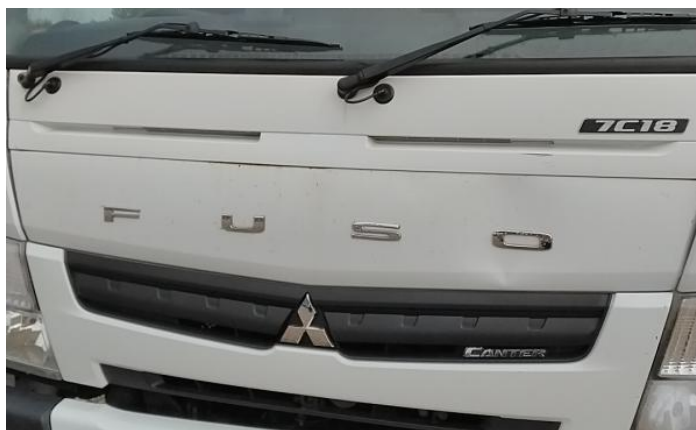
2: Bonnet  
Dented  
Between 10mm + 30mm

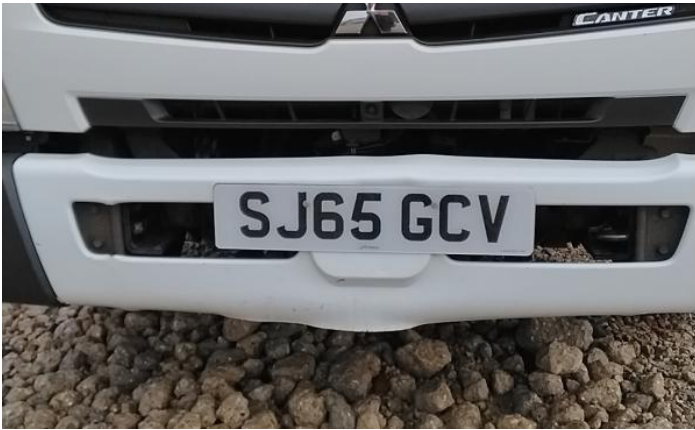
3: Bumper Front  
Dented  
Over 30mm

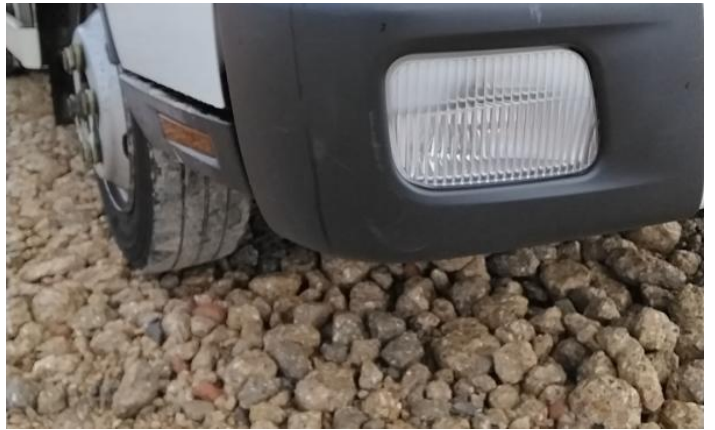
4: Bumper Front Moulding  
Scuffed (Unpainted)  
Over 100mm

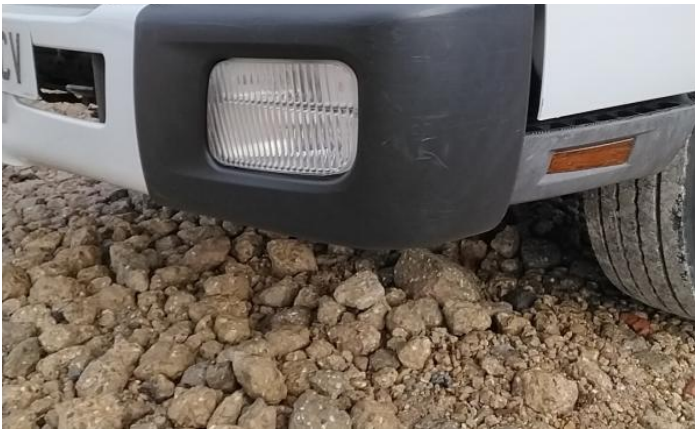
5: Bumper Front Moulding  
Scuffed (Unpainted)  
Over 100mm

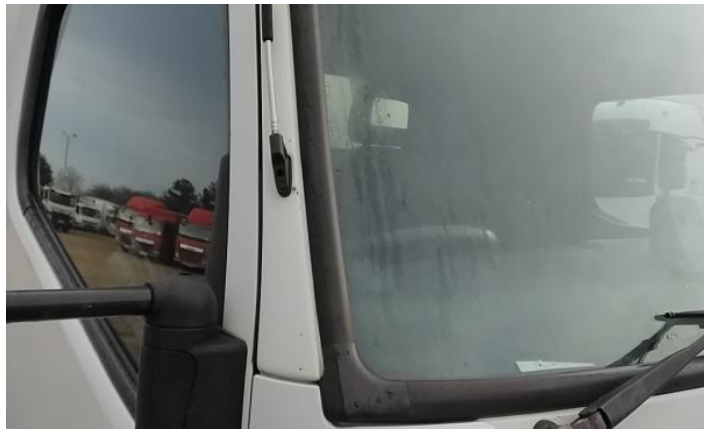
6: A Post os  
Chipped  
Multiple Chips

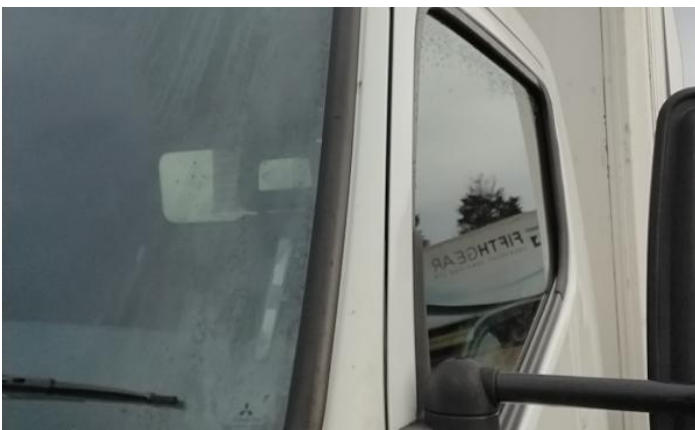
7: A Post ns  
Chipped  
Multiple Chips

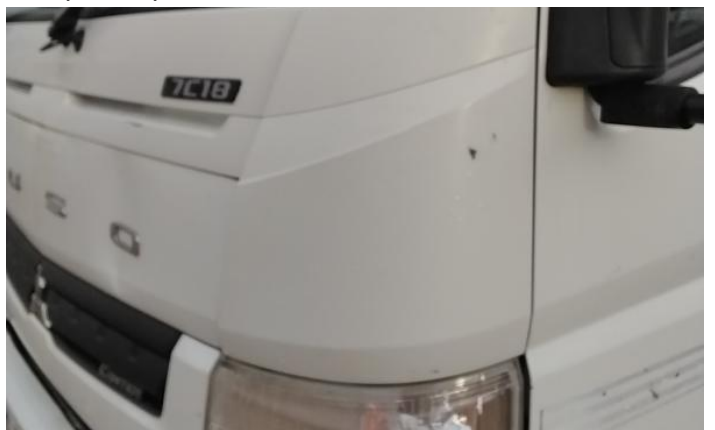
8: Wing nsf  
Scratched  
Over 25mm Thru Paint

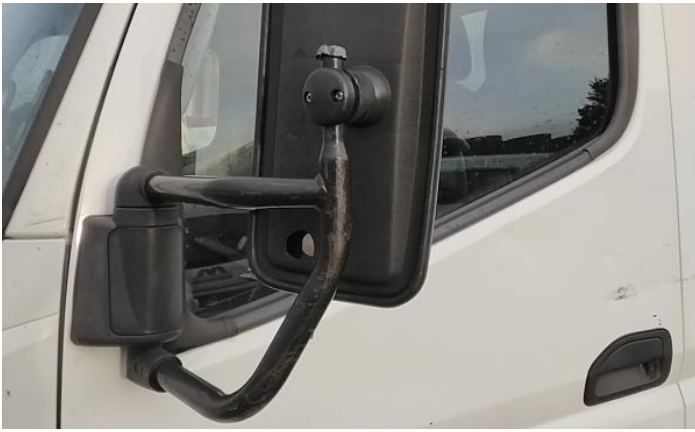
9: Door Mirror Assy nsf  
Scuffed (Unpainted)  
Over 100mm

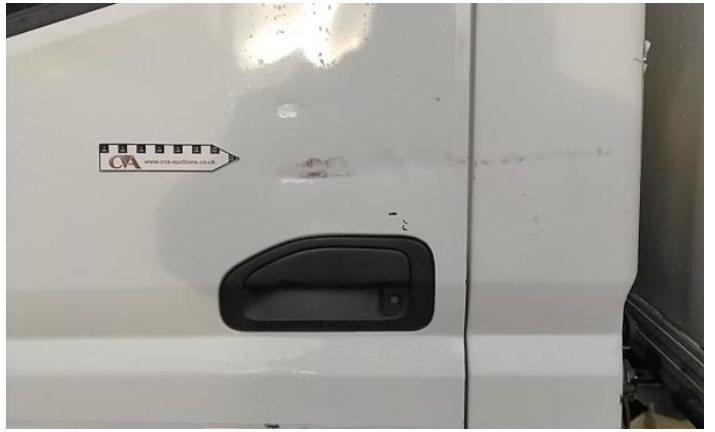
10: Door nsf  
Dented  
With Paint Damage

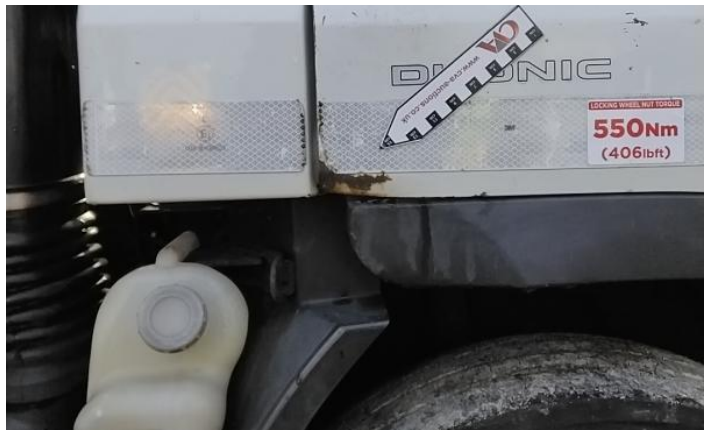
14: Door osf  
Dented  
Between 10mm + 30mm

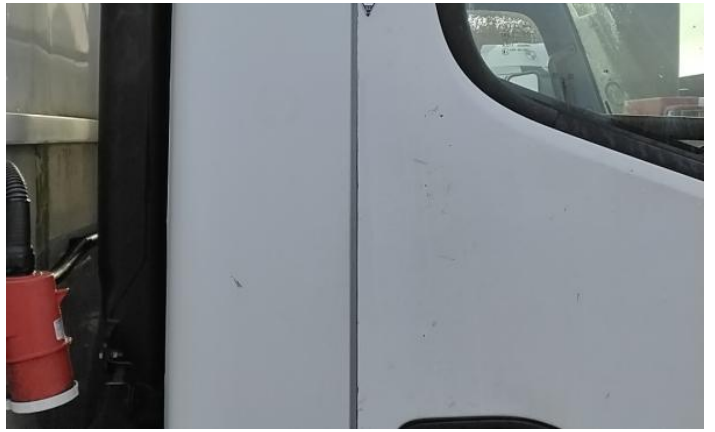
16: Door osf  
Chipped  
Edge Chip

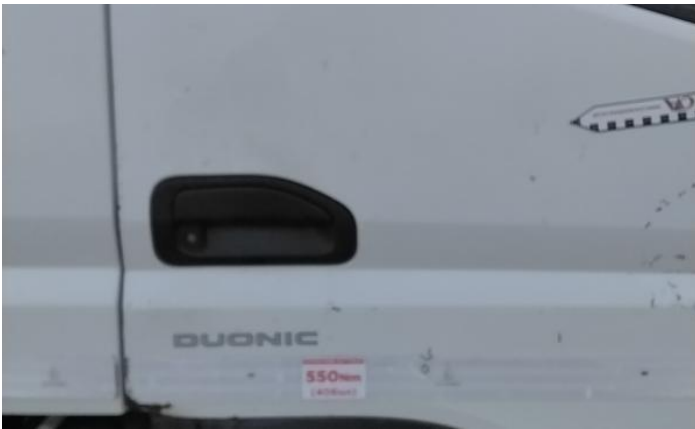
17: Door osf  
Scratched  
Over 25mm Thru Paint

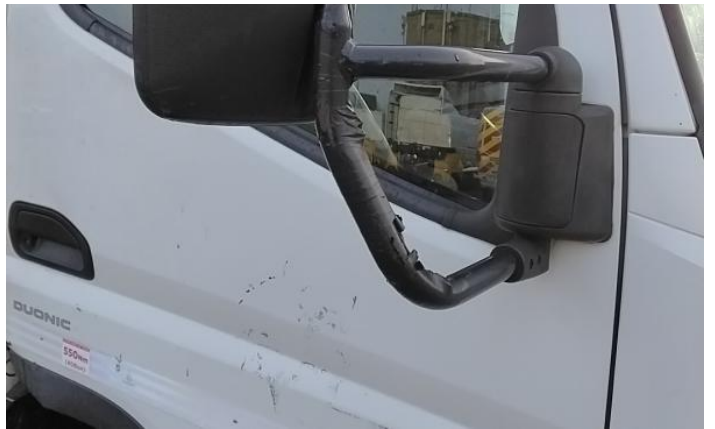
18: Door Mirror Assy osf  
Scuffed (Unpainted)  
Over 100mm

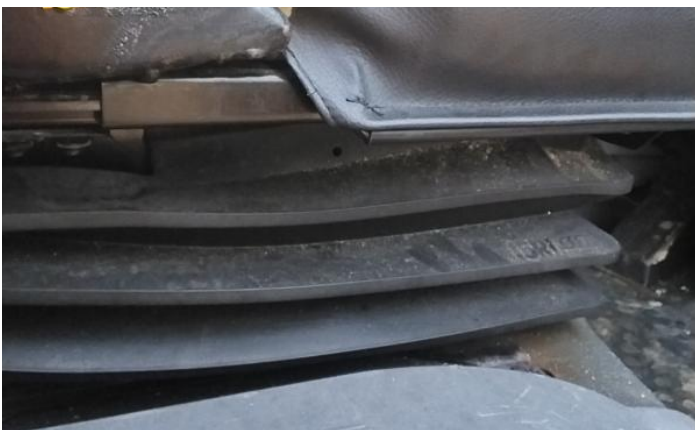
19: Seat Base Cover osf  
Torn  
Over 3mm
