## VEHICLE INSPECTION REPORT

**PJ71NLC**

### Fiat Doblo Work Up 1.6 MULTIJET 16V II

**Non Runner**

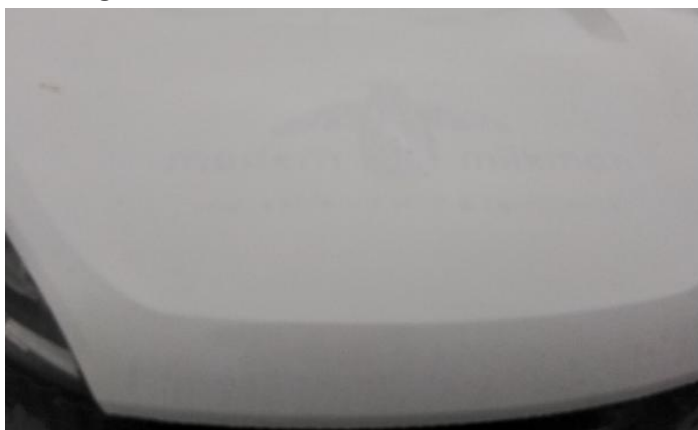
1: Bonnet  
Chipped  
Multiple Chips

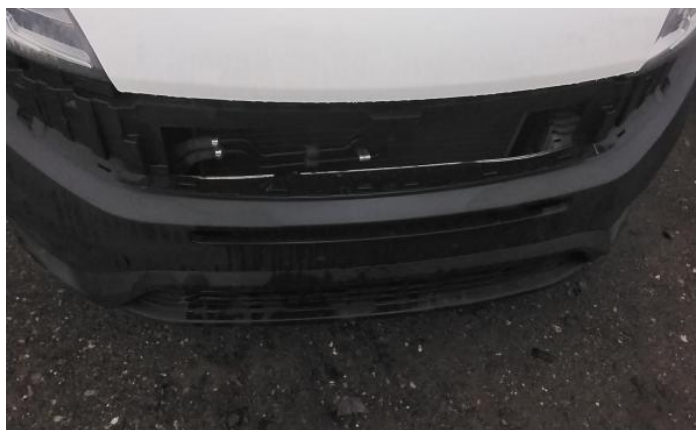
2: Bumper Front Grill  
Missing  
Replace

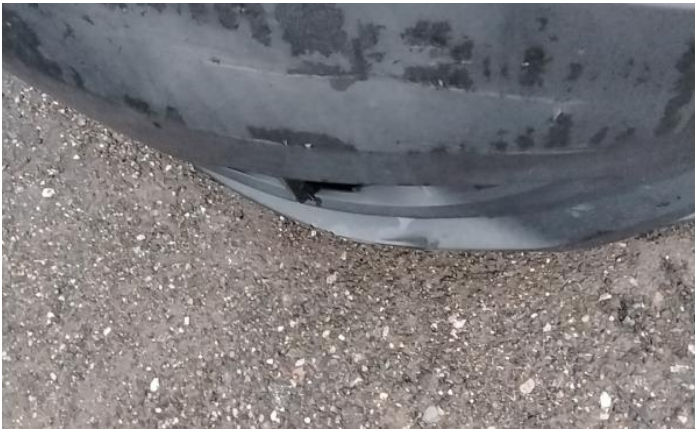
3: Bumper Front  
Dented  
Over 30mm

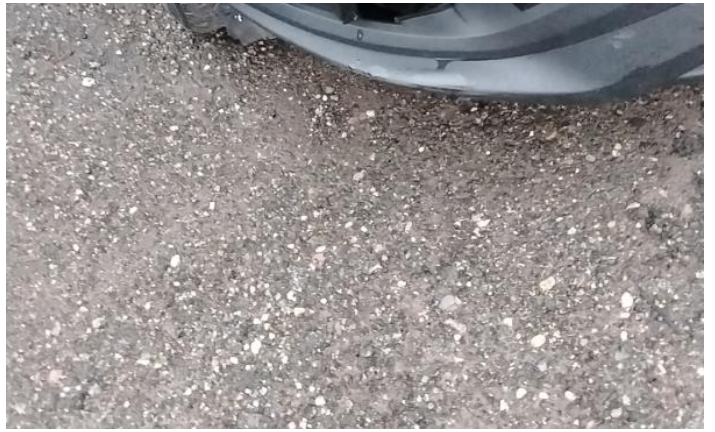
4: Bumper Front Moulding  
Missing  
Replace

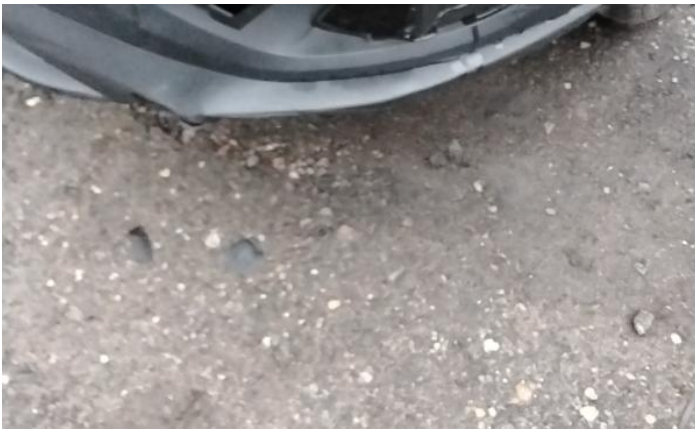
5: Bumper Front Moulding  
Missing  
Replace

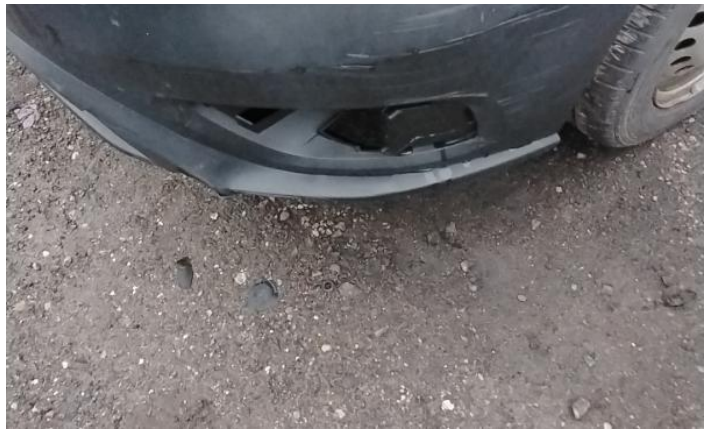
6: Bumper Front  
Scratched  
Over 100mm Thru Paint

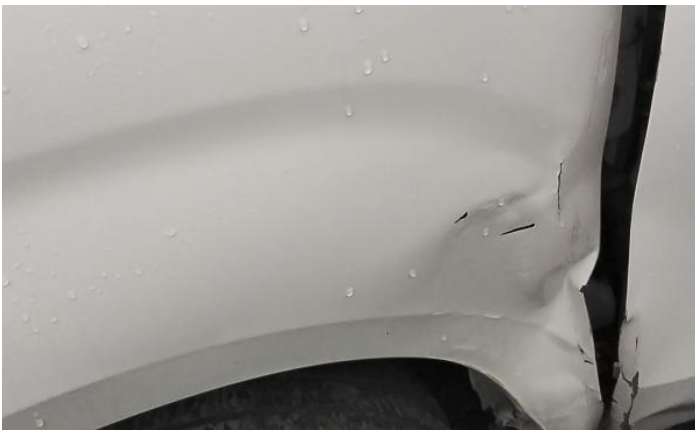
7: Wing nsf  
Dented  
With Paint Damage

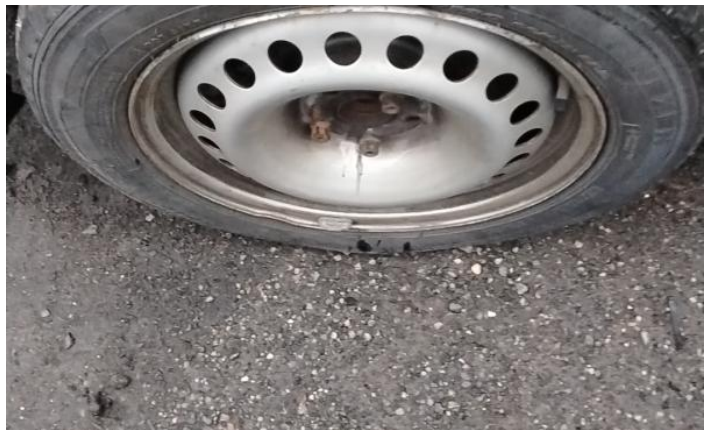
8: Wheel nsf  
Dented  
Over 30mm (Steel)

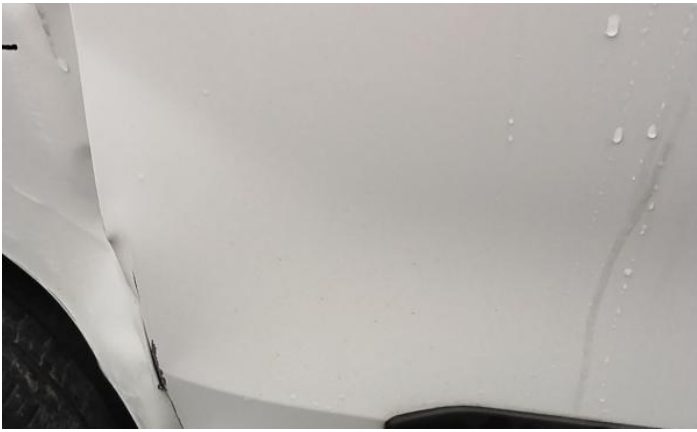
9: Door nsf  
Dented  
With Paint Damage

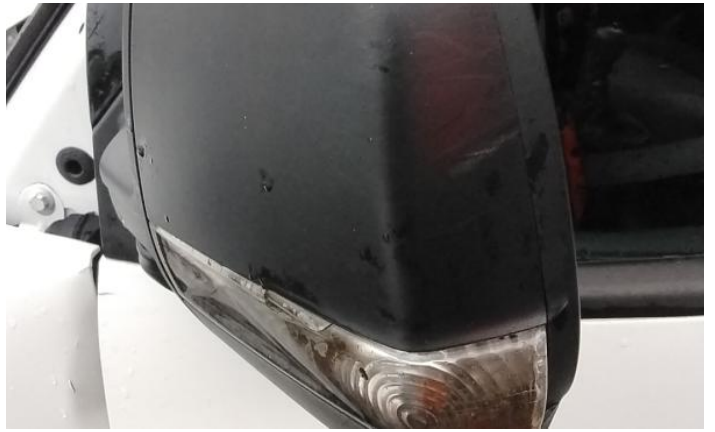
10: Door Mirror Assy nsf  
Broken  
Replace

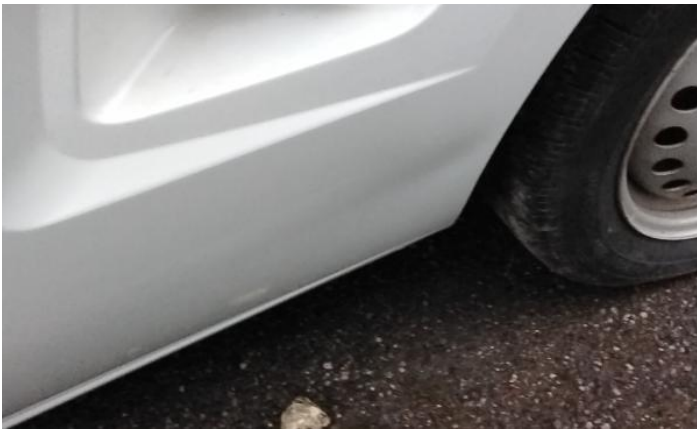
11: Qtr Panel nsr  
Dented  
Over 30mm

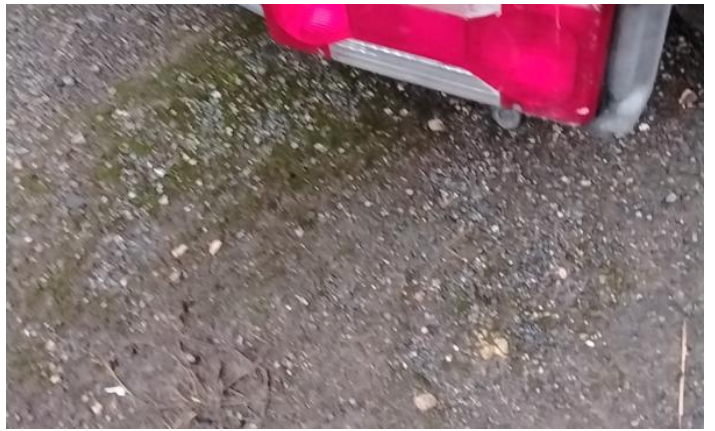
12: Bumper Rear  
Dented  
Over 30mm

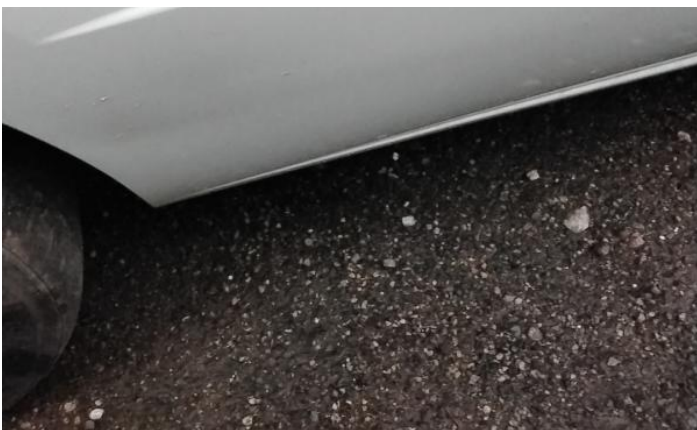
13: Qtr Panel osr  
Dented  
Over 30mm

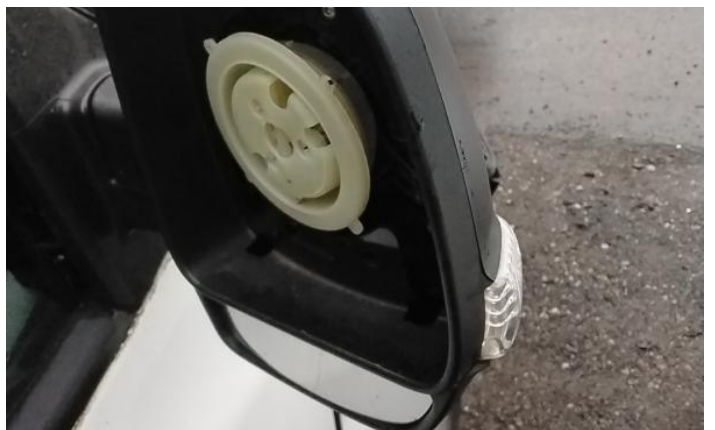
14: Door Mirror Glass os  
Missing  
Replace

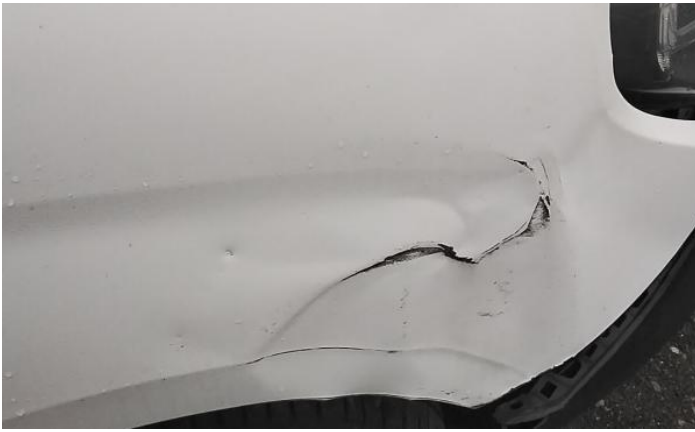
15: Wing osf  
Dented  
Over 30% Of Panel

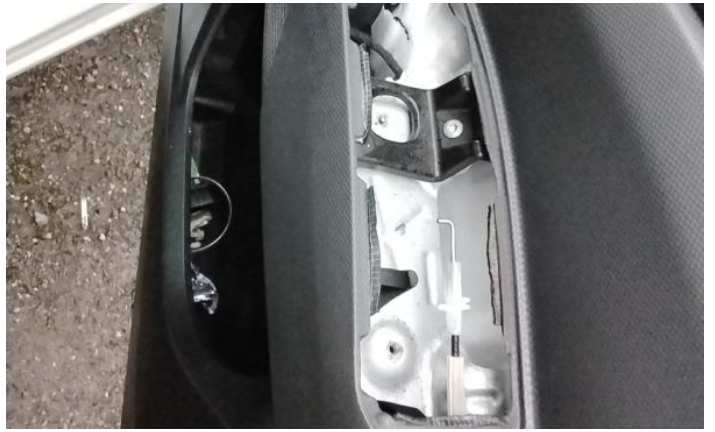
16: Door Pad osf  
Broken  
Replace

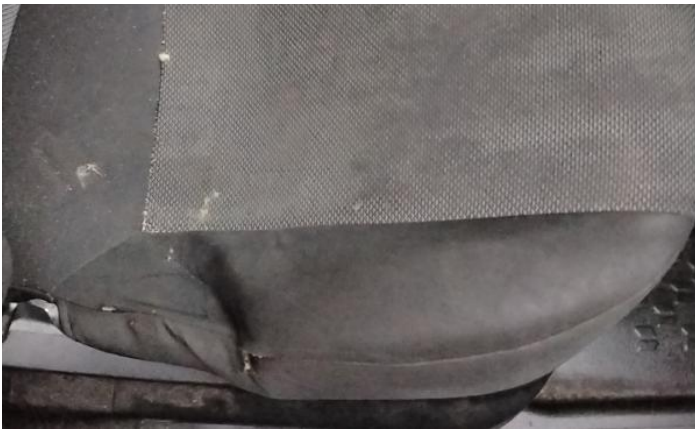
17: Seat Base Cover osf  
Soiled  
Heavy

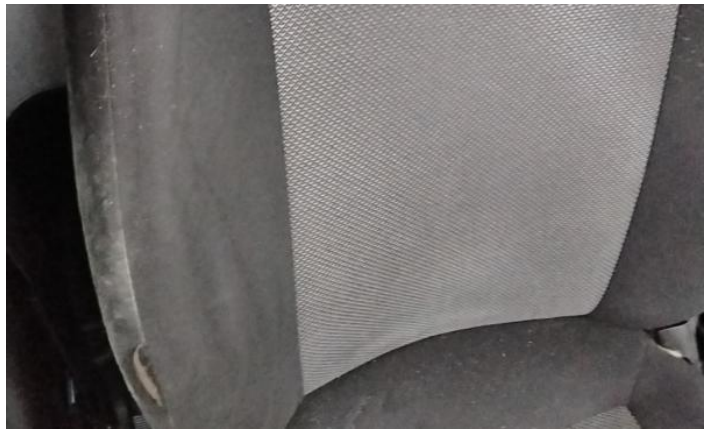
18: Seat Back Cover osf  
Holed  
Over 3mm

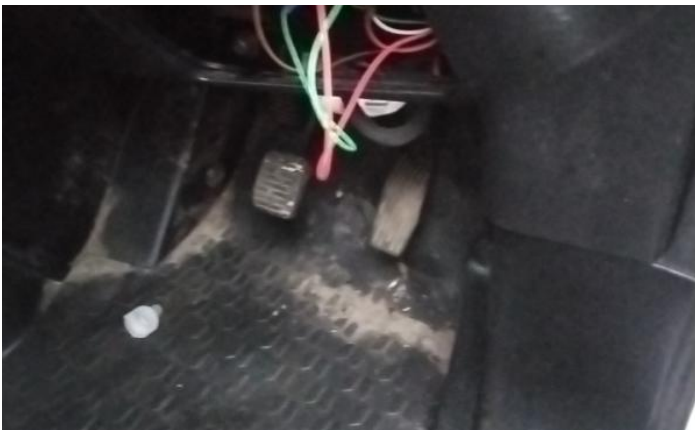
19: Fascia Panel  
Missing  
Replace

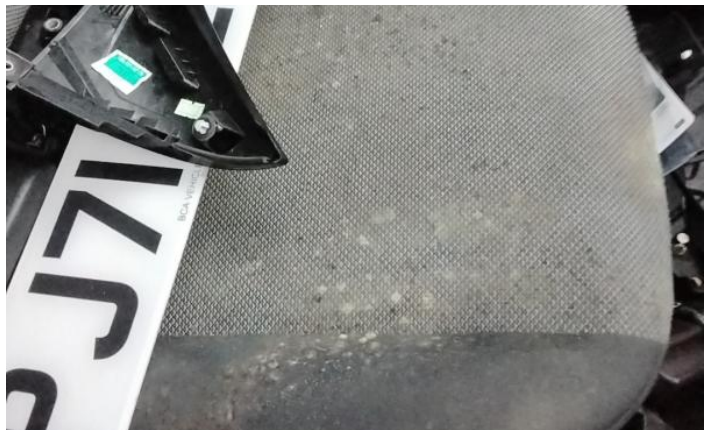
20: Seat Base Cover nsf  
Soiled  
Heavy
