# VEHICLE INSPECTION REPORT

**PF14TXU**

## Daf LF 150

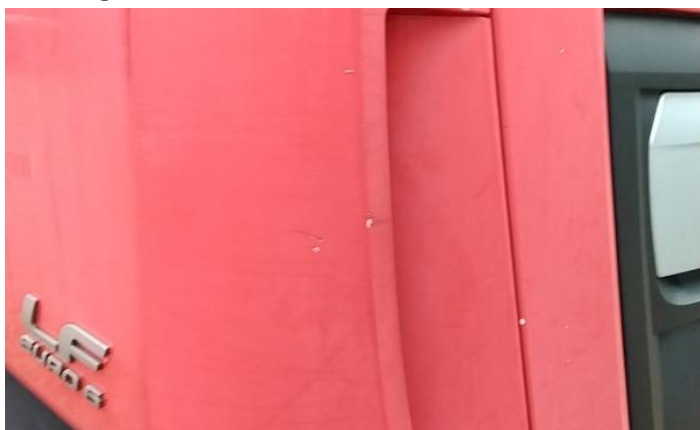
1: Wing osf  
Chipped  
Multiple Chips

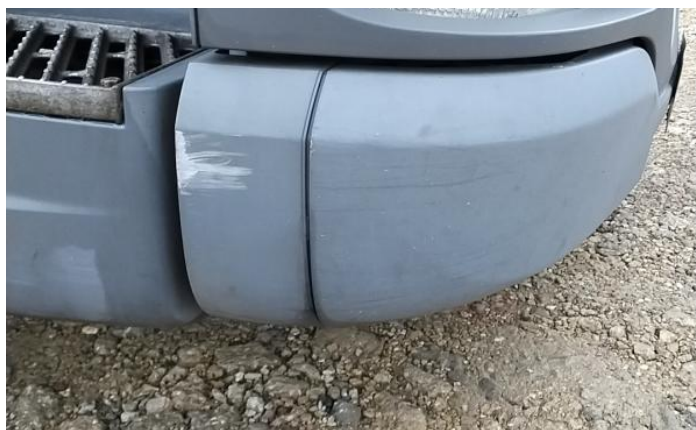
2: Bumper Front  
Scratched  
25 to 100mm Thru Paint

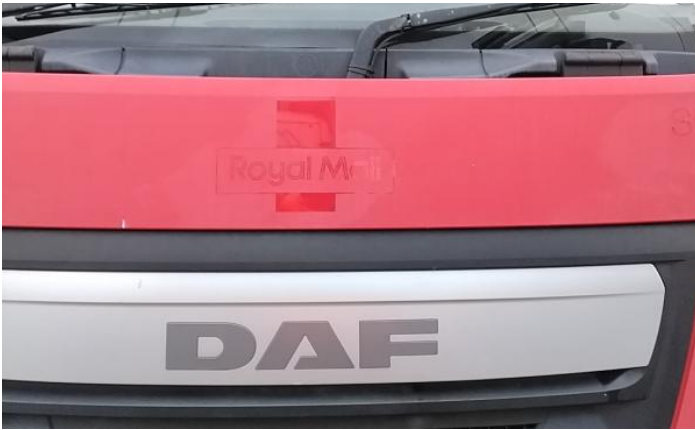
3: Bonnet  
Chipped  
Multiple Chips

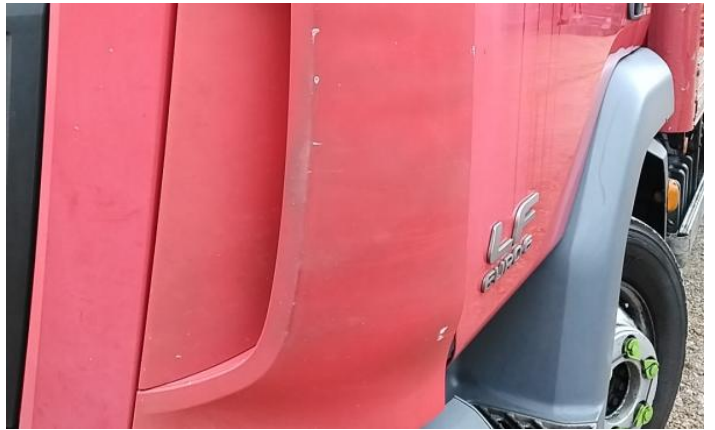
4: Wing nsf  
Chipped  
Multiple Chips

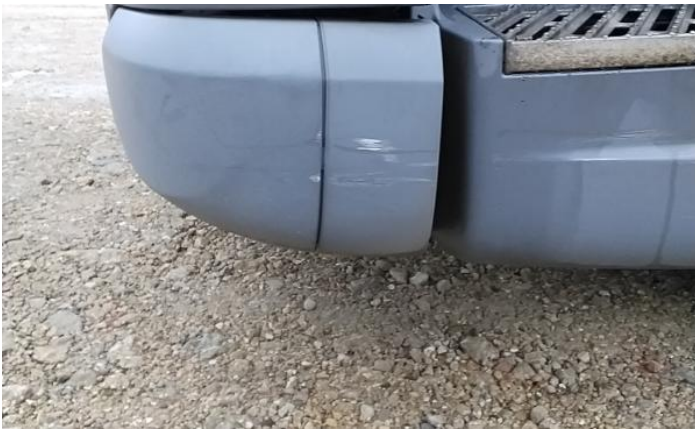
5: Bumper Front  
Scratched  
25 to 100mm Thru Paint

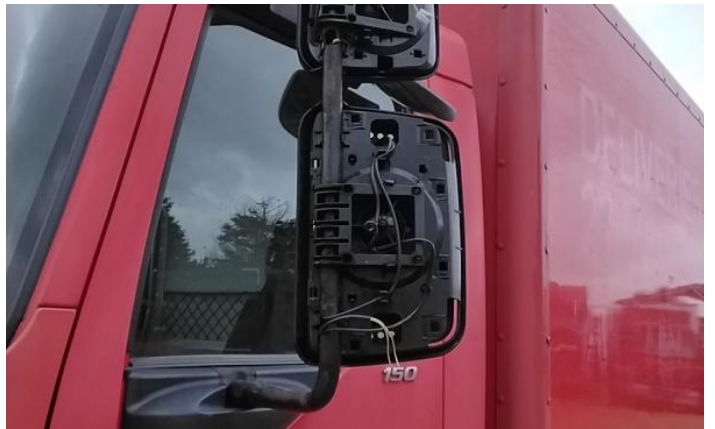
6: Door Mirror Assy nsf  
Broken  
Replace

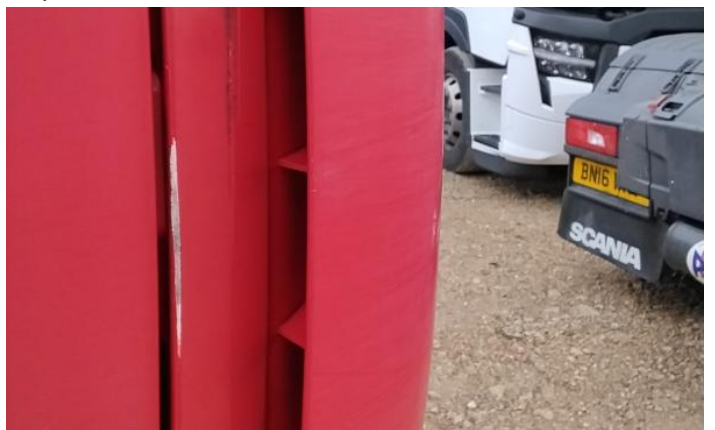
8: Wing osf  
Scratched  
Over 25mm Thru Paint

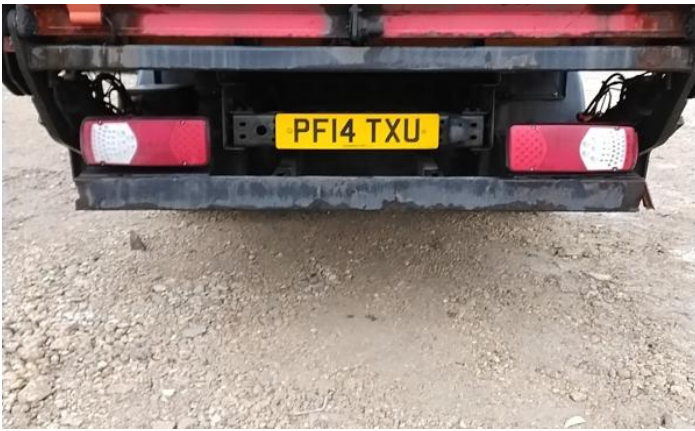
11: Bumper Rear  
Rusted  
Over 5mm

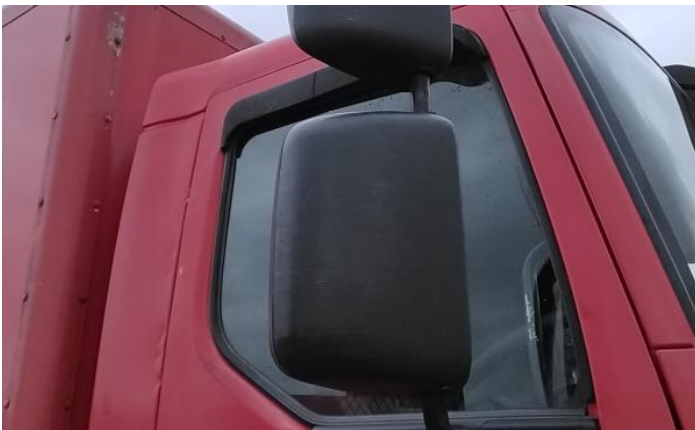
13: Door Mirror Assy osf  
Scuffed (Unpainted)  
Over 100mm

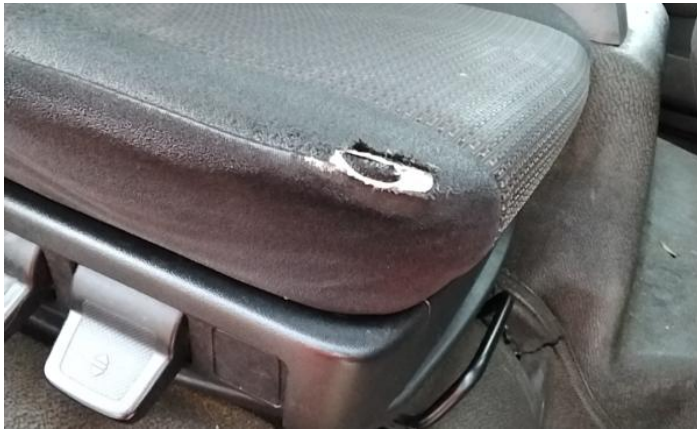
15: Seat Base Cover osf  
Holed  
Over 3mm

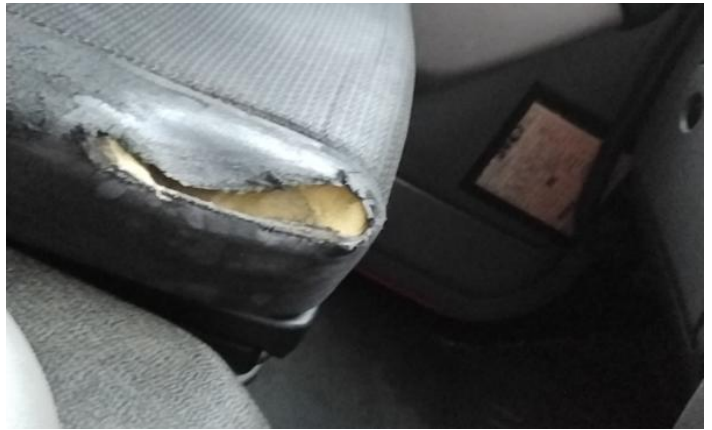
16: Seat Base Cover osf  
Holed  
Over 3mm
