# VEHICLE INSPECTION REPORT

**PE63MZF**

## Daf LF 45.140

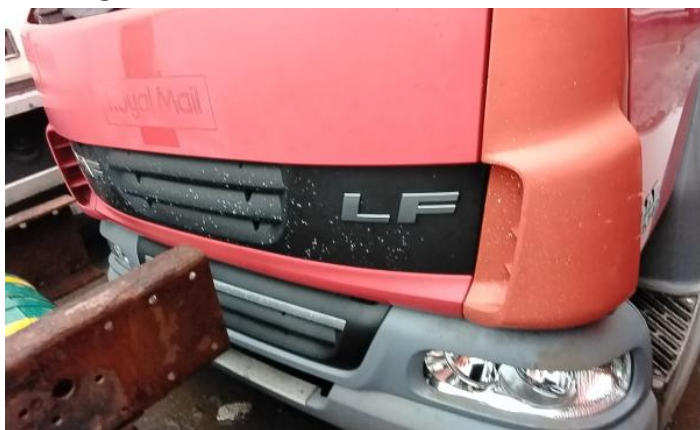
1: Bonnet  
Chipped  
Multiple Chips

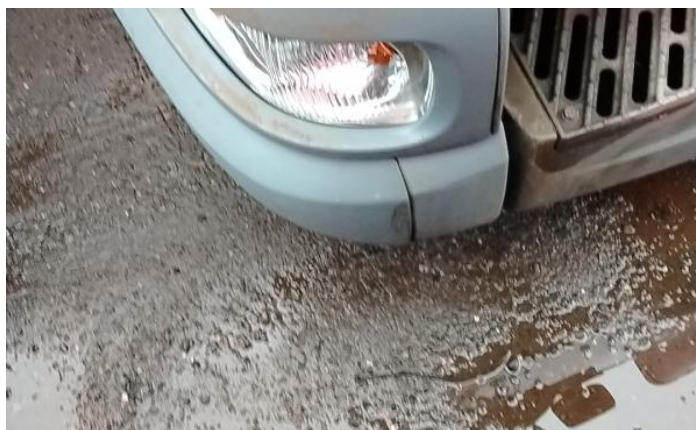
2: Bumper Front  
Scratched  
Over 100mm Thru Paint

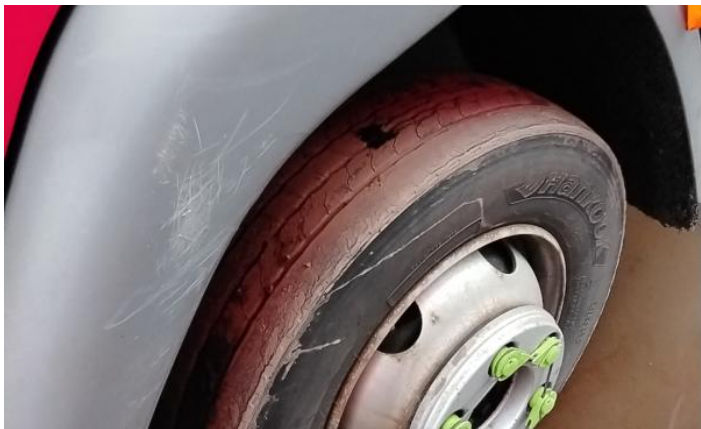
3: Wing nsf  
Scratched  
Over 25mm Thru Paint

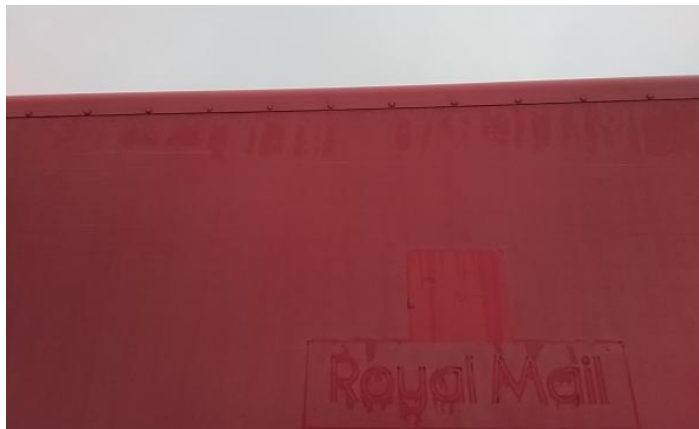
4: Qtr Panel nsr  
Scratched  
Over 25mm Thru Paint

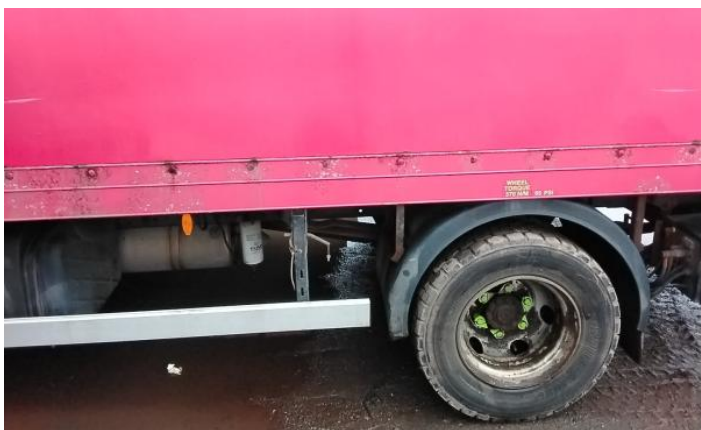
5: Qtr Panel nsr  
Scratched  
Over 25mm Thru Paint

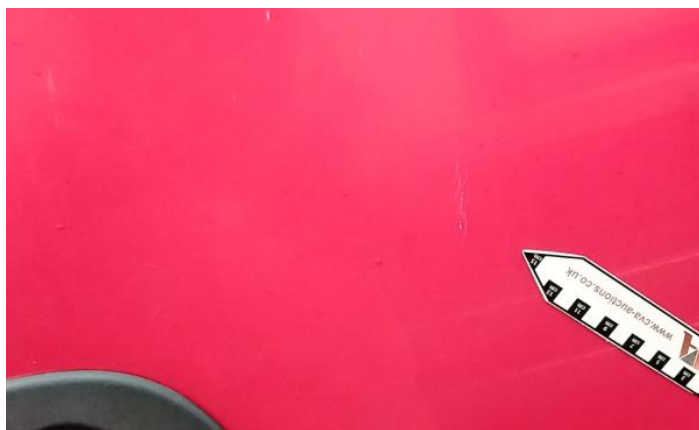
6: Door osf  
Dented  
With Paint Damage

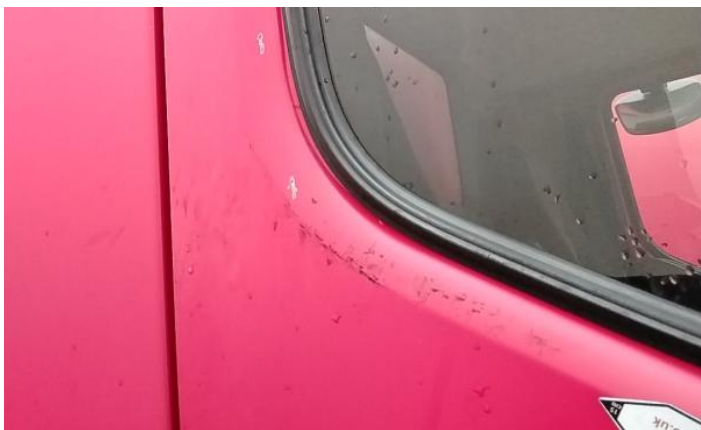
7: Door osf  
Scratched  
Over 25mm Thru Paint

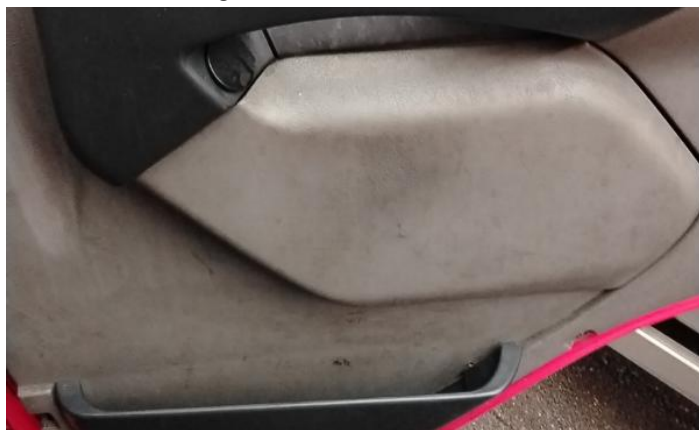
8: Door Pad osf  
Soiled  
Heavy

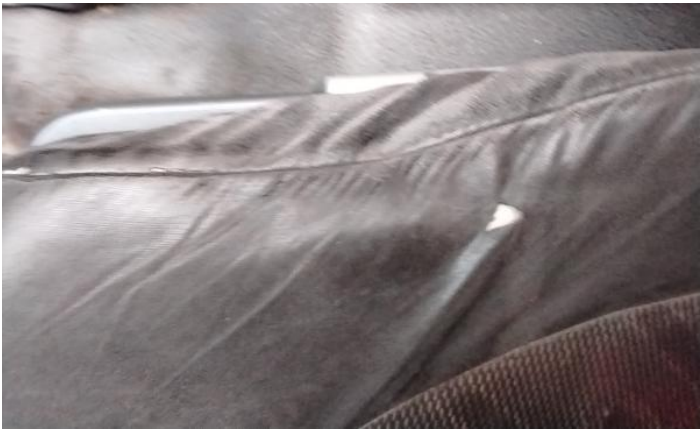
9: Seat Base Cover osf  
Torn  
Over 3mm
