# VEHICLE INSPECTION REPORT

**PJ66BPU**

## Daf LF 150

\*COLLECTED AS NON-RUNNER, OIL LEAK, WARNING LIGHT ON DASH\*

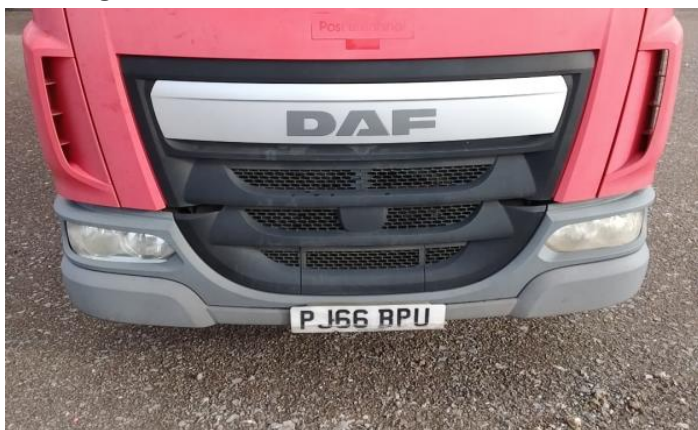
1: Bonnet  
Chipped  
Multiple Chips

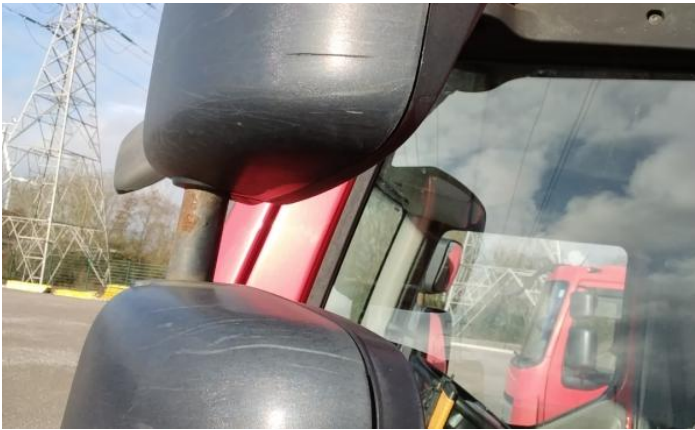
3: Door Mirror Assy nsf  
Broken  
Replace

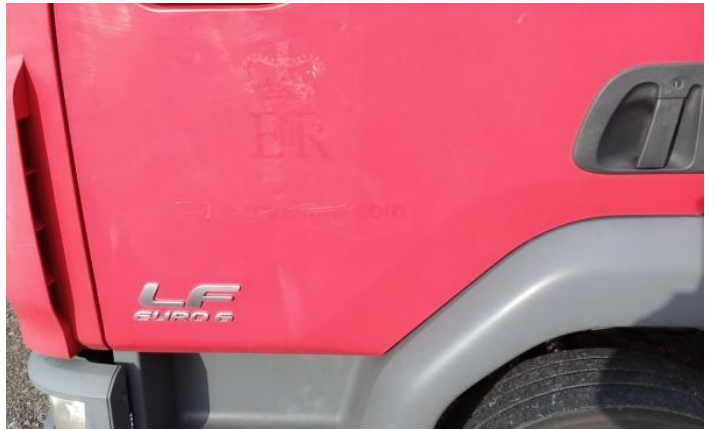
4: Door nsf  
Chipped  
Multiple Chips

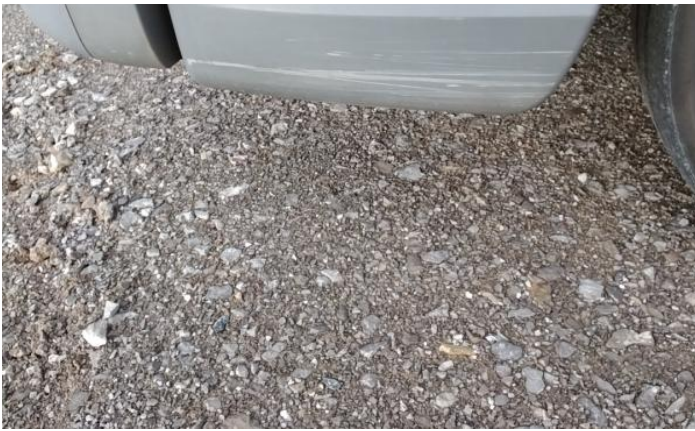
5: Moulding nsf Wing  
Scratched (Painted)  
Over 25mm Thru Paint

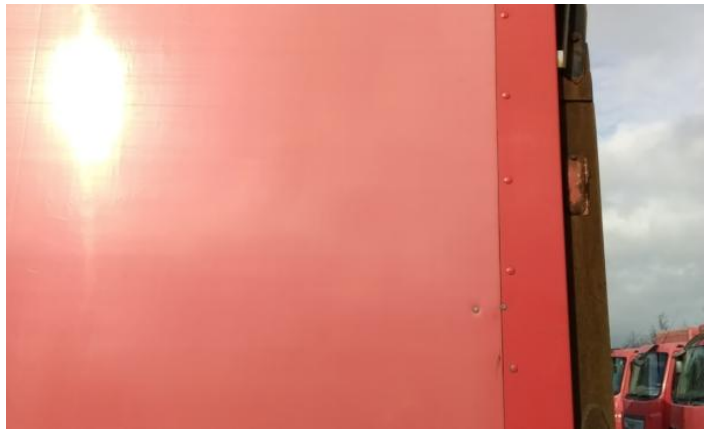
6: Qtr Panel nsr  
Scratched  
Over 25mm Not Thru Paint

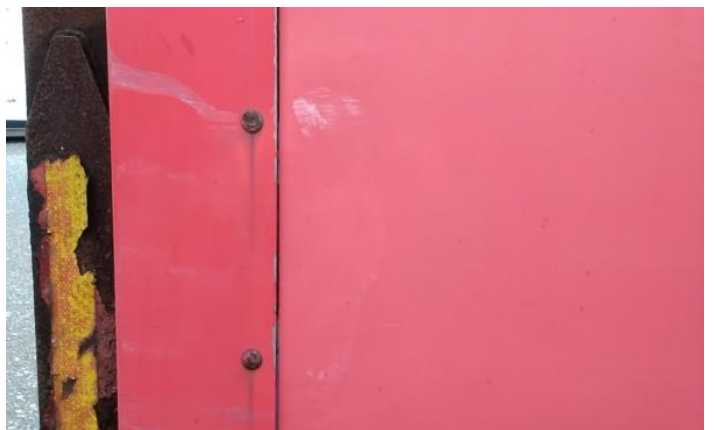
8: Qtr Panel osr  
Scratched  
Over 25mm Thru Paint

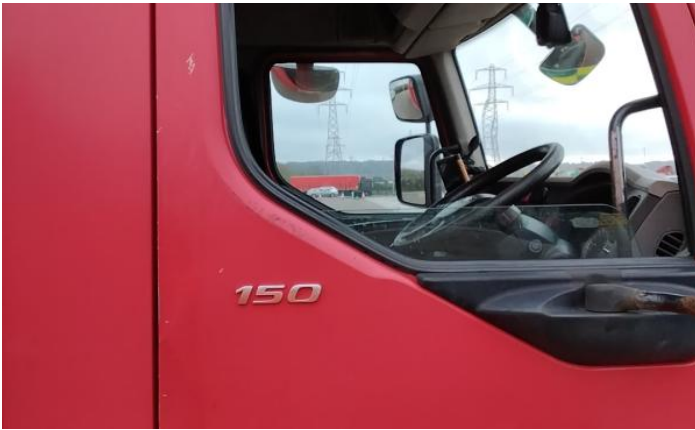
9: Door osf  
Chipped  
Multiple Chips

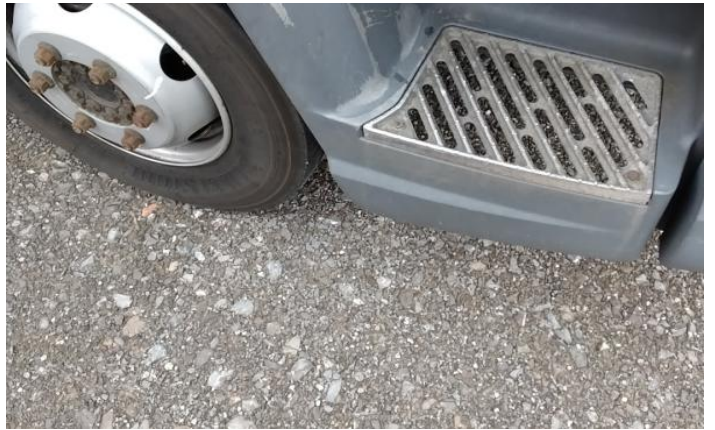
10: Moulding osf Wing  
Scratched (Painted)  
Over 25mm Thru Paint

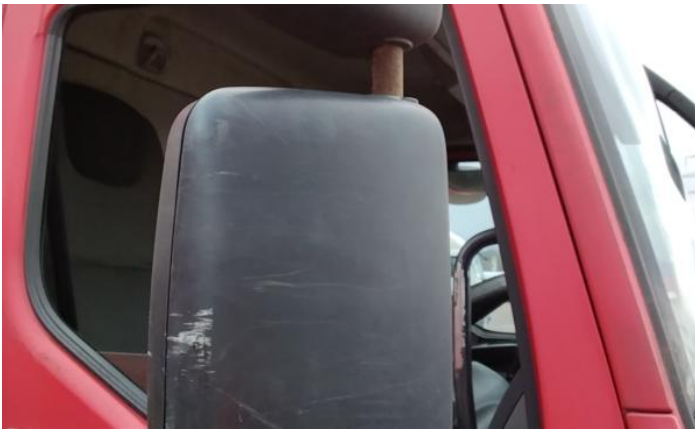
11: Door Mirror Assy osf  
Scratched (Painted)  
Over 25mm Thru Paint

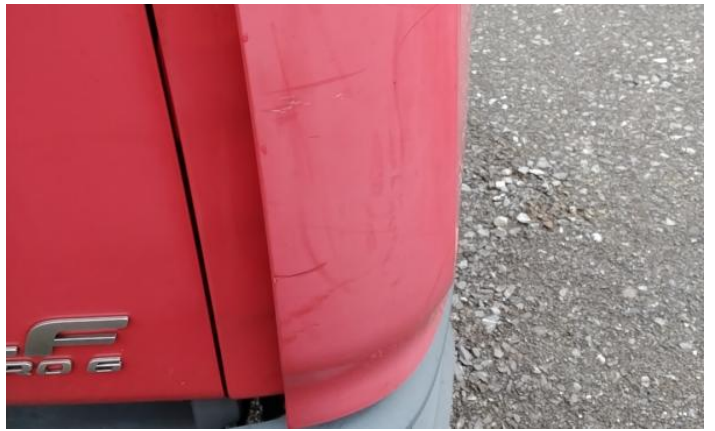
12: Moulding osf Wing  
Broken  
Replace

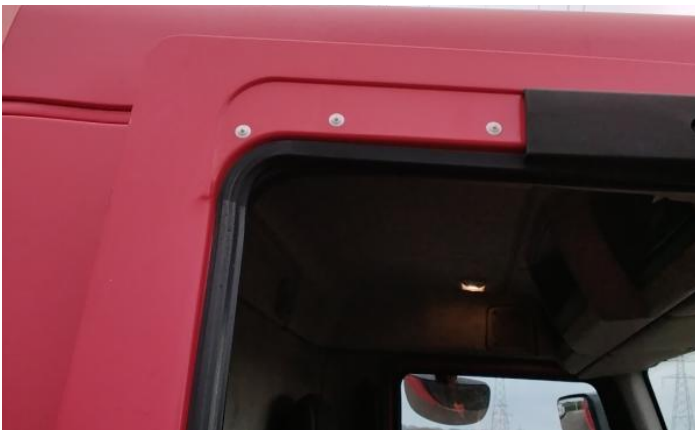
13: Door Moulding osf  
Missing  
Replace

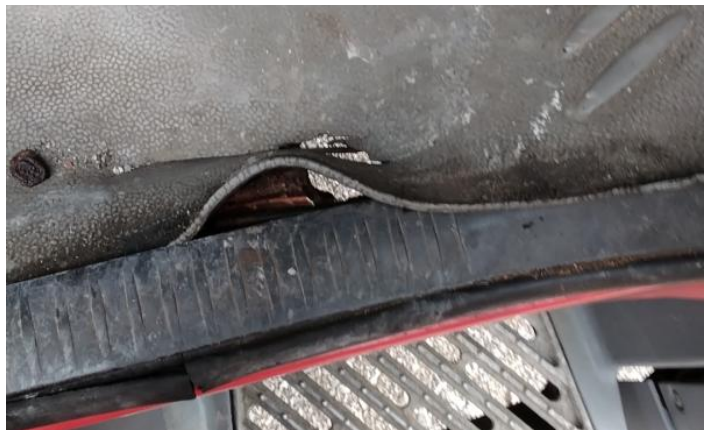
14: Carpets Front  
Holed  
Over 3mm

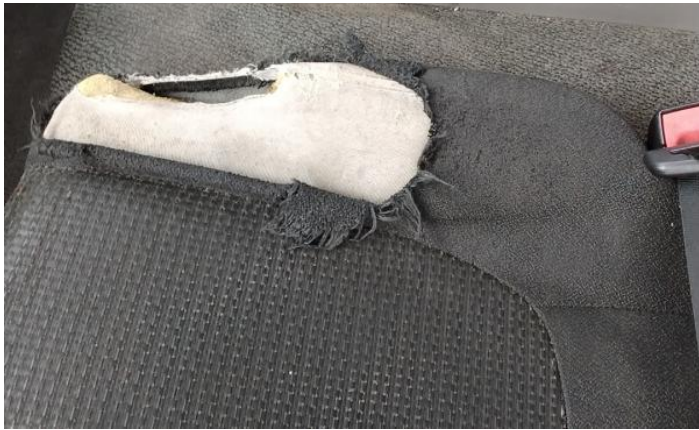
15: Seat Base Cover nsf  
 Holed  
 Over 3mm
