# VEHICLE INSPECTION REPORT

**PK19JZE**

## Daf CF 410

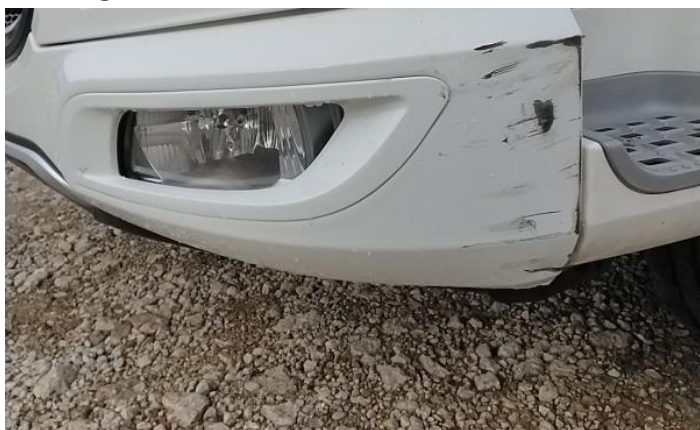
1: Bumper Front  
Scratched  
Over 100mm Thru Paint

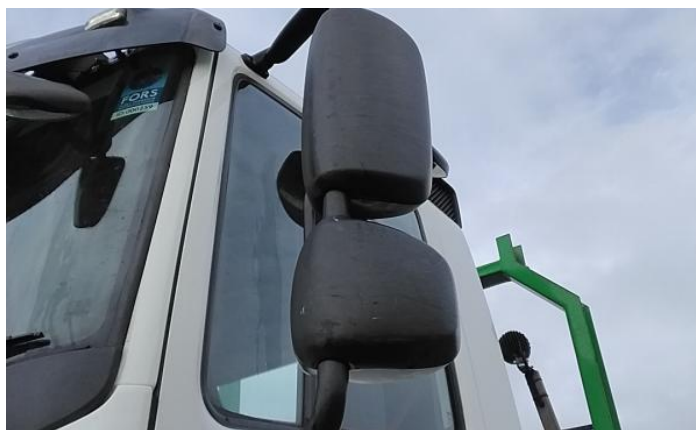
2: Door Mirror Assy nsf  
Scuffed (Unpainted)  
Over 100mm

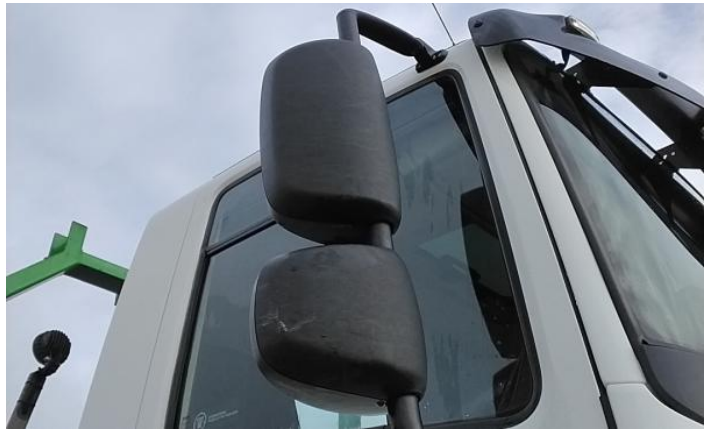
4: Door Mirror Assy osf  
Scuffed (Unpainted)  
Over 100mm

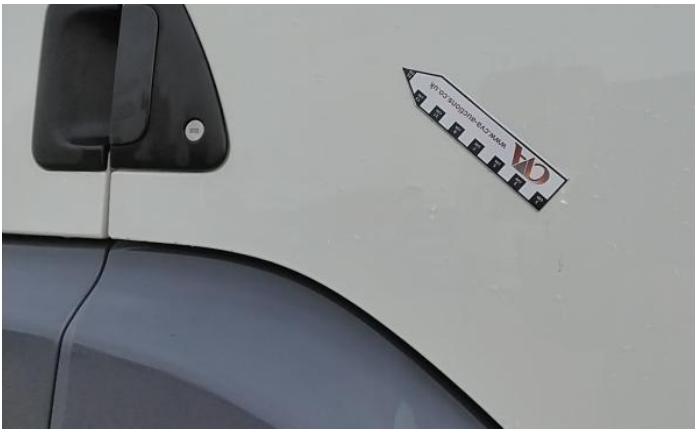
5: Door osf  
Dented  
Over 2 UpTo 10mm

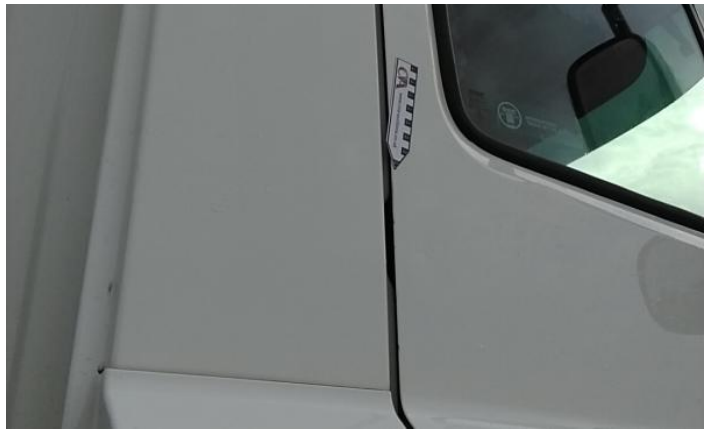
6: Door osf  
Chipped  
Edge Chip

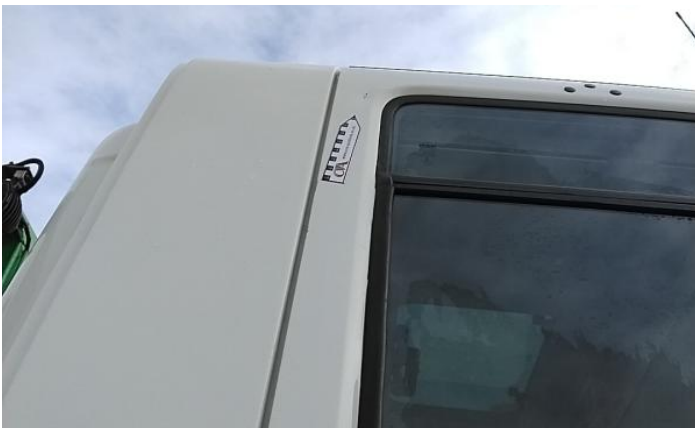
7: Door osf  
Dented  
Between 10mm + 30mm

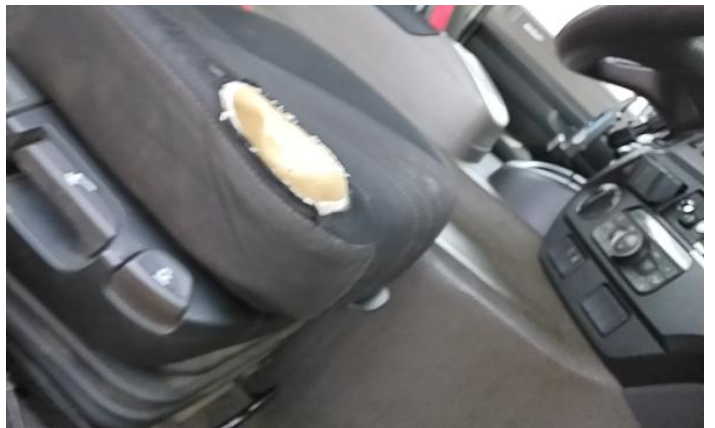
8: Seat Base Cover osf  
Holed  
Over 3mm
