# VEHICLE INSPECTION REPORT

**PK67VFM**

## Daf CF 450

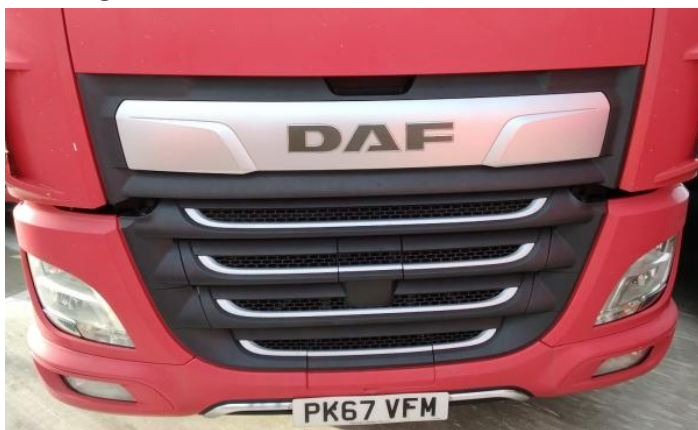
1: Bonnet  
Chipped  
Multiple Chips

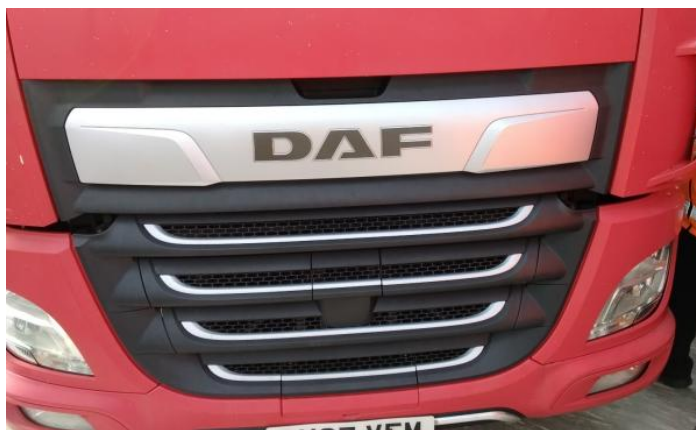
2: Bonnet  
Chipped  
Multiple Chips

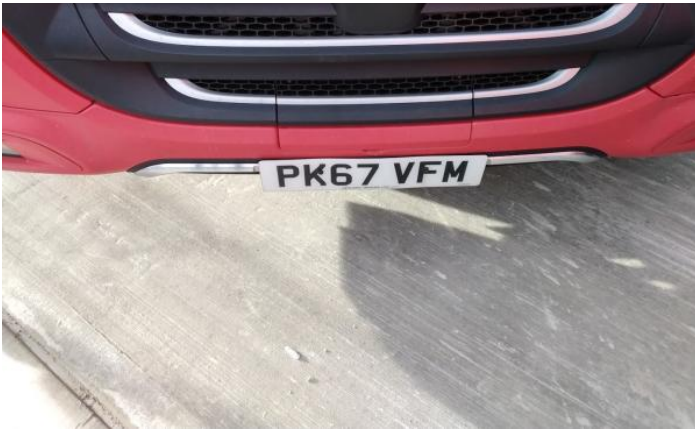
3: Bumper Front  
Chipped  
Multiple Chips

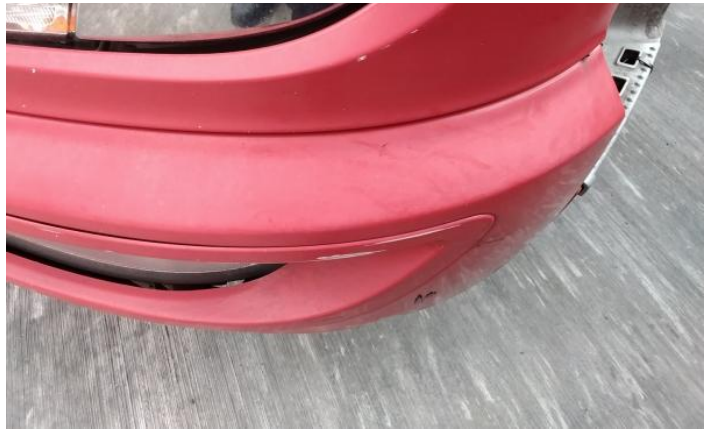
4: Bumper Front Moulding  
Scratched (Painted)  
Over 25mm Thru Paint

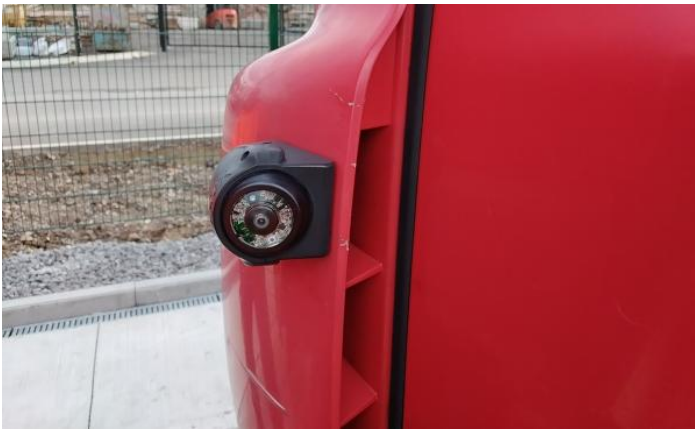
5: Panel Front  
Cracked  
Replace

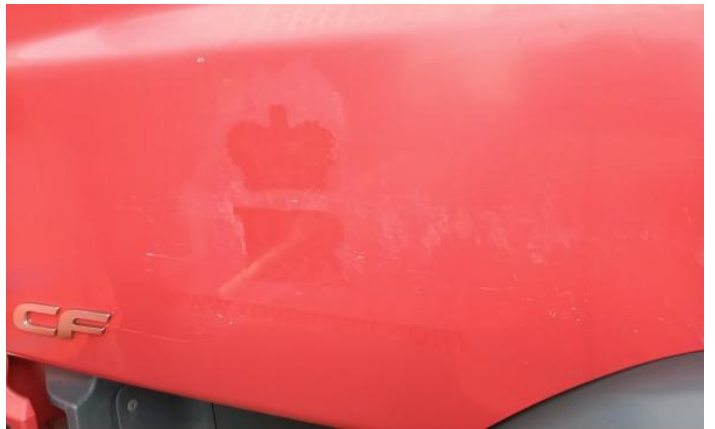
6: Door nsf  
Chipped  
Multiple Chips

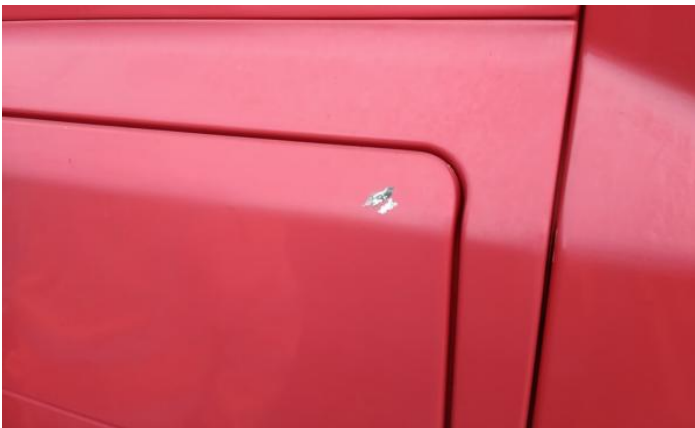
7: Qtr Panel nsr  
Scratched  
Over 25mm Thru Paint

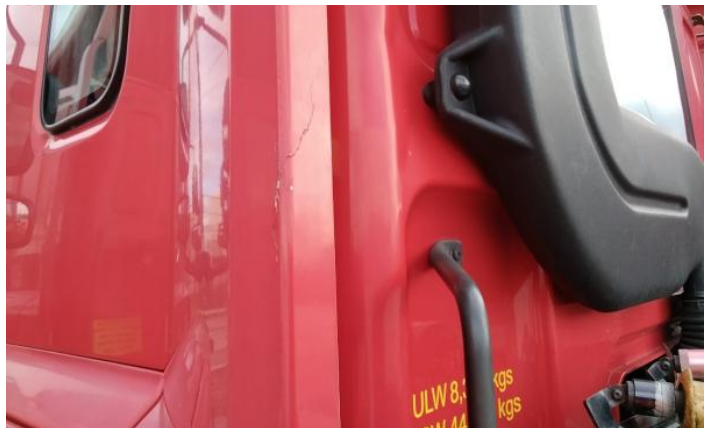
8: Qtr Panel Moulding ns  
Broken  
Replace

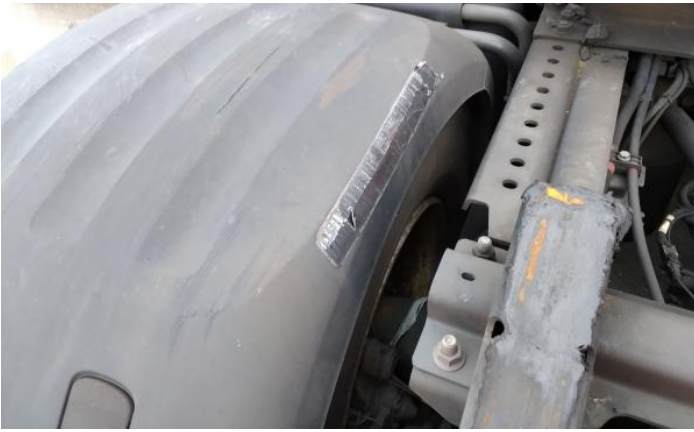
9: Qtr Panel Moulding ns  
Broken  
Replace

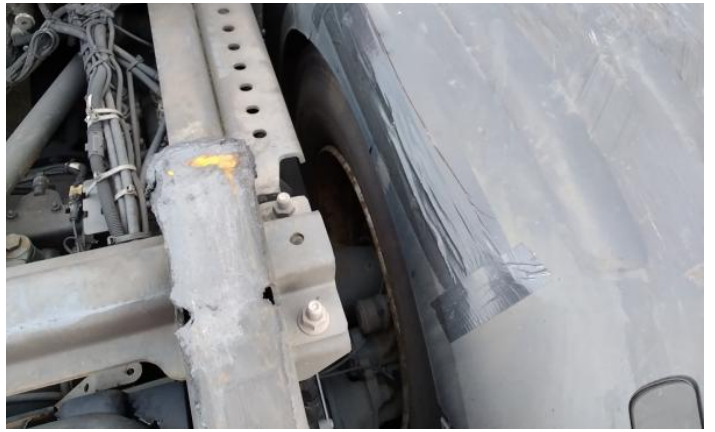
10: Qtr Panel Moulding os  
Broken  
Replace

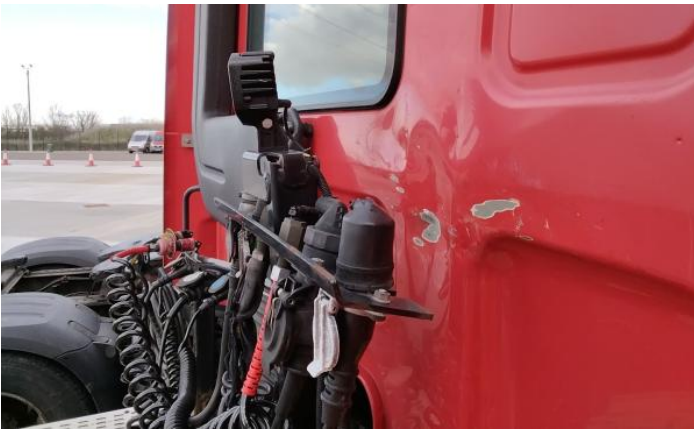
11: Panel Rear  
Dented  
With Paint Damage

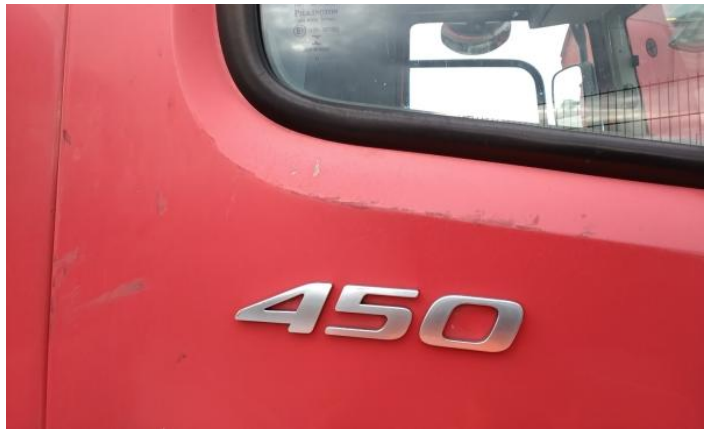
12: Door osf  
Chipped  
Multiple Chips

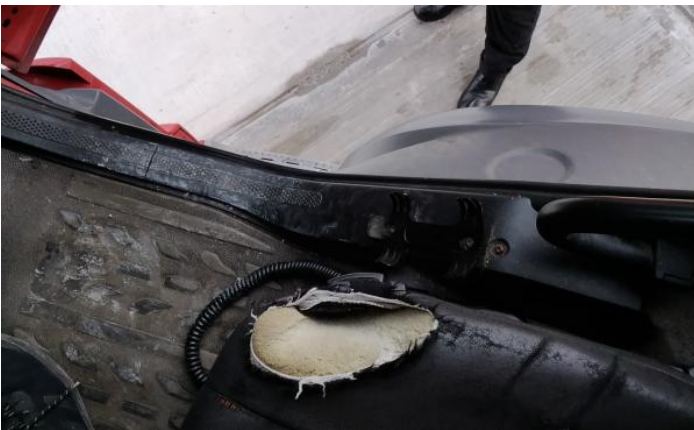
13: Seat Base Cover osf  
Holed  
Over 3mm
