## VEHICLE INSPECTION REPORT

**GU73FFP**

### Volkswagen Crafter 35 2.0 TDI 140PS

**Non Runner**

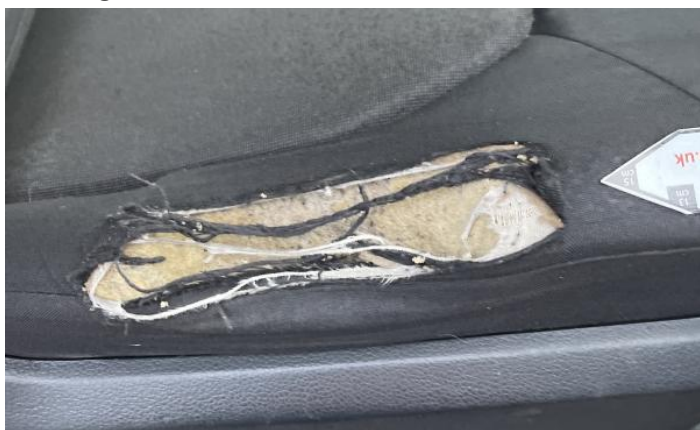
1: Seat Base Cover osf  
Torn  
Over 3mm

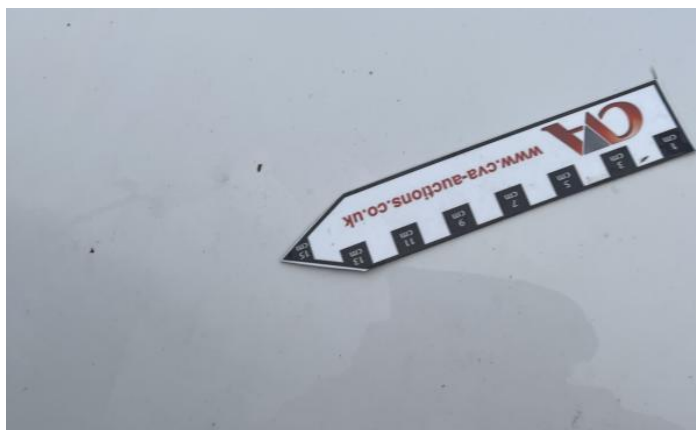
2: Bonnet  
Dented  
Over 2 UpTo 10mm

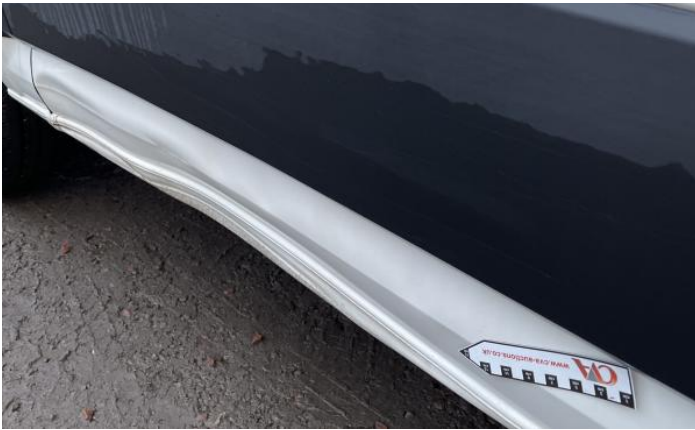
3: Sill os  
Dented  
With Paint Damage

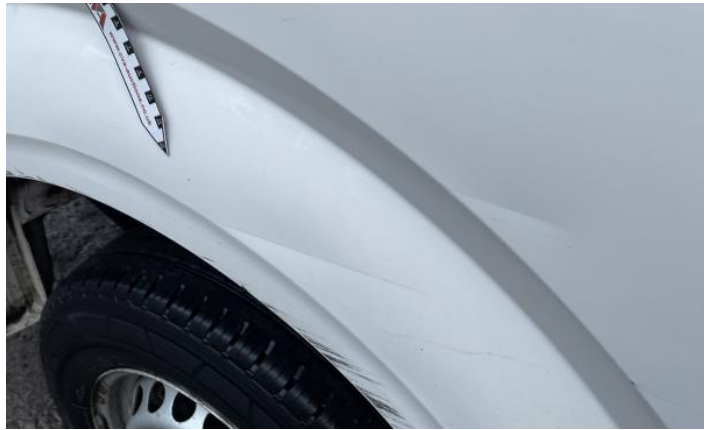
4: Qtr Panel osr  
Dented  
With Paint Damage

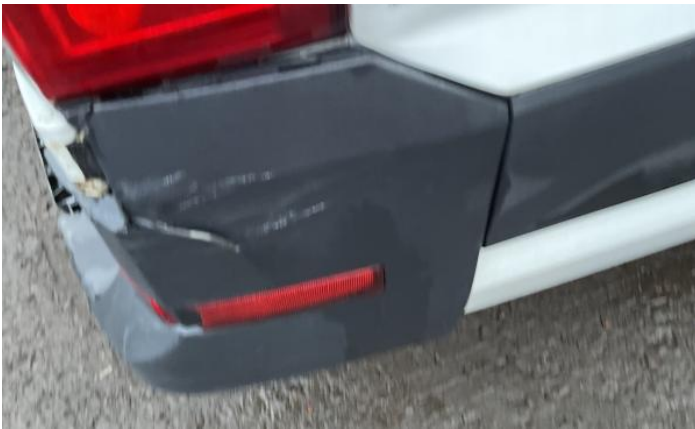
5: Bumper Rear Moulding  
Broken  
Replace

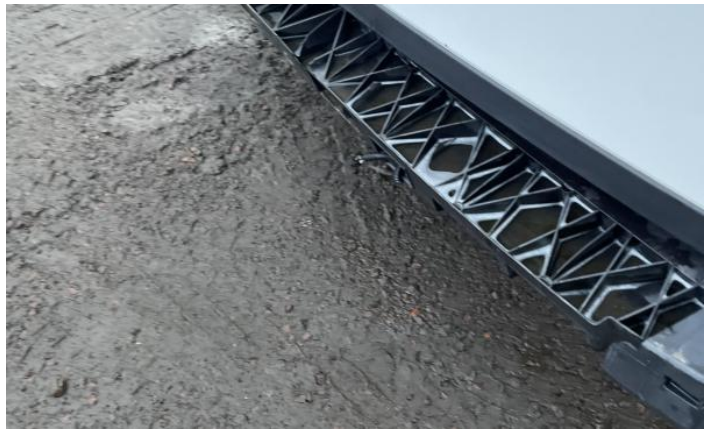
6: Bumper Rear Moulding  
Missing  
Replace

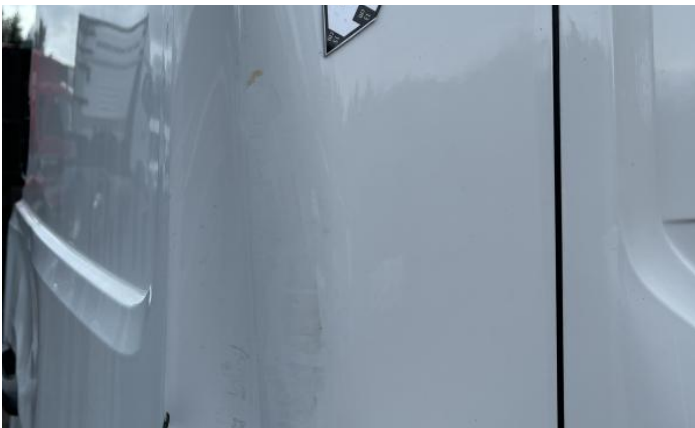
7: D Post os  
Dented  
With Paint Damage

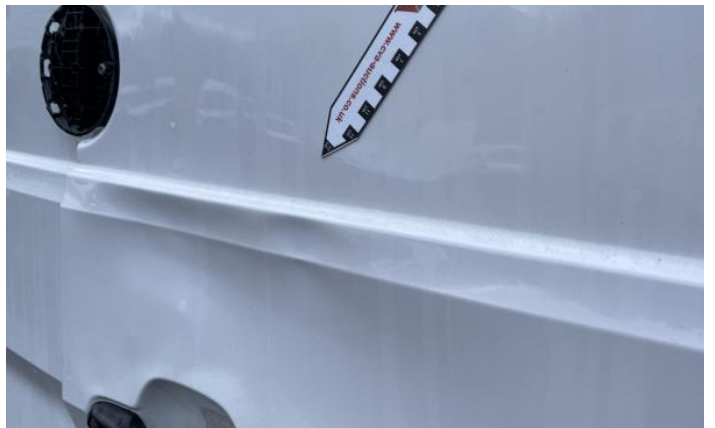
8: Tailgate  
Dented  
With Paint Damage

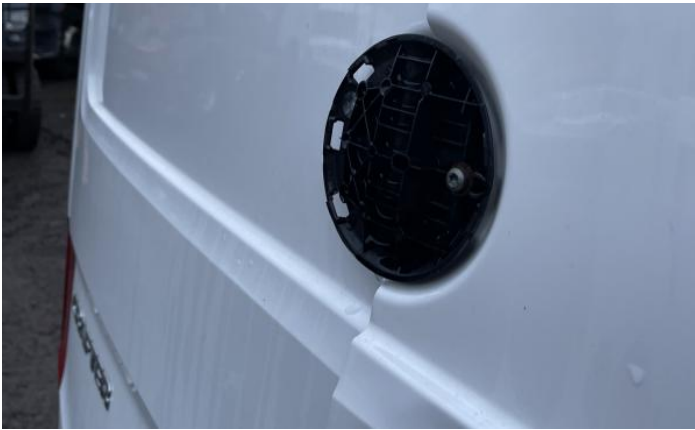
9: Badgedecal Rear  
Missing  
Replace

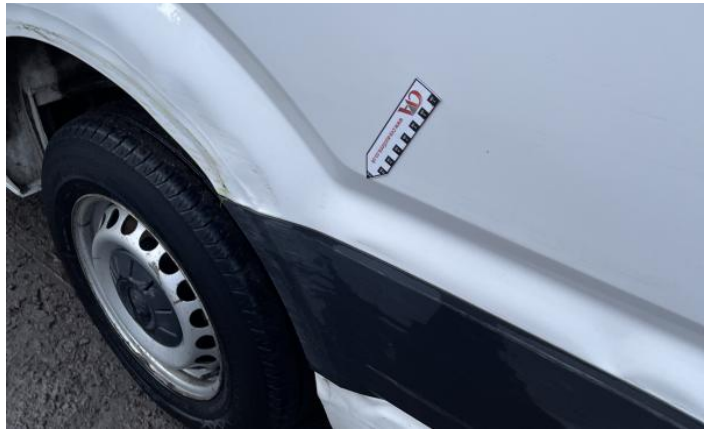
10: Qtr Panel nsr  
Dented  
With Paint Damage

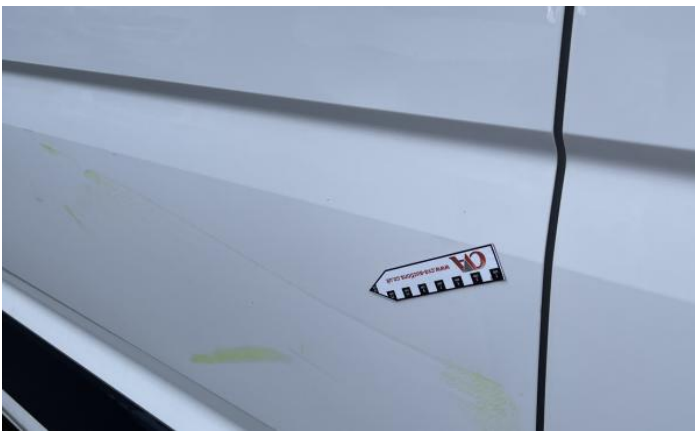
11: Door nsr  
Dented  
With Paint Damage

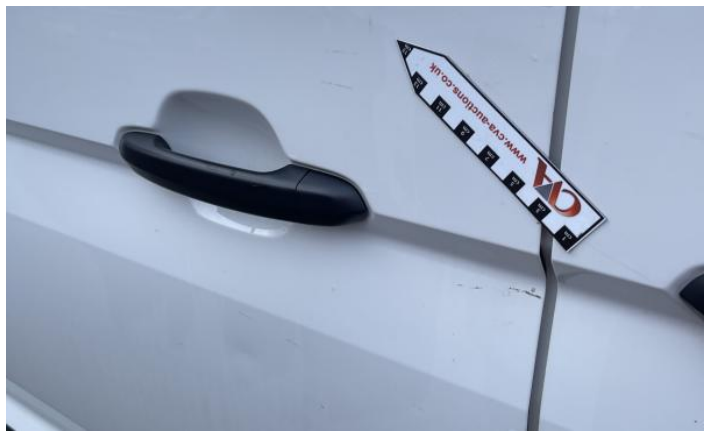
12: Door nsf  
Dented  
Over 30mm

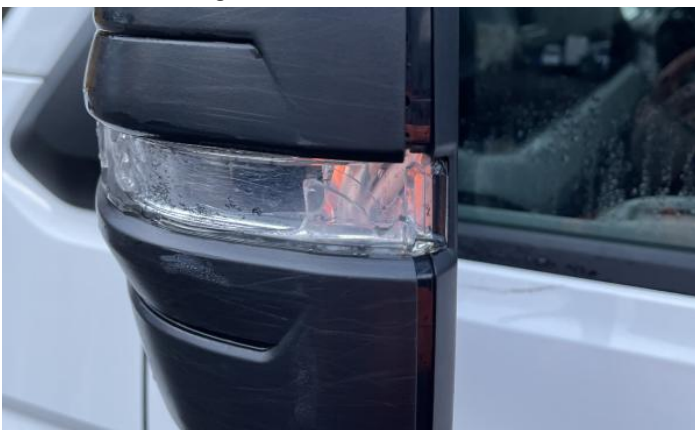
13: Flasher Side Repeater ns  
Broken  
Replace
