# VEHICLE INSPECTION REPORT

**PE63NHB**

## Daf LF 45.140

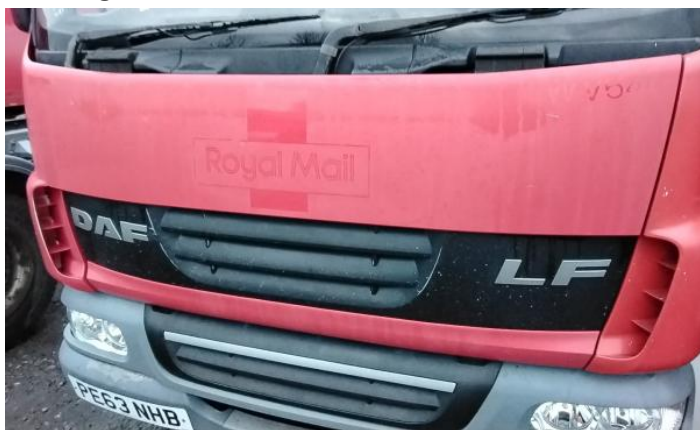
1: Bonnet  
Chipped  
Multiple Chips

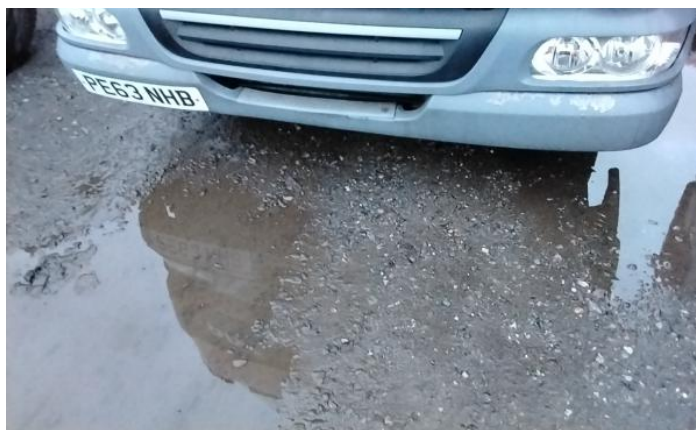
2: Bumper Front  
Scratched  
Over 100mm Thru Paint

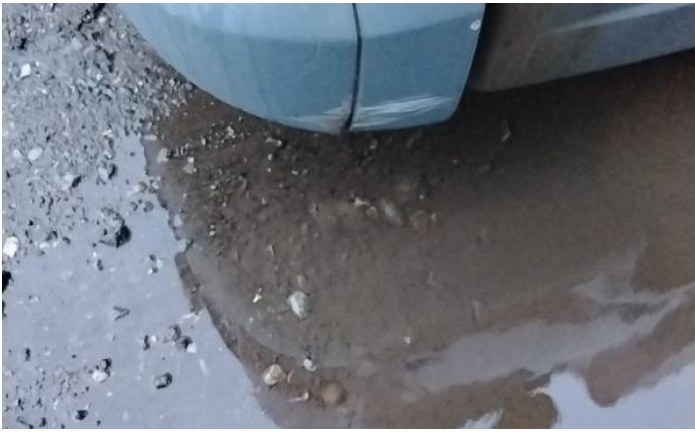
3: Bumper Front  
Scratched  
Over 100mm Thru Paint

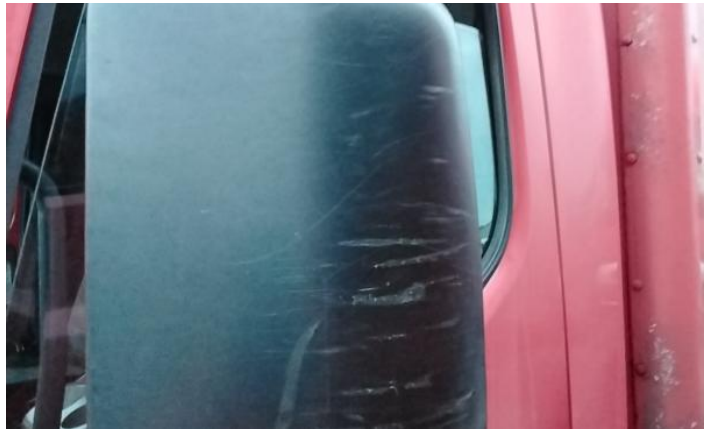
4: Door Mirror Assy nsf  
Scuffed (Unpainted)  
Over 100mm

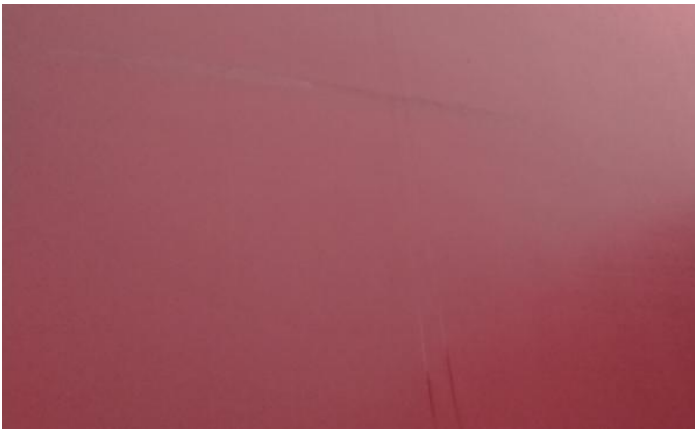
5: Qtr Panel nsr  
Scratched  
Over 25mm Thru Paint

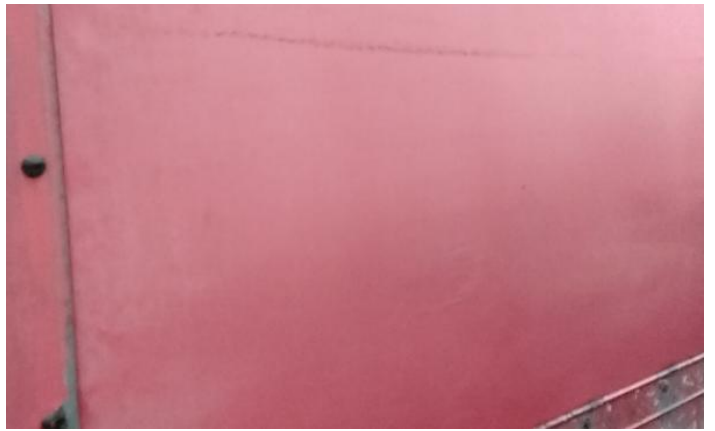
6: Qtr Panel osr  
Scratched  
Over 25mm Not Thru Paint

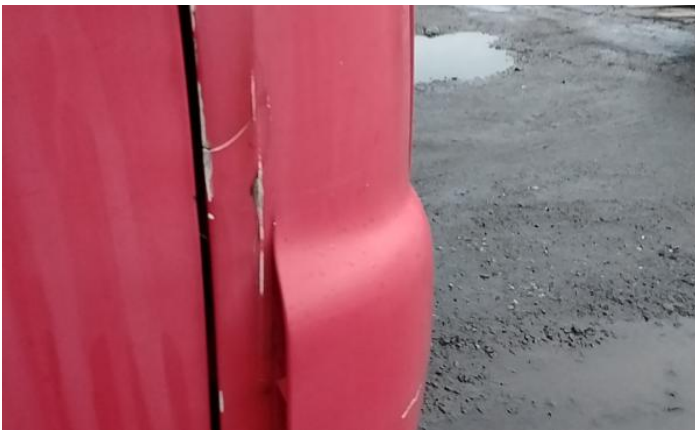
7: Panel Front  
Cracked  
Replace

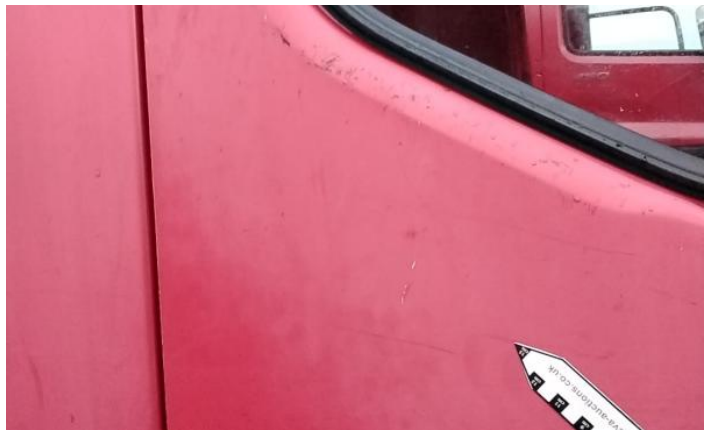
8: Door osf  
Scratched  
Over 25mm Thru Paint

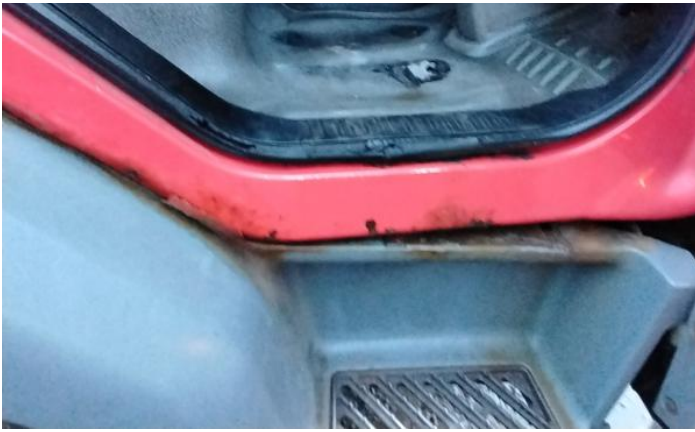
9: Wing osf  
Cracked  
Replace

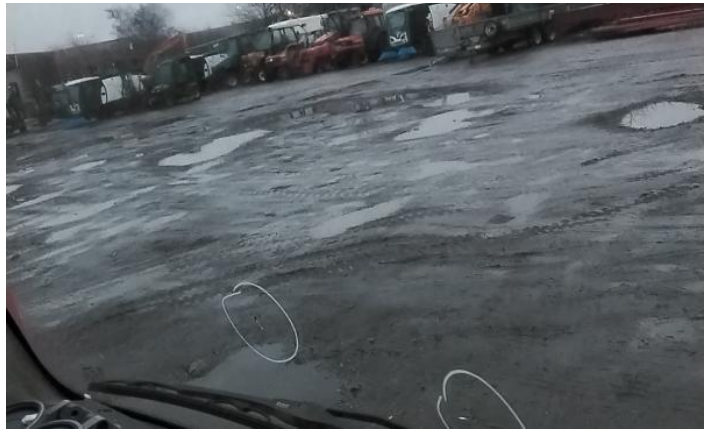
10: Screen Front  
Cracked  
Replace

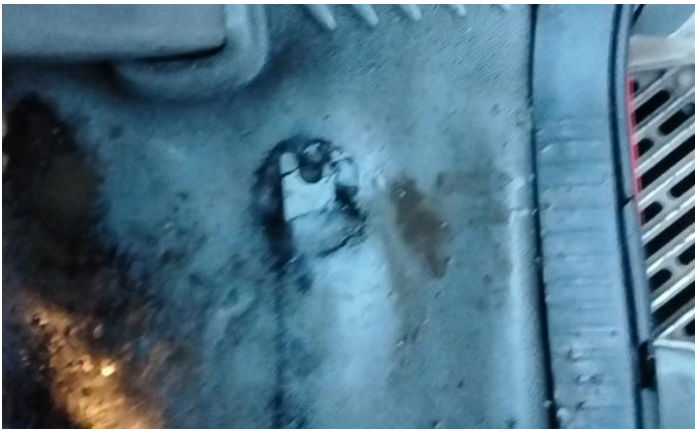
11: Carpets Front  
Holed  
Over 3mm

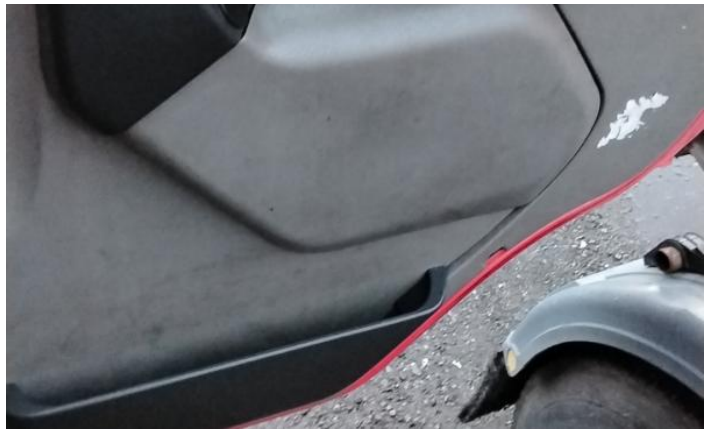
12: Door Pad osf  
Soiled  
Heavy

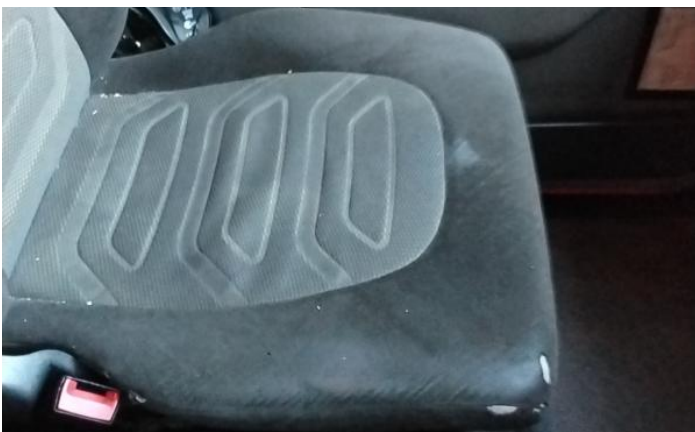
13: Seat Base Cover nsf  
Torn  
Over 3mm
