## VEHICLE INSPECTION REPORT

**WD65OWX**

### Isuzu D-Max 2.5 TD

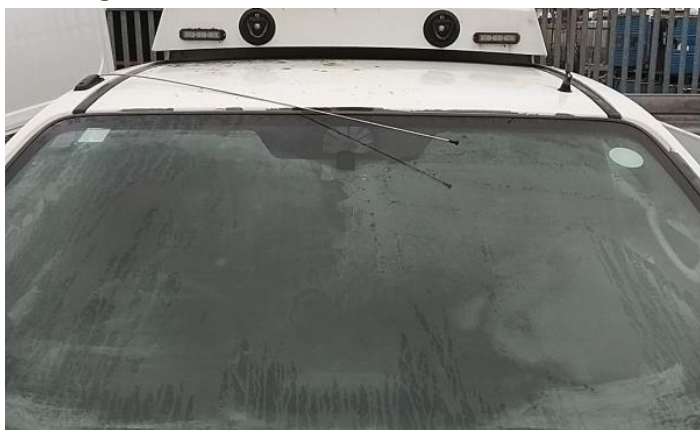
1: Roof  
Scratched  
Over 25mm Thru Paint

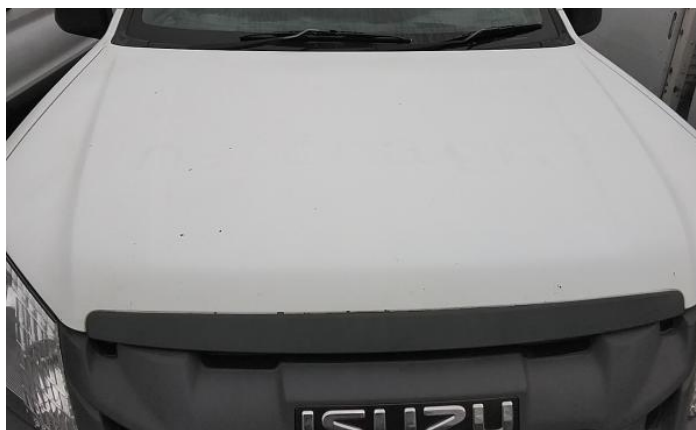
2: Bonnet  
Chipped  
Multiple Chips

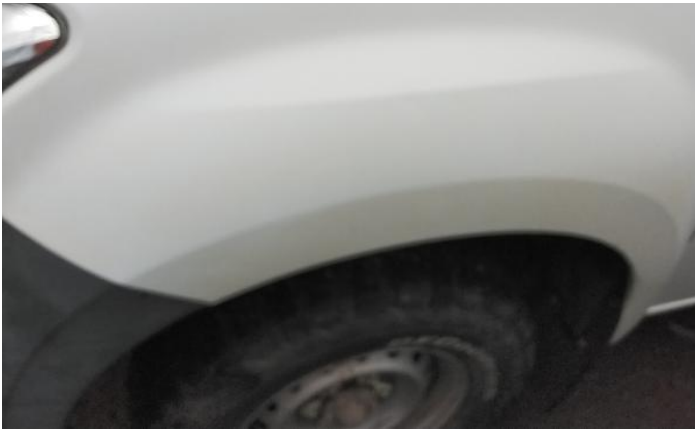
3: Wing nsf  
Chipped  
Multiple Chips

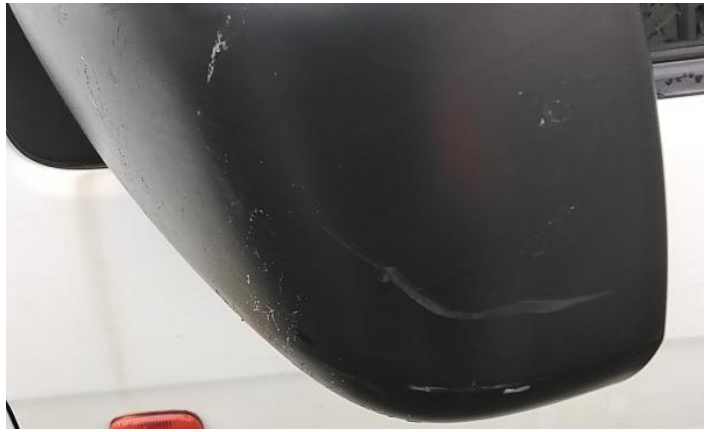
4: Door Mirror Assy nsf  
Scuffed (Unpainted)  
UpTo 100mm

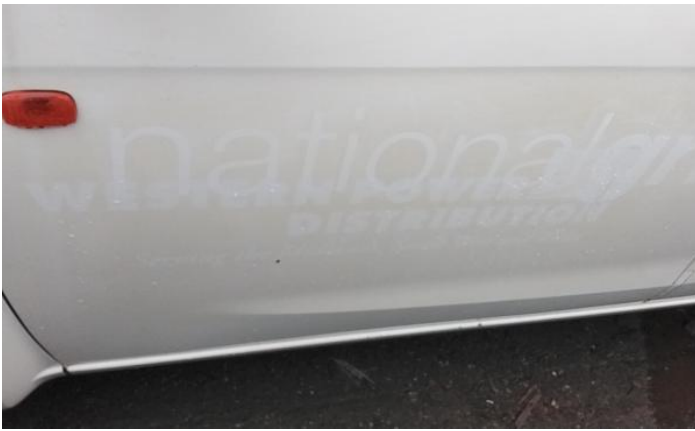
5: Door nsf  
Chipped  
Multiple Chips

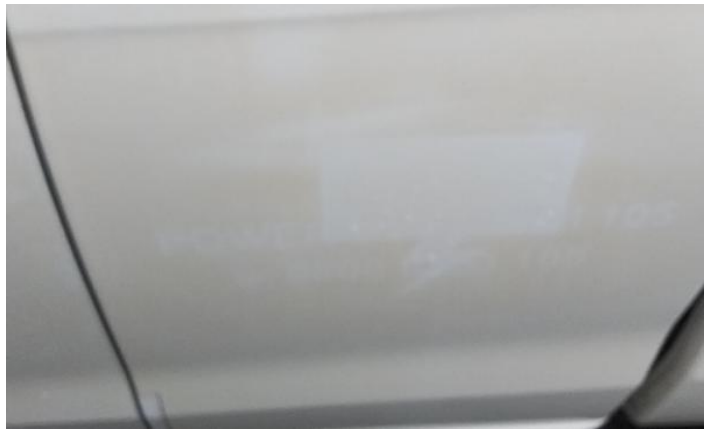
6: Qtr Panel nsr  
Chipped  
Multiple Chips

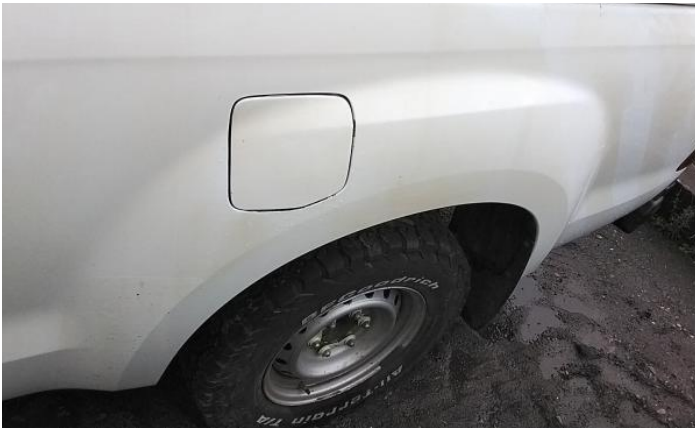
7: Qtr Panel nsr  
Chipped  
Multiple Chips

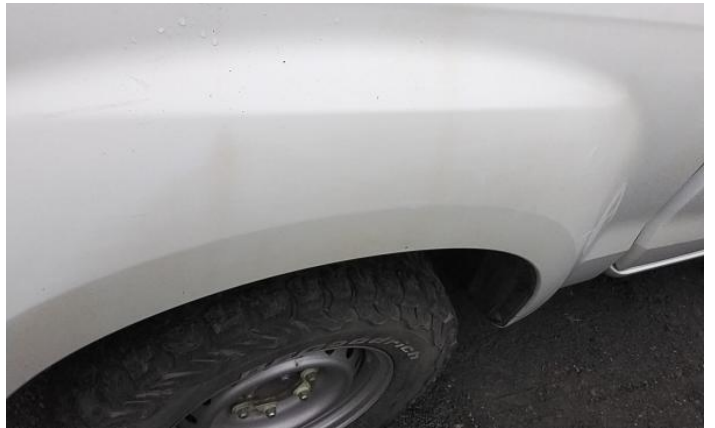
8: Qtr Panel osr  
Chipped  
Multiple Chips

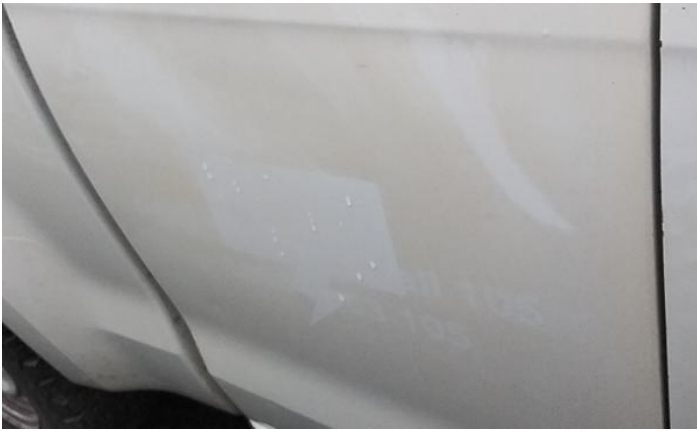
9: Qtr Panel osr  
Chipped  
Multiple Chips

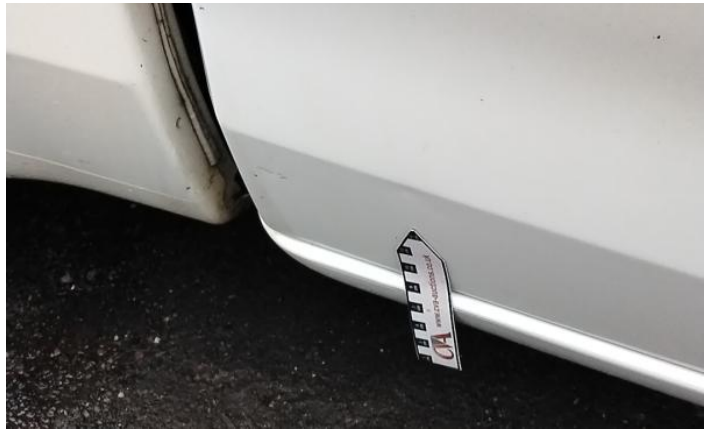
10: Qtr Panel osr  
Dented  
Over 30mm

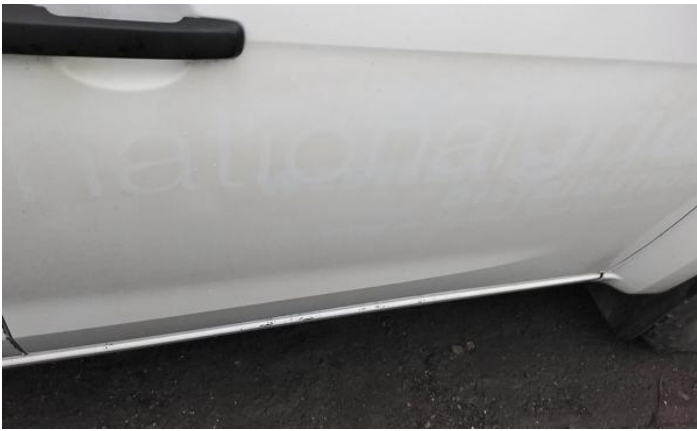
11: Door osf  
Chipped  
Multiple Chips

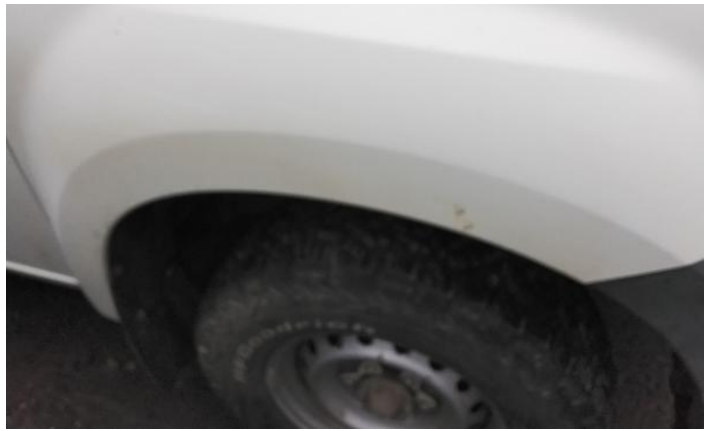
12: Wing osf  
Chipped  
Multiple Chips

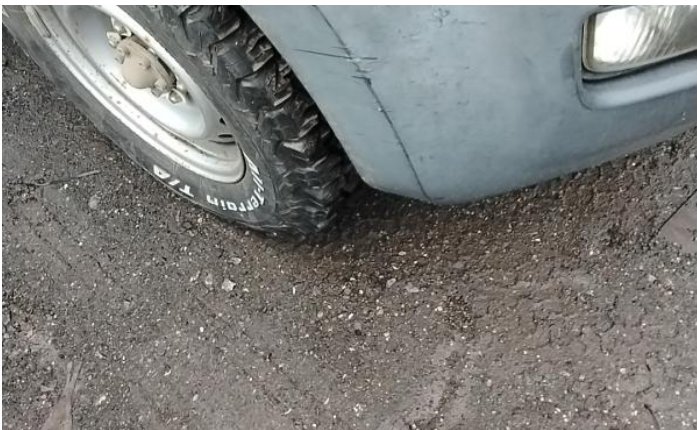
13: Bumper Front  
Scratched  
Over 100mm Thru Paint

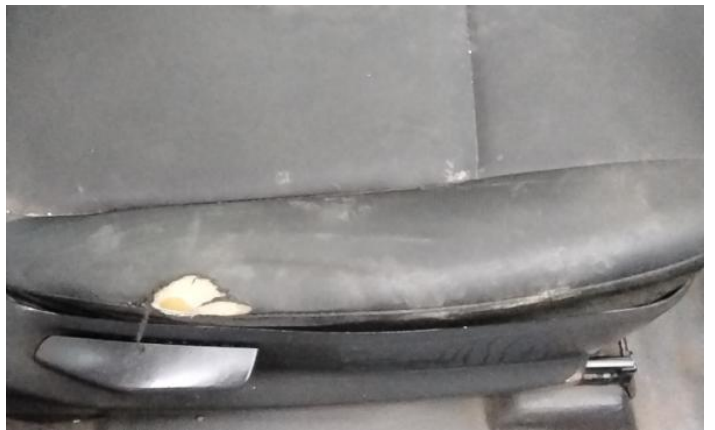
14: Seat Base Cover osf  
Holed  
Over 3mm

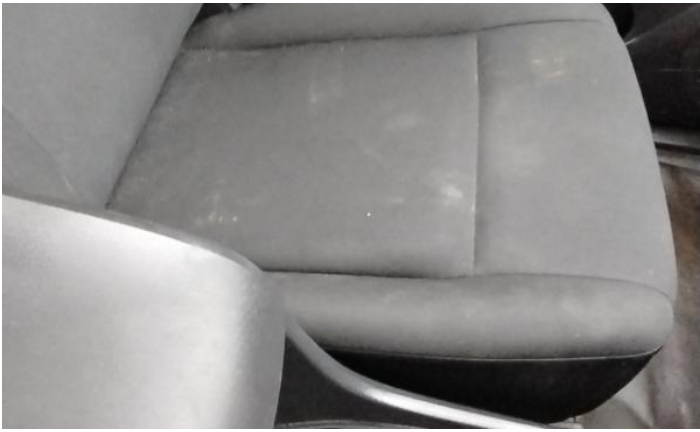
15: Seat Base Cover nsf  
Soiled  
Heavy
