# VEHICLE INSPECTION REPORT

**PE17HRF**

## Daf CF 440

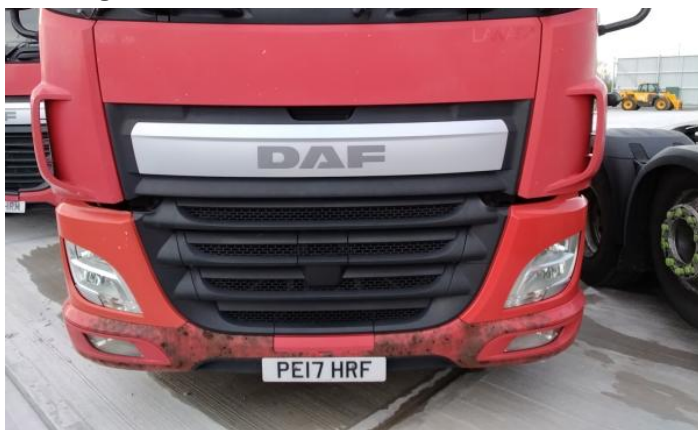
1: Bonnet  
Chipped  
Multiple Chips

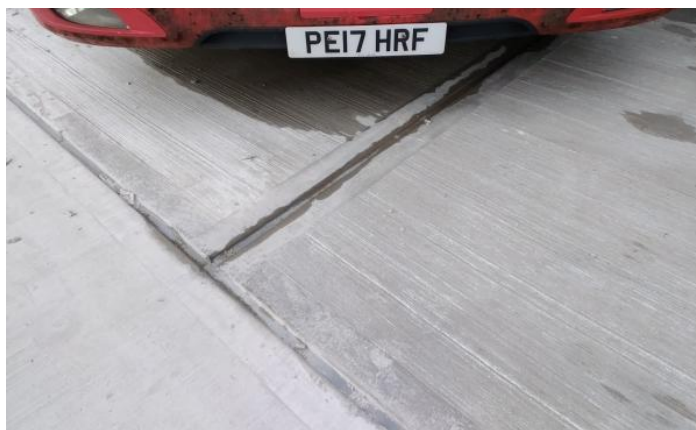
2: Bumper Front  
Rusted  
Over 5mm

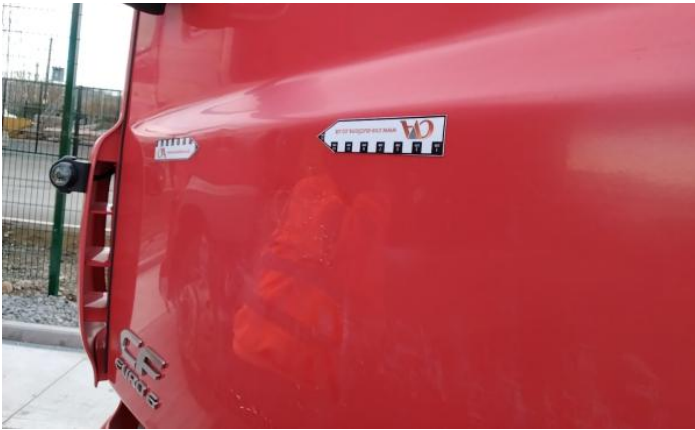
3: Door nsf  
Dented  
Over 30mm

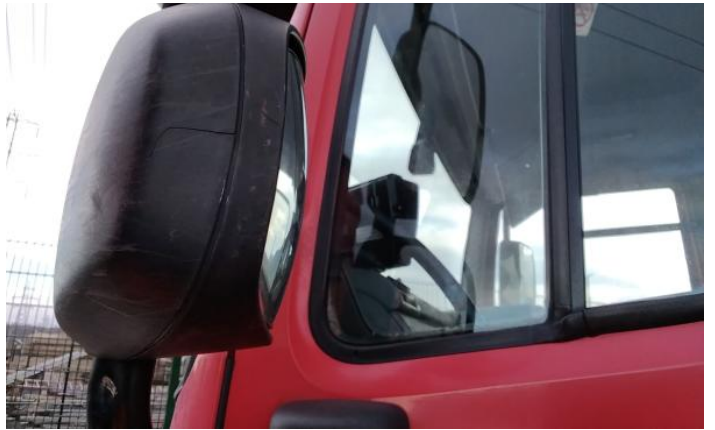
4: Door Mirror Assy nsf  
Broken  
Replace

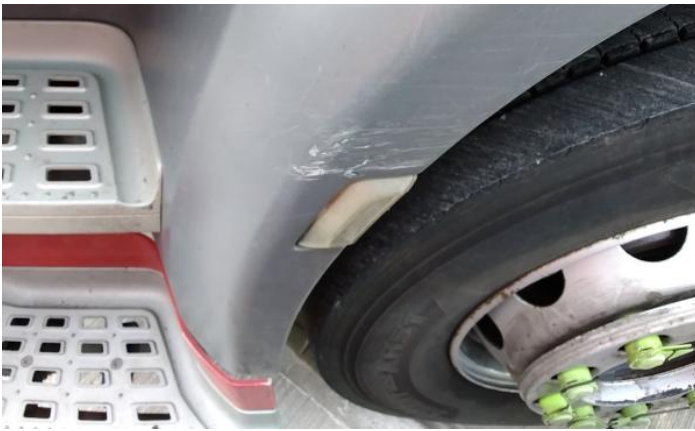
5: Wing nsf  
Scratched  
Over 25mm Thru Paint

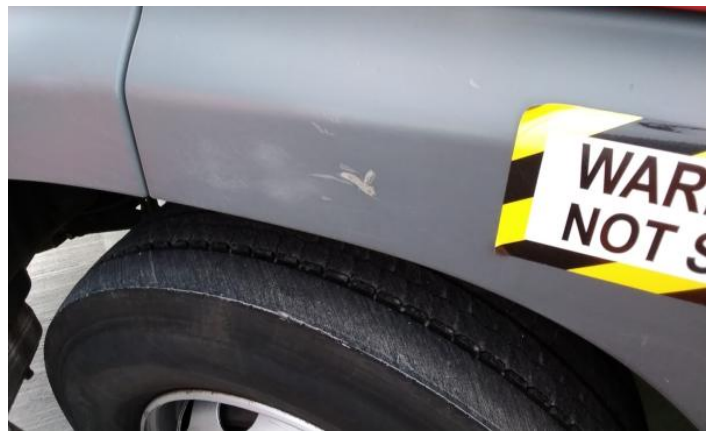
6: Qtr Panel Moulding ns  
Scratched (Painted)  
Over 25mm Thru Paint

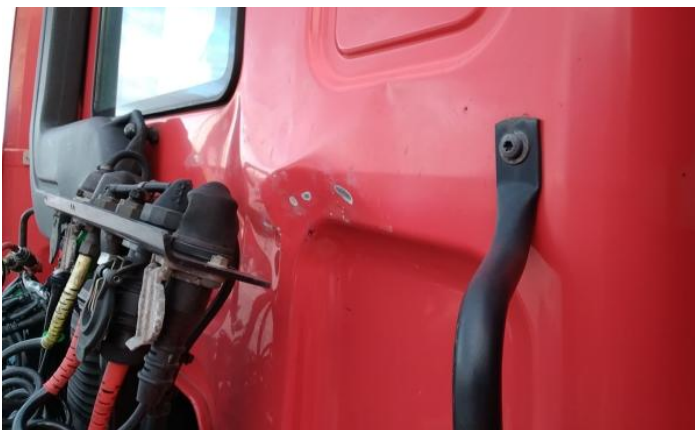
7: Panel Rear  
Dented  
With Paint Damage

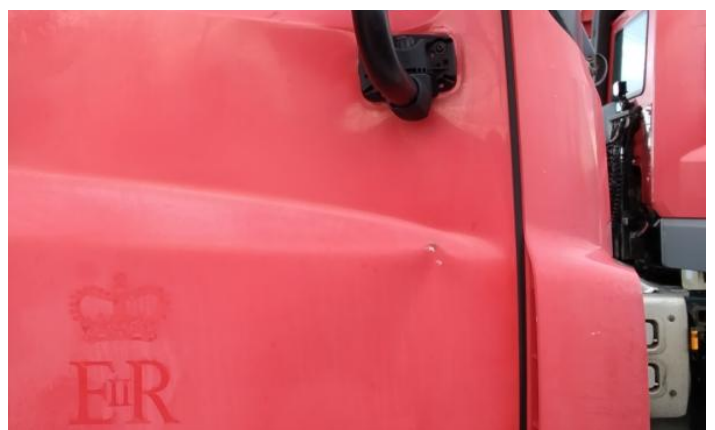
8: Door osf  
Dented  
Over 30% Of Panel

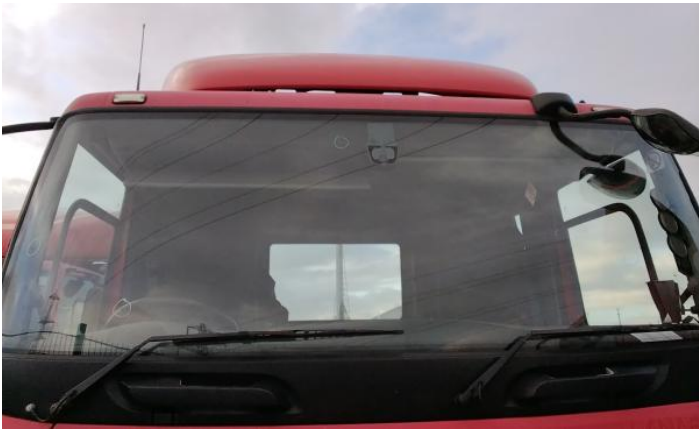
9: Screen Front  
Chipped  
Over 10mm

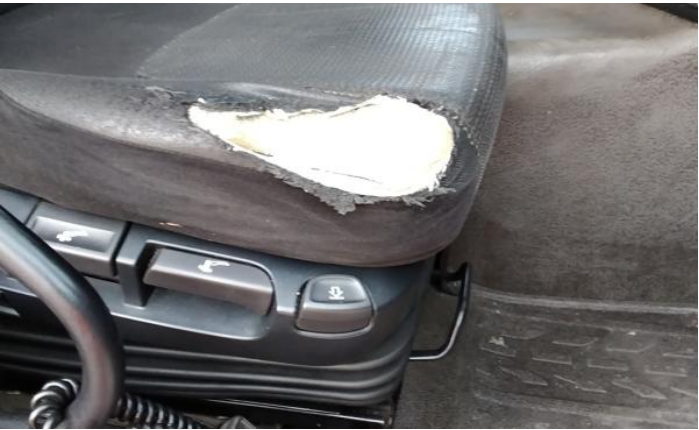
10: Seat Base Cover osf  
Holed  
Over 3mm

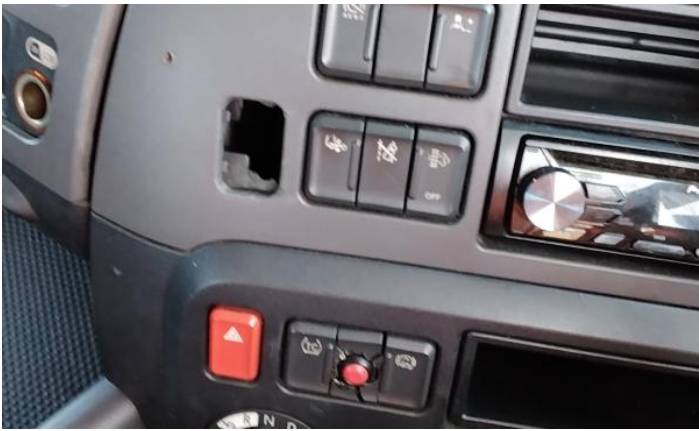
11: Switches And Controls  
Broken  
Replace

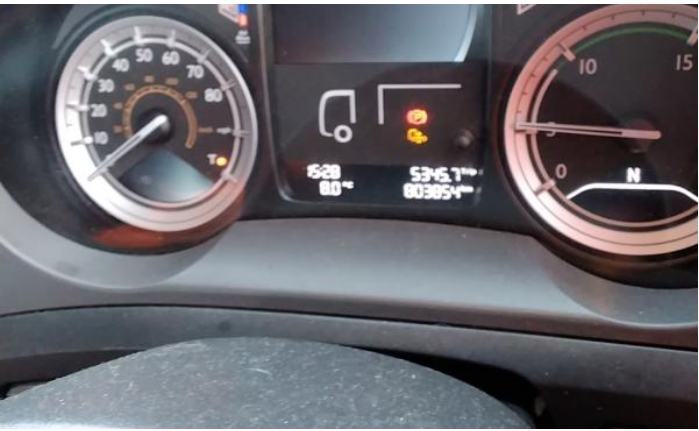
12: Dash Warning Lights  
Displayed  
No Action
