VEHICLE INSPECTION REPORT

MX09FSL

Daf LF 55.220 18 TONNE

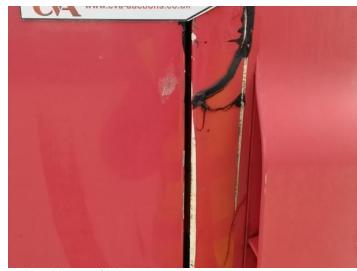
1: Moulding osf Wing Broken Replace

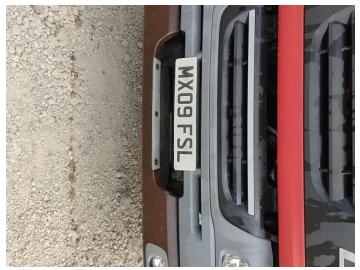
2: Bumper Front Rusted Over 5mm

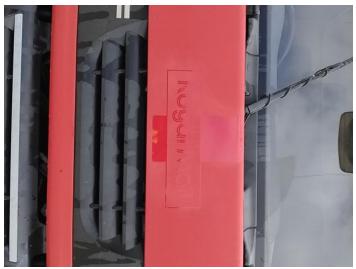
3: Bonnet Chipped Multiple Chips

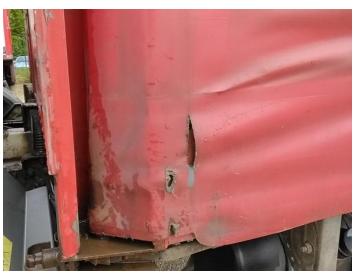
4: General Exterior Soiled Light

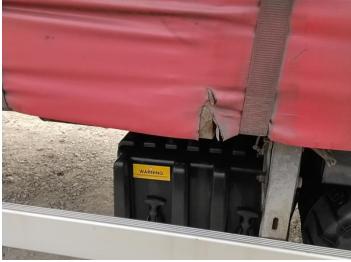
5: General Exterior Soiled Light
