# VEHICLE INSPECTION REPORT

**CU65CKJ**

## Ford Transit 350 2.2 TDCI 155PS

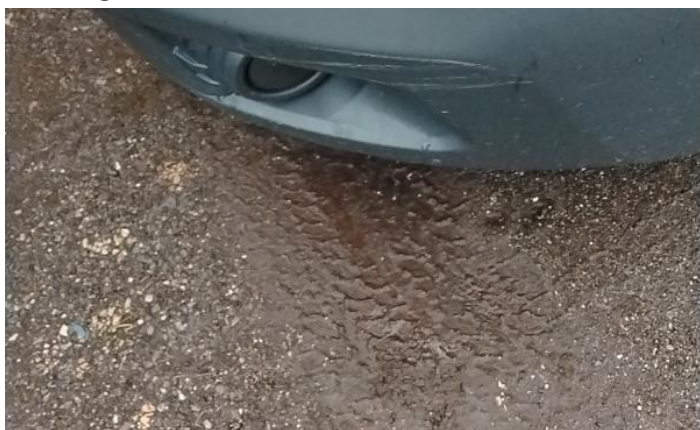
1: Bumper Front  
Scratched  
Over 100mm Thru Paint

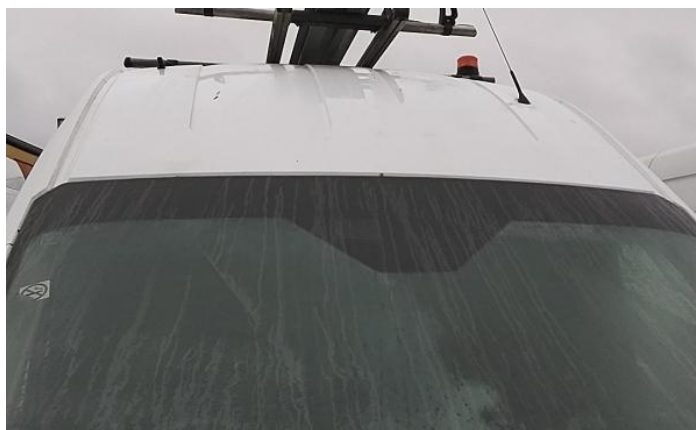
2: Roof  
Chipped  
Multiple Chips

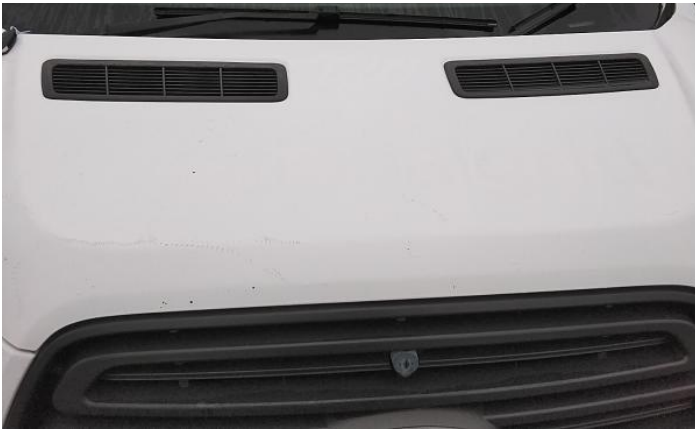
3: Bonnet  
Chipped  
Multiple Chips

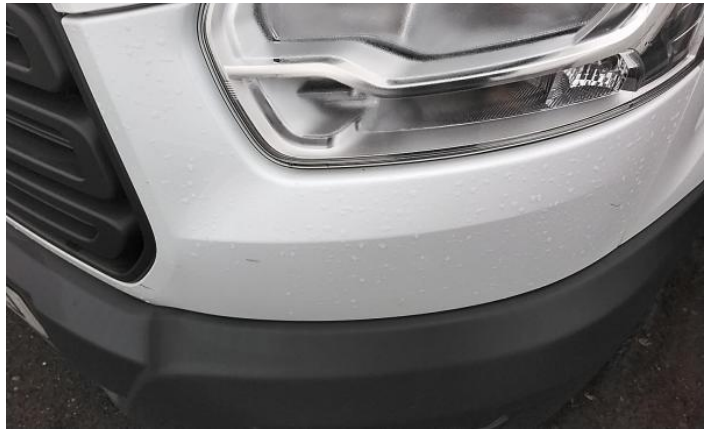
4: Panel Front  
Scratched  
Over 25mm Thru Paint

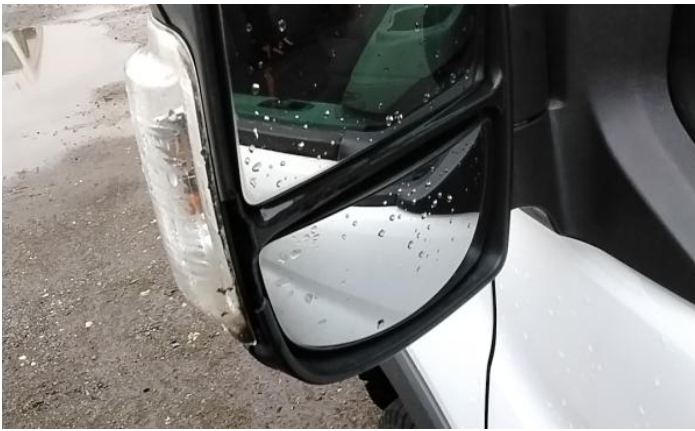
5: Door Mirror Assy nsf  
Broken  
Replace

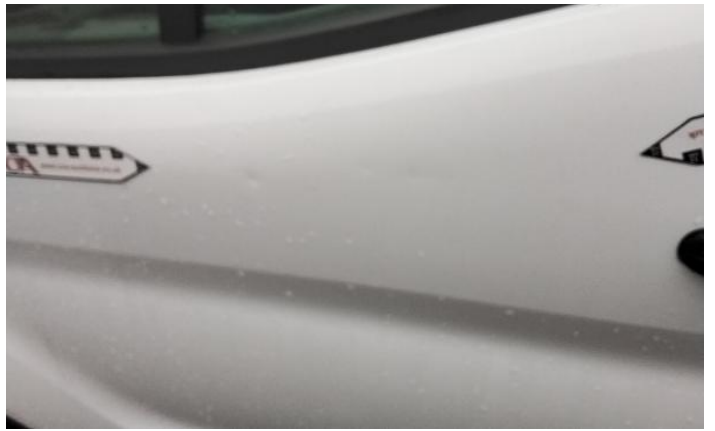
6: Door nsf  
Dented  
Over 30mm

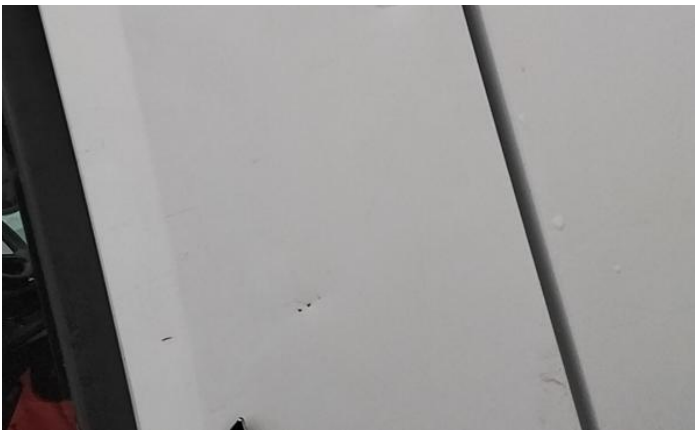
7: Door nsf  
Dented  
With Paint Damage

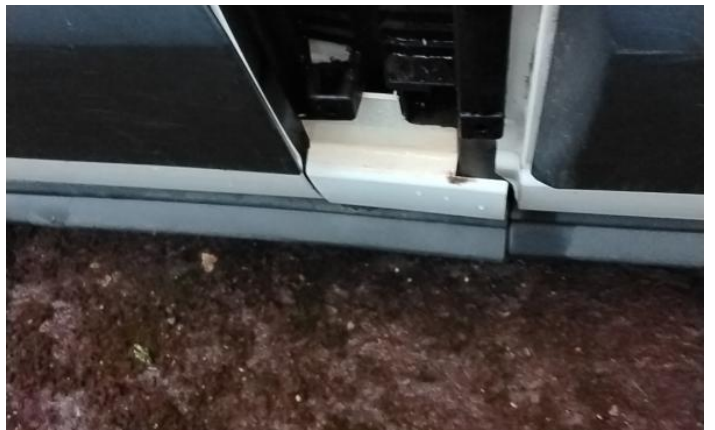
8: Door Moulding nsf  
Missing  
Replace

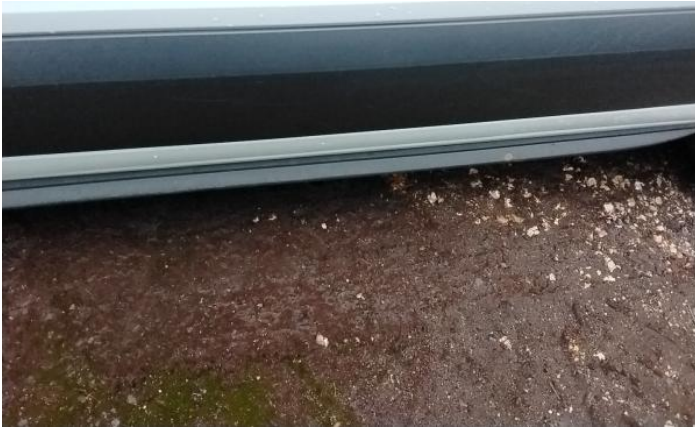
9: Qtr Panel Moulding ns  
Scuffed (Unpainted)  
Over 100mm

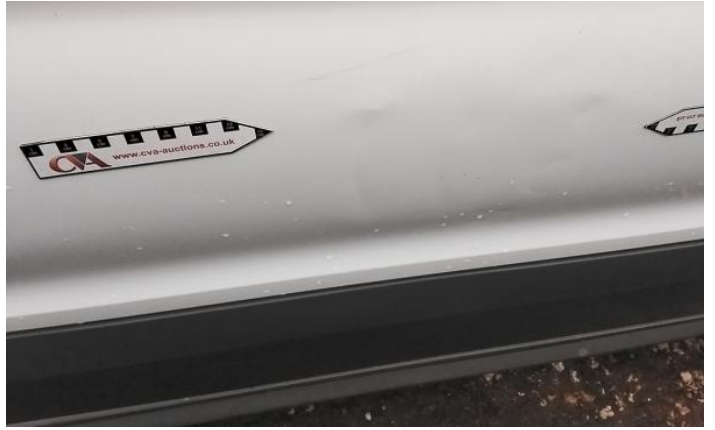
10: Qtr Panel nsr  
Dented  
Over 30mm

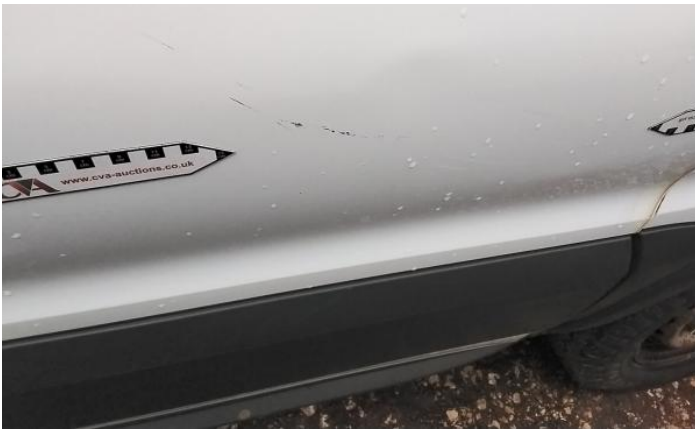
11: Qtr Panel nsr  
Dented  
With Paint Damage

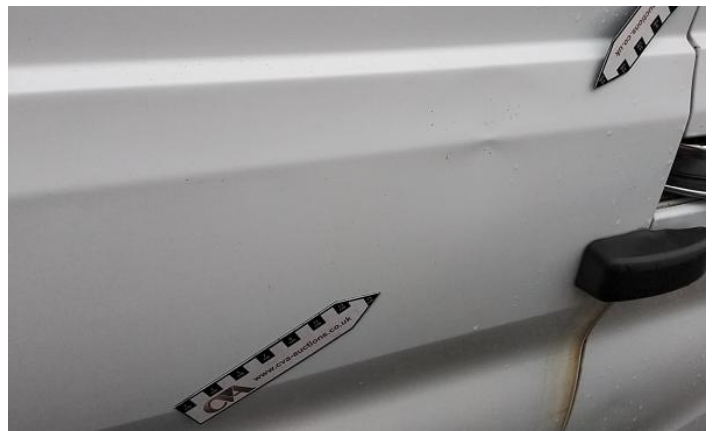
12: Qtr Panel nsr  
Dented  
Over 30mm

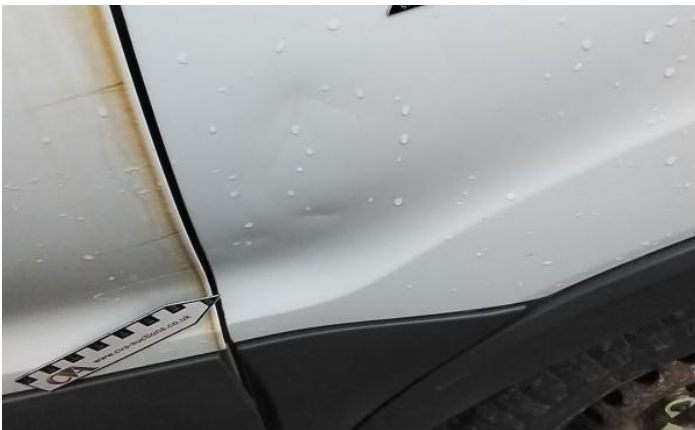
13: Qtr Panel nsr  
Dented  
With Paint Damage

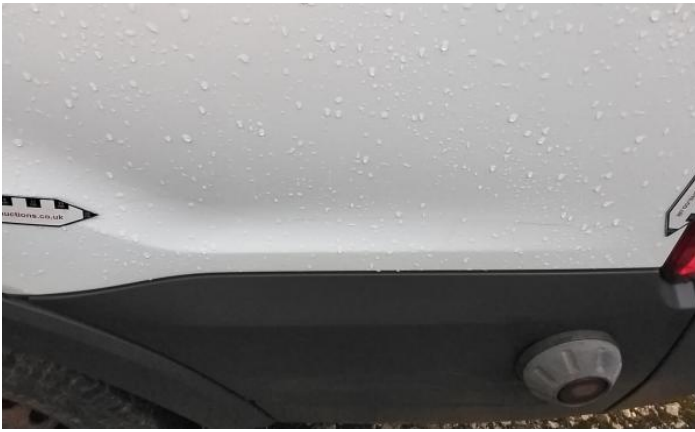
15: Qtr Panel nsr  
Scratched  
Over 25mm Thru Paint

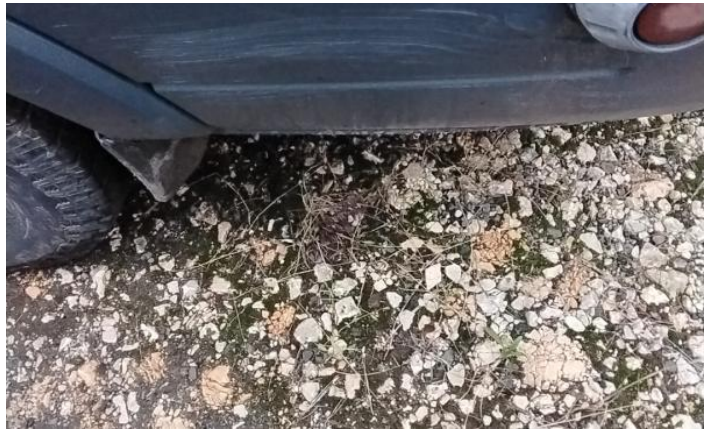
16: Qtr Panel Moulding ns  
Scuffed (Unpainted)  
Over 100mm

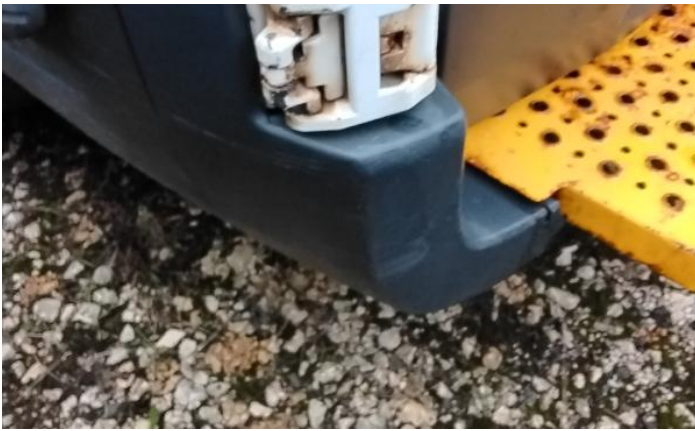
17: Bumper Rear Moulding  
Scuffed (Unpainted)  
Over 100mm

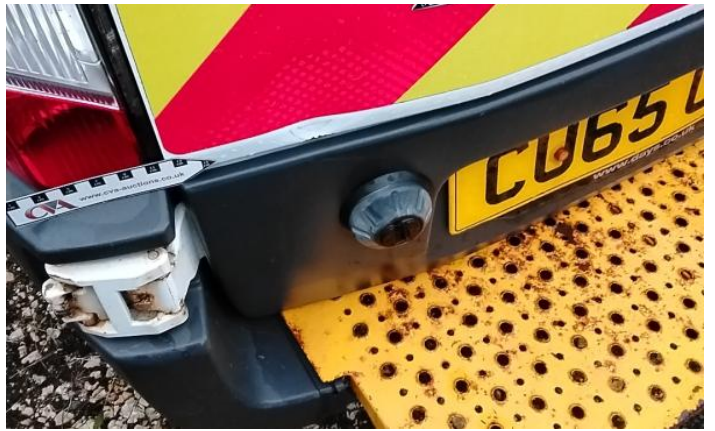
18: Door nsr  
Dented  
Over 30mm

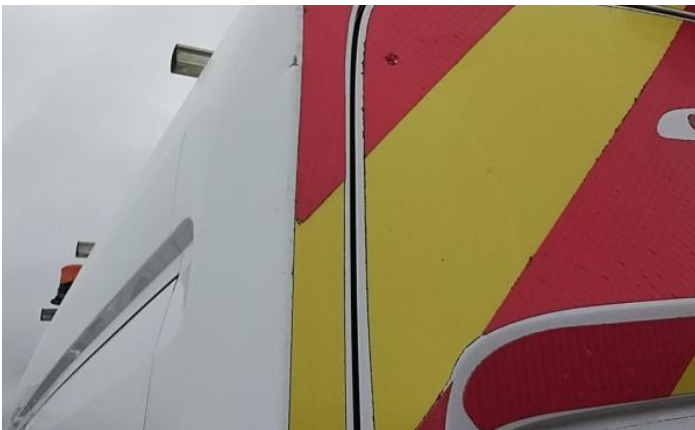
19: C Post ns  
Dented  
With Paint Damage

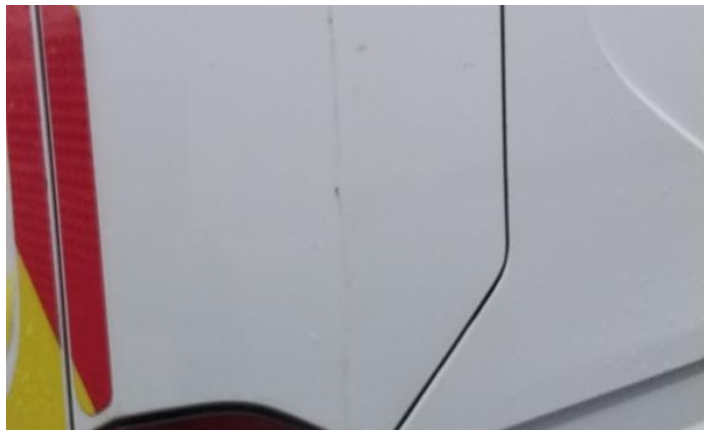
20: C Post os  
Scratched  
Over 25mm Thru Paint

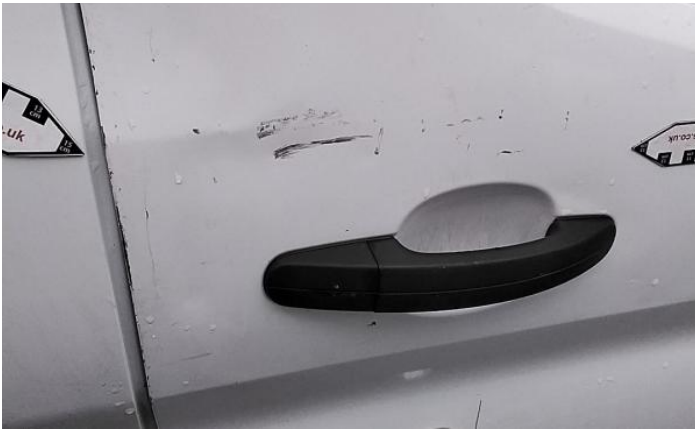
21: Door osf  
Dented  
With Paint Damage

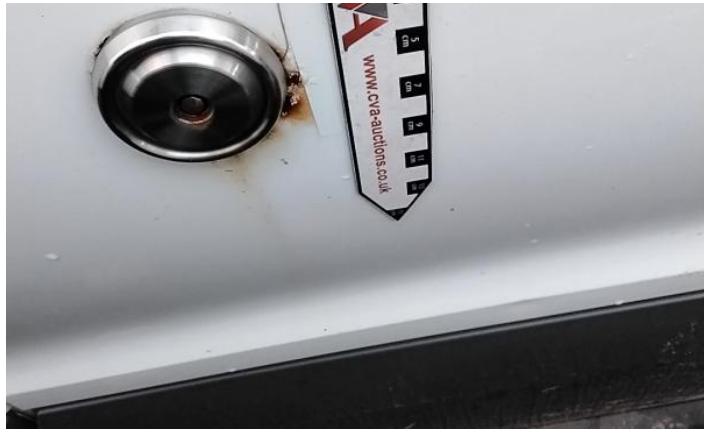
22: Door osf  
Scratched  
Over 25mm Thru Paint

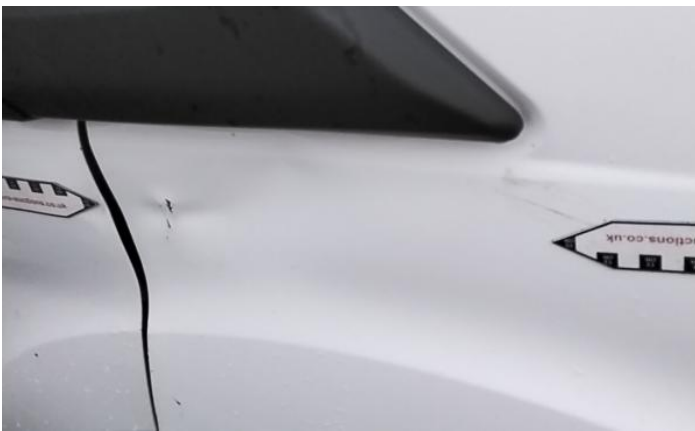
23: Wing osf  
Dented  
With Paint Damage

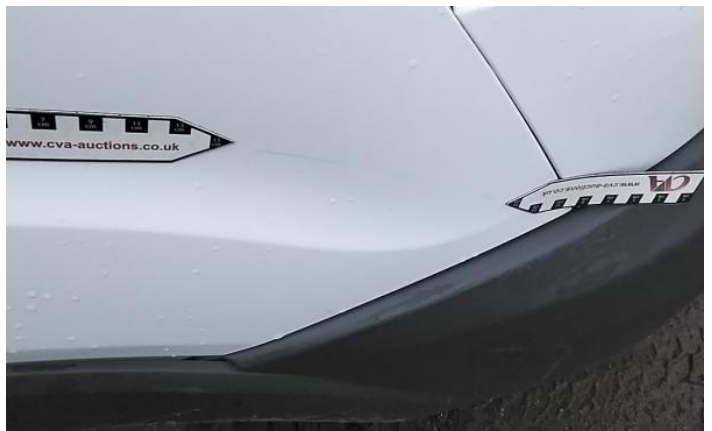
24: Wing osf  
Scratched  
Over 25mm Not Thru Paint

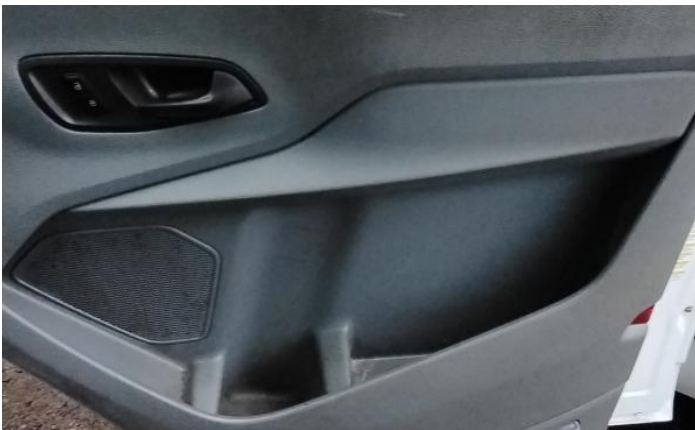
25: Door Pad osf  
Soiled  
Heavy

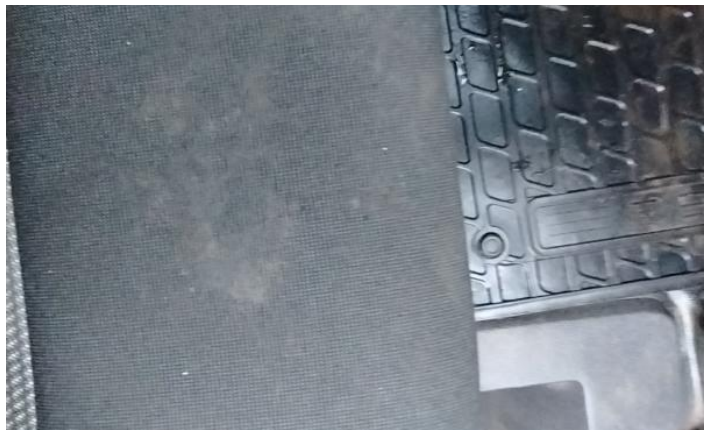
26: Seat Base Cover osf  
Soiled  
Heavy
