# **VEHICLE INSPECTION REPORT**

**PK67VGR**

## **Daf CF 450**

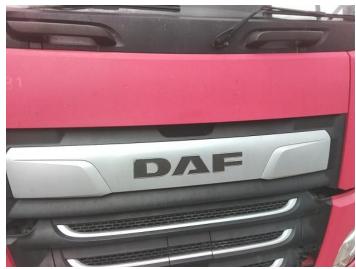
1: Bonnet Chipped Multiple Chips

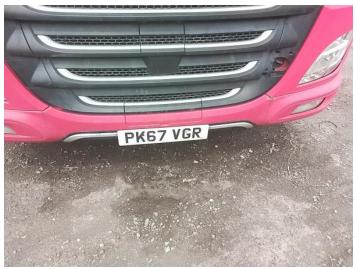
2: Bumper Front Chipped Multiple Chips

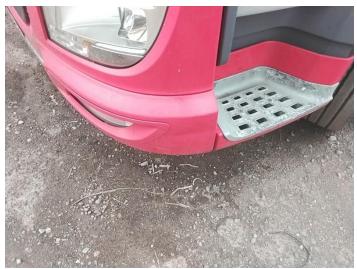
3: Bumper Front Dented Over 30mm

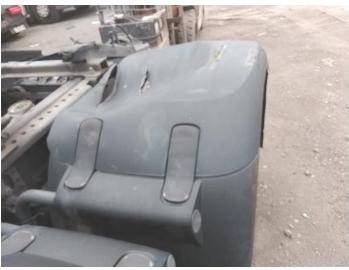
4: Qtr Panel Moulding ns Broken Replace

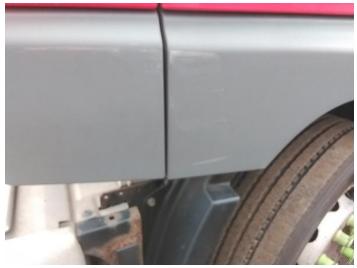
5: Qtr Panel Moulding os Scuffed (Unpainted) Over 100mm
