# VEHICLE INSPECTION REPORT

**YC72FBN**

## Renault Trafic LL30 BLUEDCI 130PS

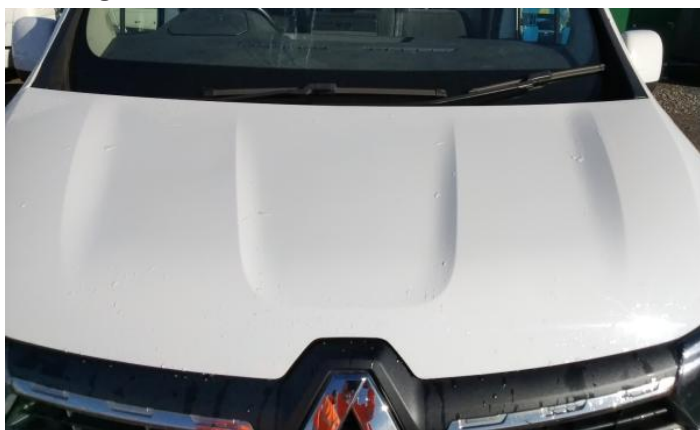
1: Bonnet  
Chipped  
Multiple Chips

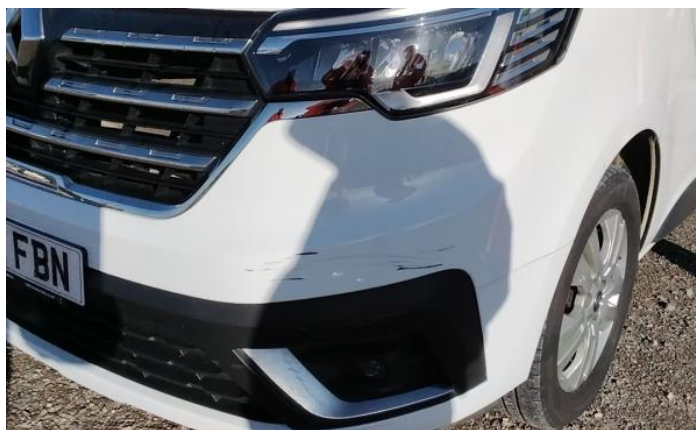
2: Bumper Front  
Scratched  
Over 100mm Thru Paint

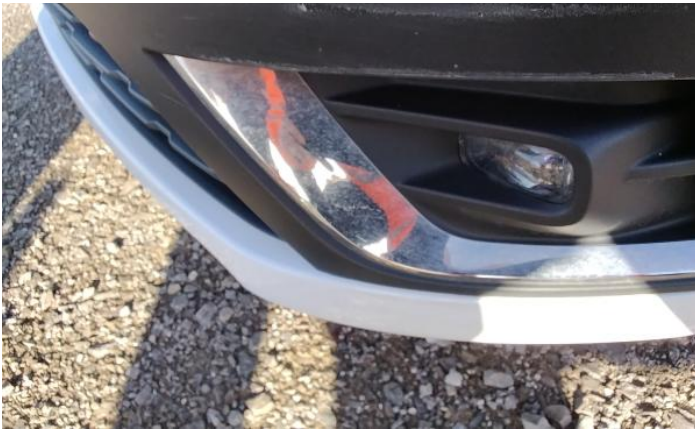
3: Bumper Front Moulding  
Scuffed (Unpainted)  
Over 100mm

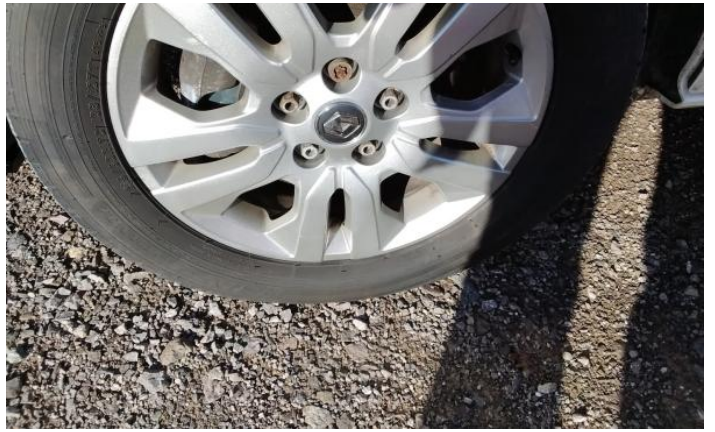
4: Wheel nsf  
Scratched  
Over 50mm

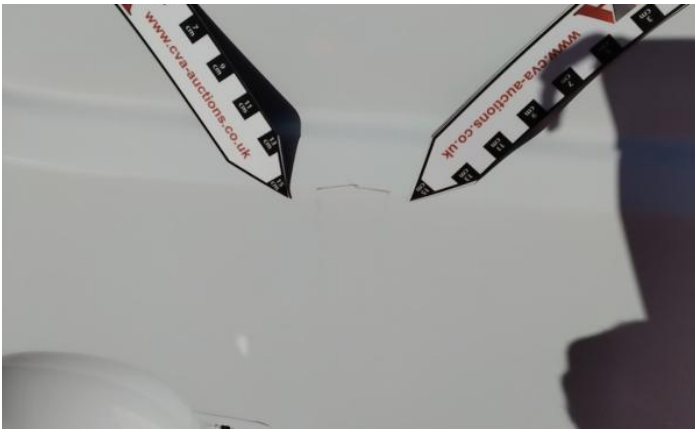
5: Qtr Panel nsr  
Scratched  
Over 25mm Thru Paint

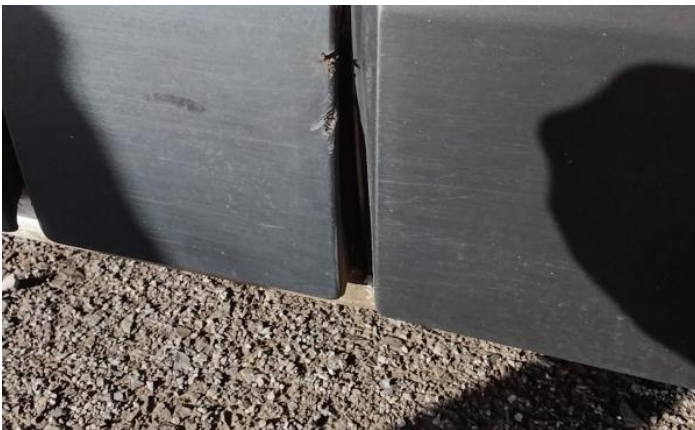
7: Door Moulding nsf  
Scuffed (Unpainted)  
UpTo 100mm

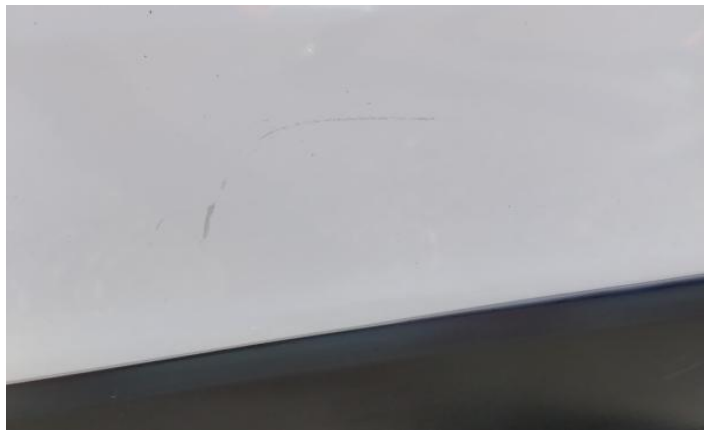
8: Qtr Panel nsr  
Scratched  
Over 25mm Not Thru Paint

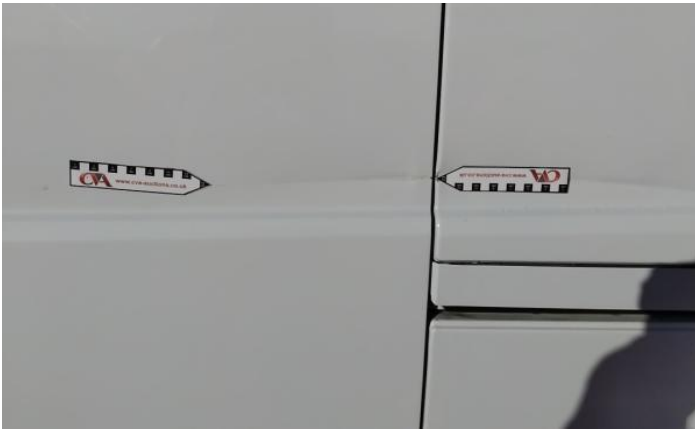
9: Qtr Panel Moulding ns  
Scratched (Painted)  
Over 25mm Thru Paint

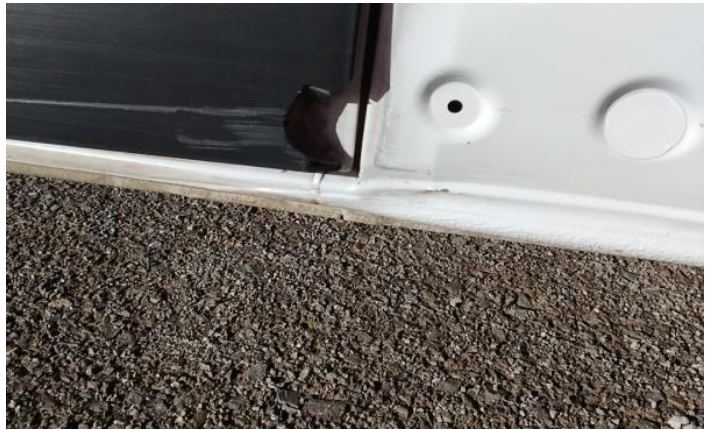
10: Moulding nsf Wing  
Broken  
Replace

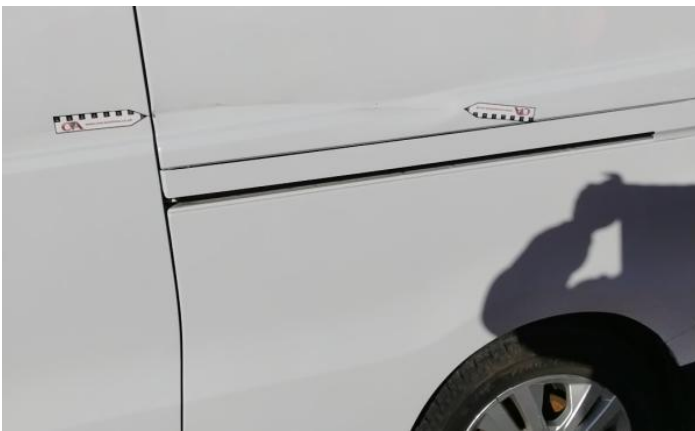
11: Qtr Panel nsr  
Scratched  
Over 25mm Thru Paint

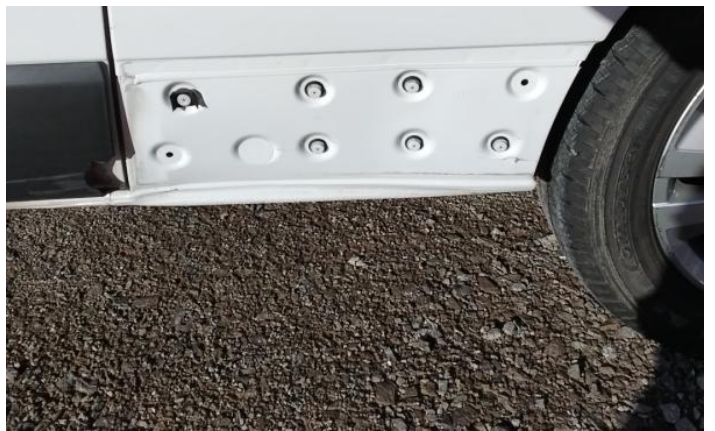
12: Qtr Panel Moulding ns  
Missing  
Replace

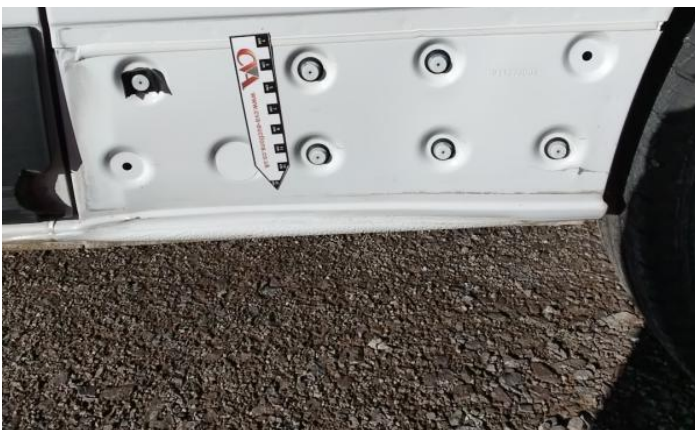
13: Sill ns  
Dented  
Over 30mm

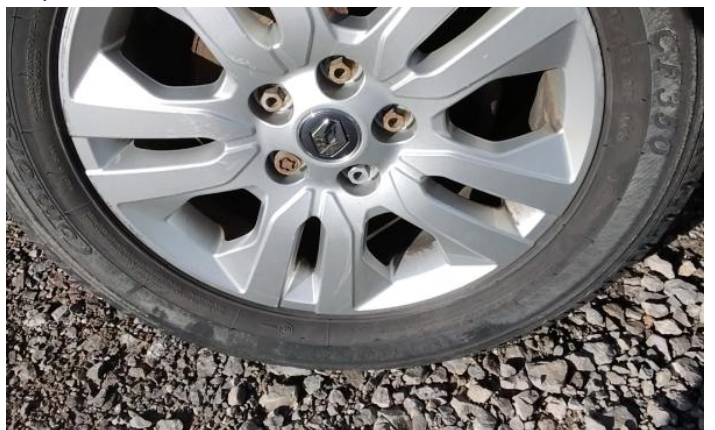
14: Wheel nsr  
Scratched  
Up To 50mm

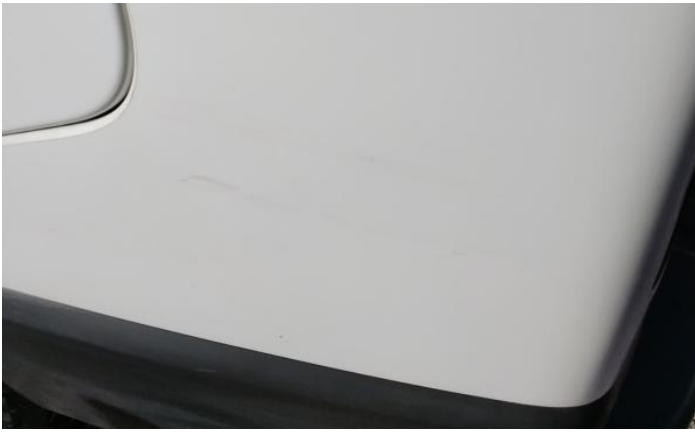
15: Qtr Panel Moulding ns  
Scratched (Painted)  
Over 25mm Thru Paint

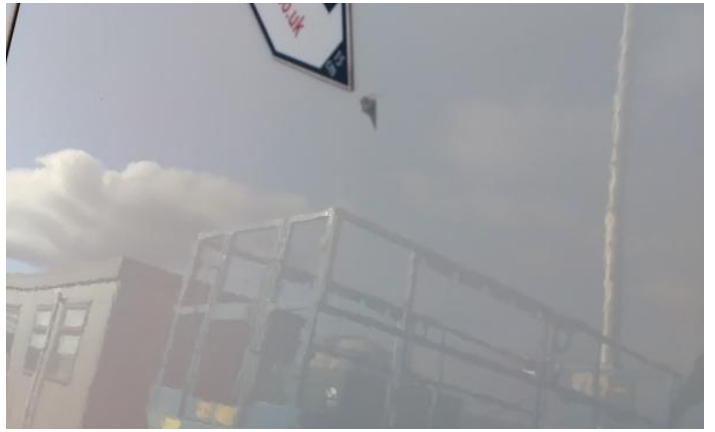
16: Door osr  
Chipped  
Over 5mm

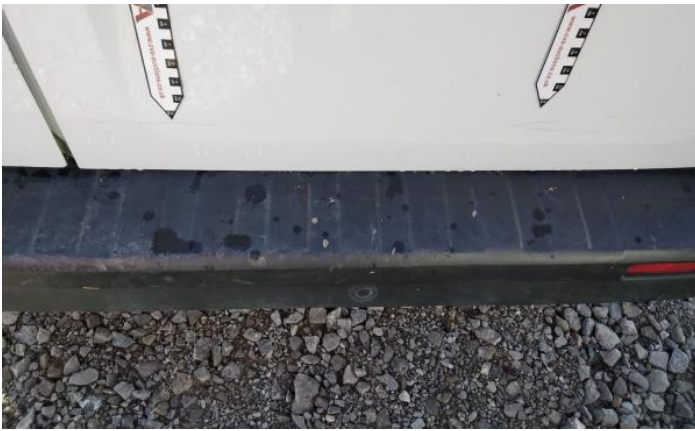
17: Door osr  
Scratched  
Over 25mm Thru Paint

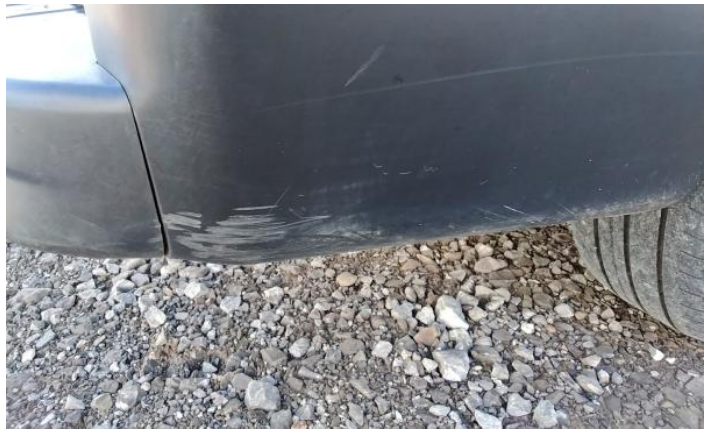
18: Qtr Panel Moulding os  
Scuffed (Unpainted)  
Over 100mm

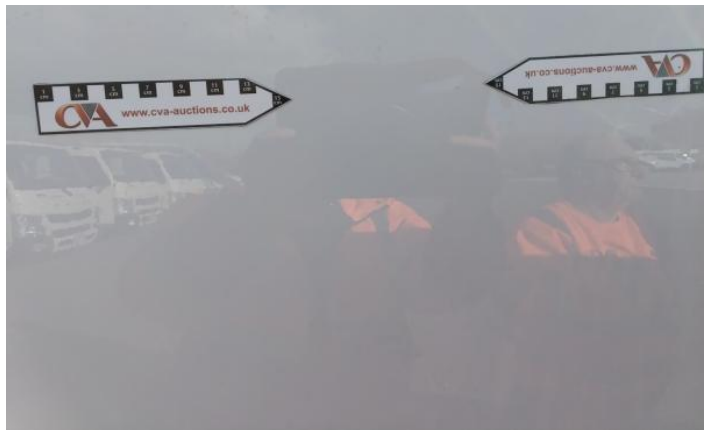
20: Qtr Panel osr  
Dented  
Over 30mm

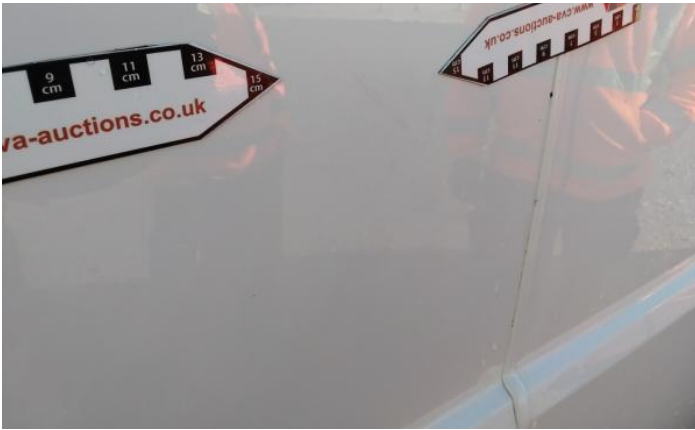
21: Qtr Panel osr  
Scratched  
Over 25mm Thru Paint

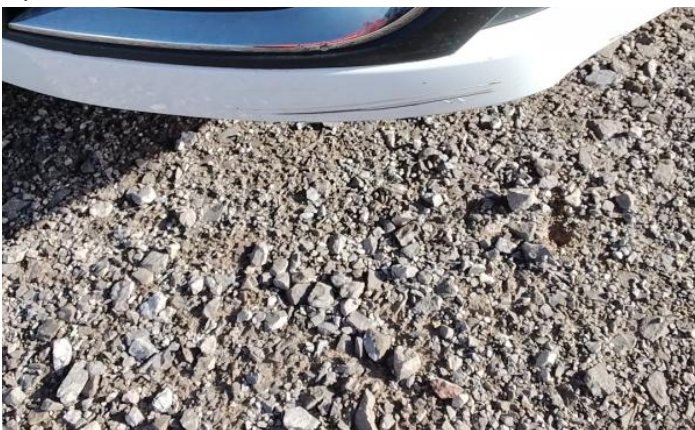
24: Bumper Front  
Chipped  
Multiple Chips

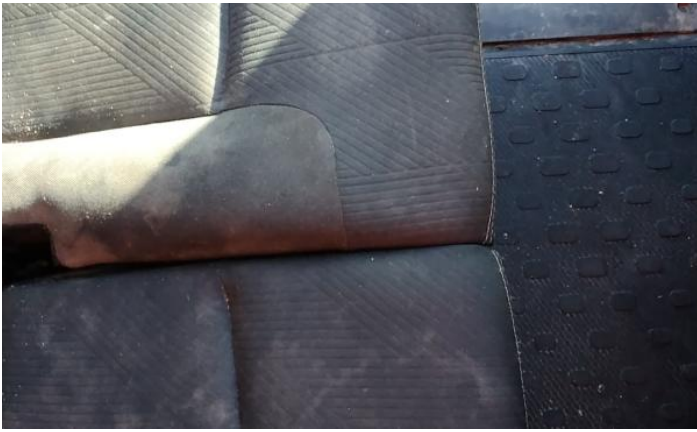
27: Seat Base Cover nsr  
Soiled  
Heavy

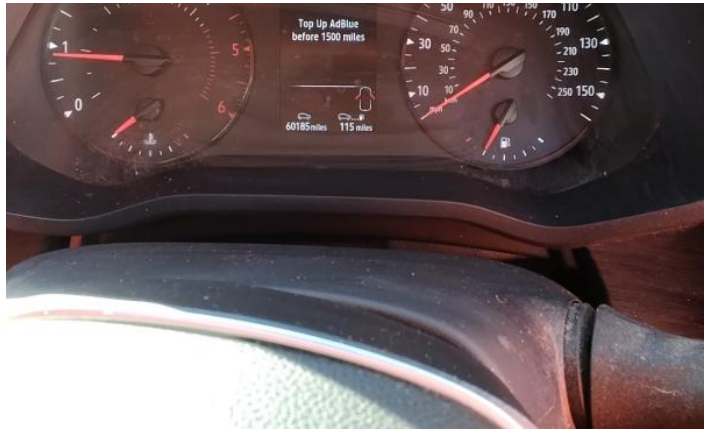
28: Dash Warning Lights  
Displayed  
No Action
