VEHICLE INSPECTION REPORT

HX69VYD

Mercedes-Benz Sprinter 314 CDI

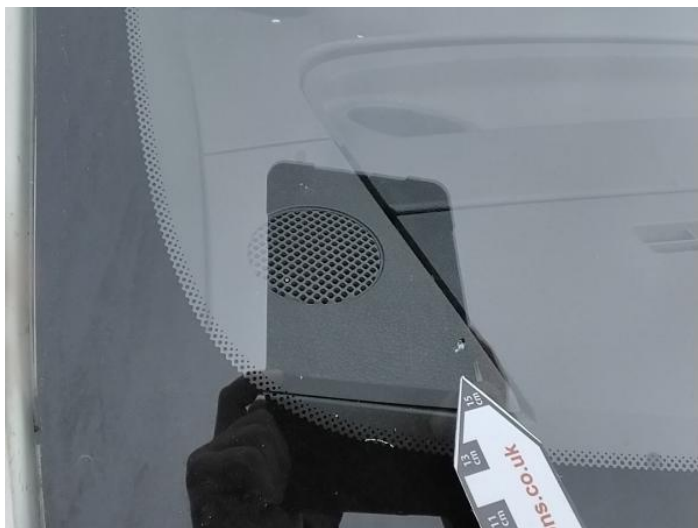
1: Screen Front
Chipped
Over 10mm

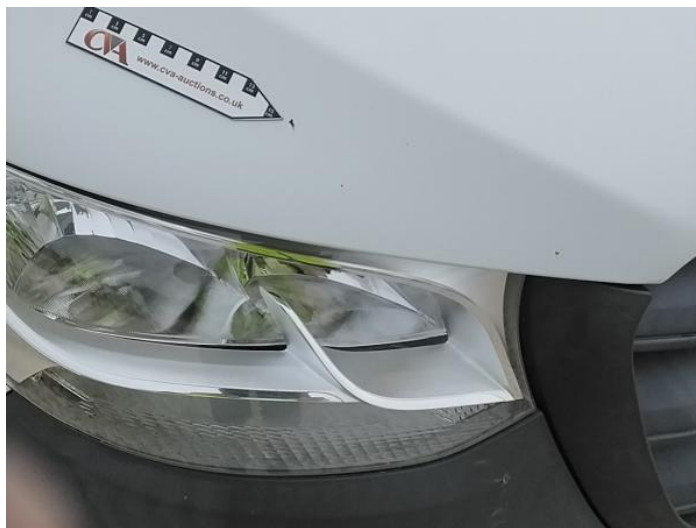
2: Bonnet
Chipped
Multiple Chips

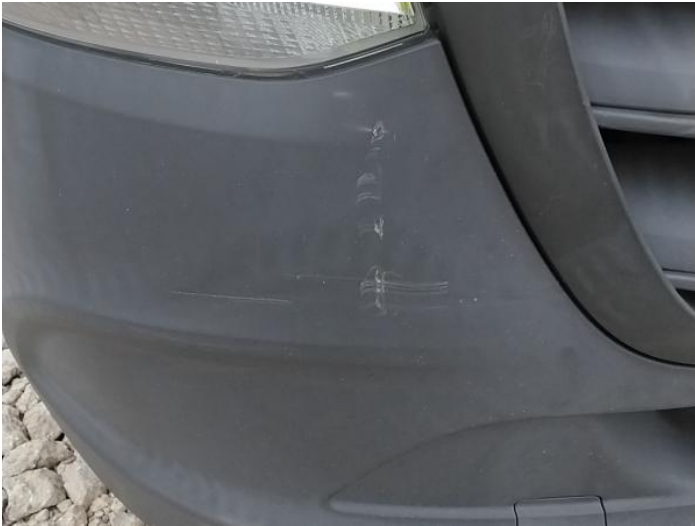
3: Bumper Front
Scratched
Over 25mm Not Thru Paint

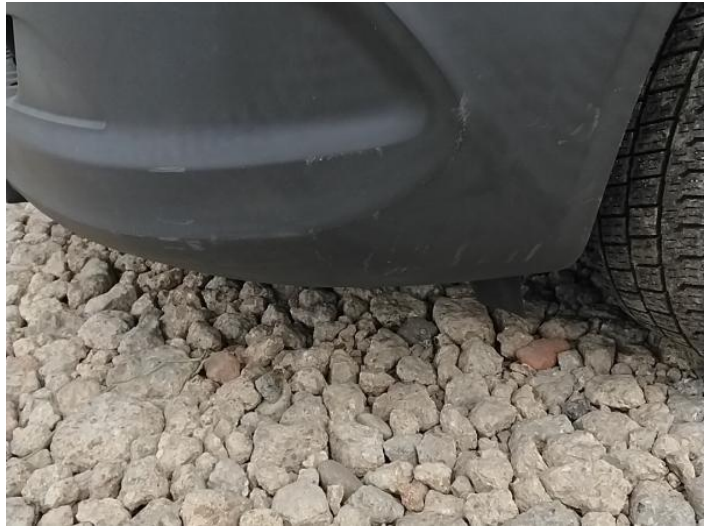
4: Bumper Front
Scratched
Over 25mm Not Thru Paint

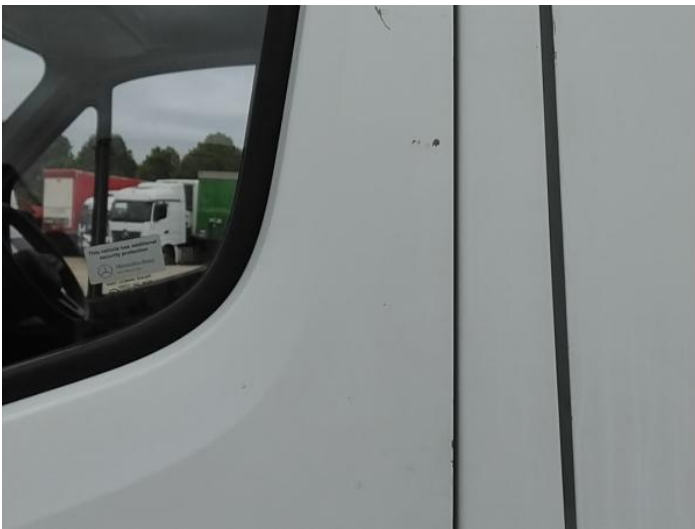
5: Door nsf
Scratched
Over 25mm Thru Paint

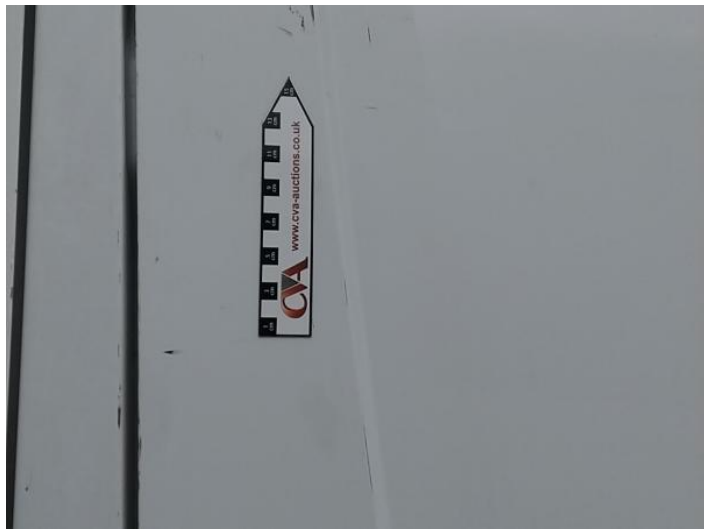
6: Door nsr
Scratched
Over 25mm Thru Paint

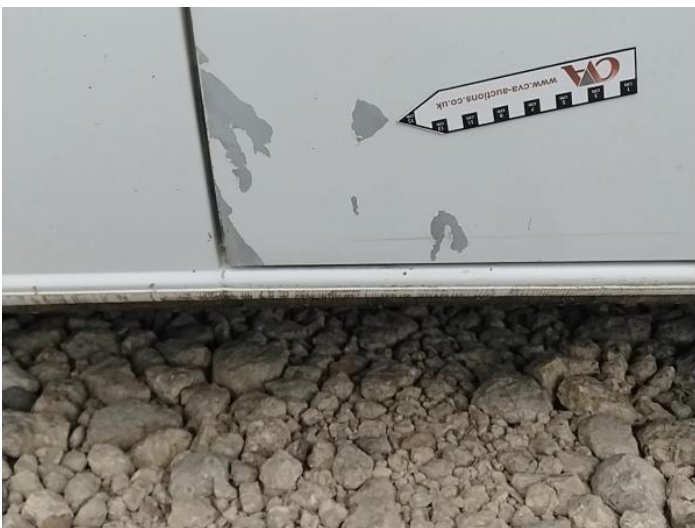
7: Door nsr
Scratched
Over 25mm Thru Paint

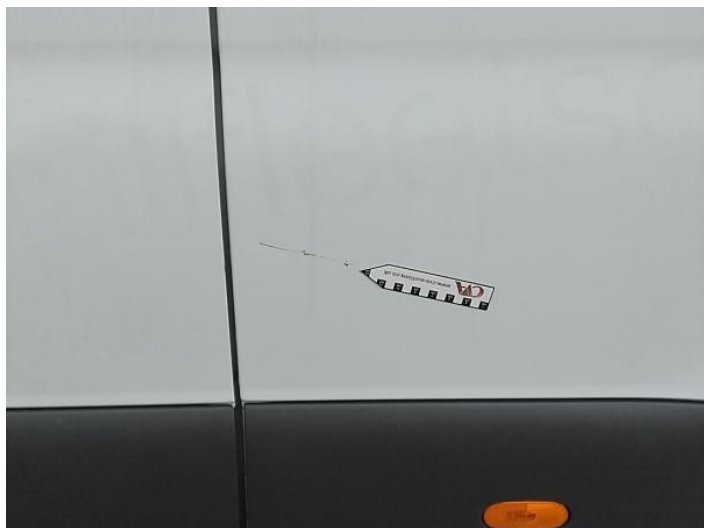
8: Qtr Panel nsr
Scratched
Over 25mm Thru Paint
