# VEHICLE INSPECTION REPORT

**SJ65GKG**

## MERCEDES-BENZ ANTOS 1827

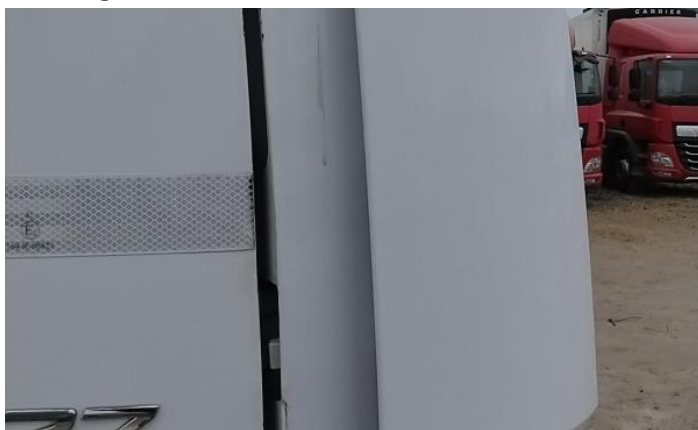
1: Wing osf  
Scratched  
Over 25mm Not Thru Paint

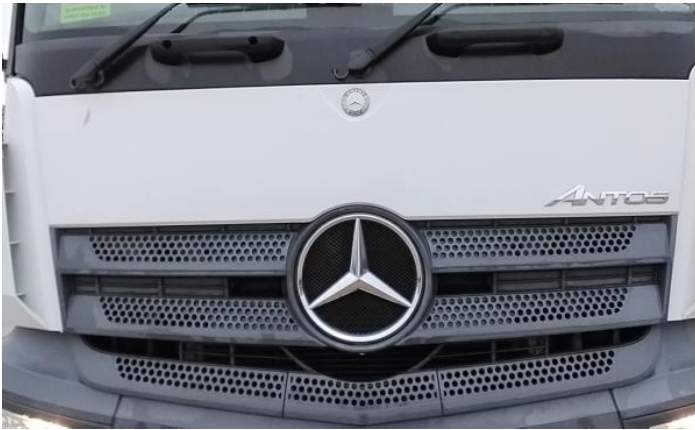
3: Bonnet  
Chipped  
1 To 5

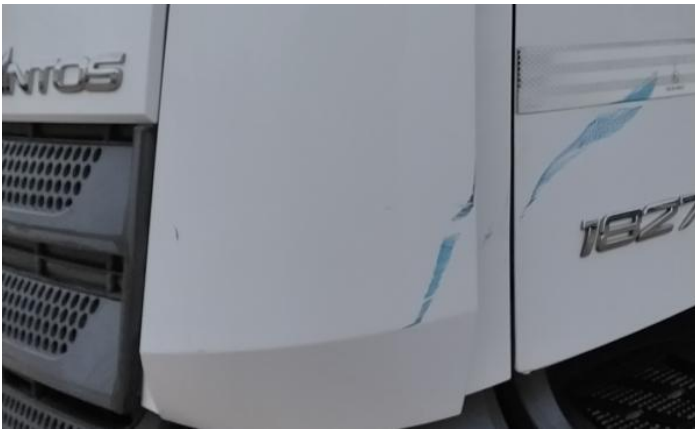
5: Wing nsf  
Scratched  
Over 25mm Not Thru Paint

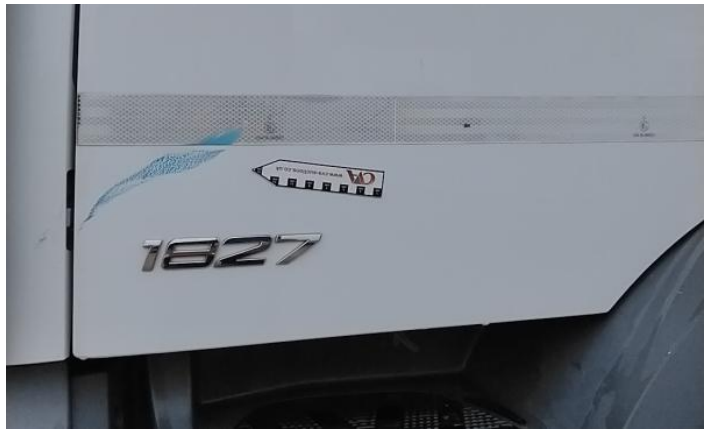
6: Door nsf  
Scratched  
Over 25mm Not Thru Paint

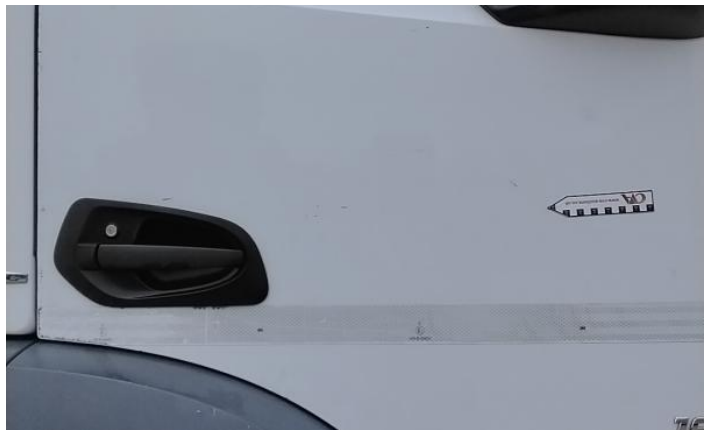
14: Door osf  
Scratched  
Over 25mm Thru Paint

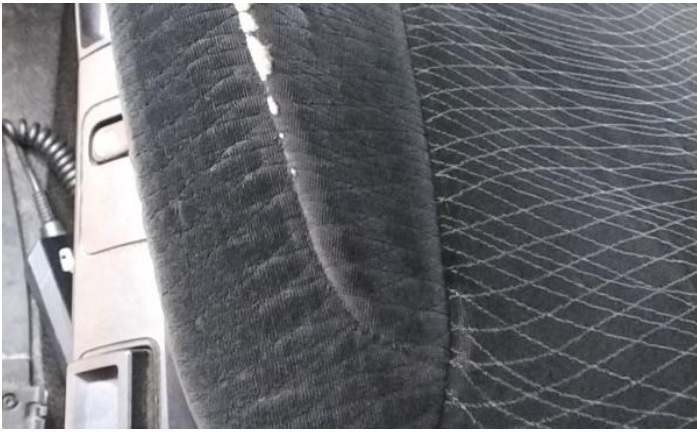
15: Seat Base Cover osf  
 Holed  
 Over 3mm

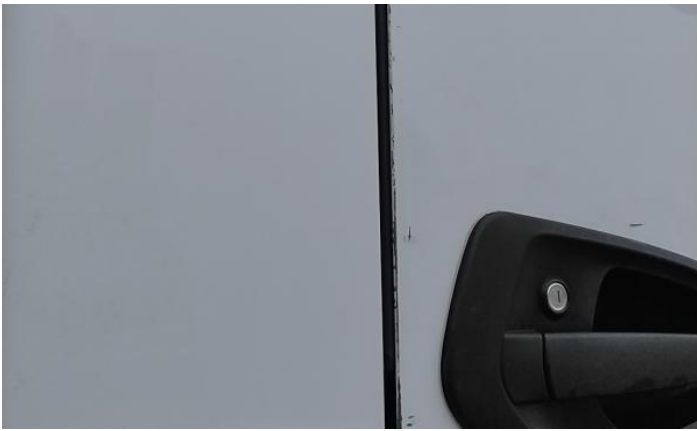
17: Door osf  
 Chipped  
 Edge Chip
