# VEHICLE INSPECTION REPORT

**SJ65GKC**

## Mercedes-Benz Antos 1827

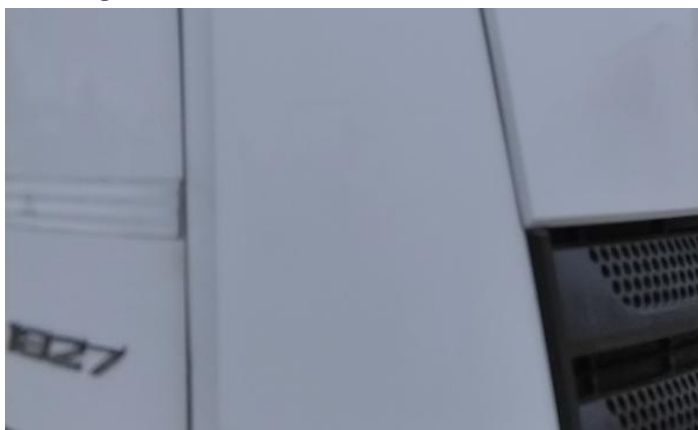
1: Wing osf  
Scratched  
Over 25mm Not Thru Paint

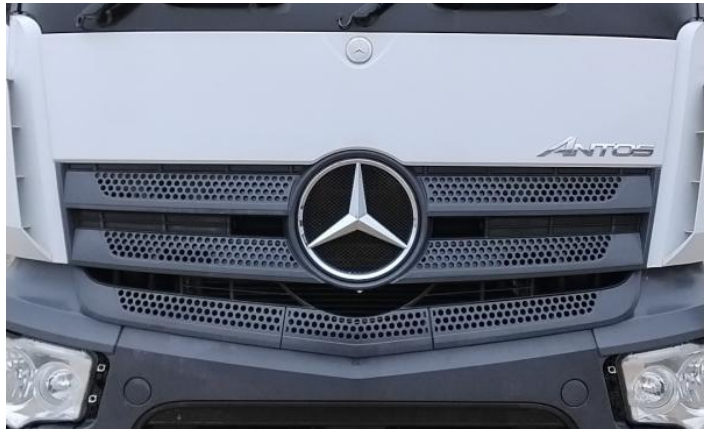
4: Bonnet  
Chipped  
Multiple Chips

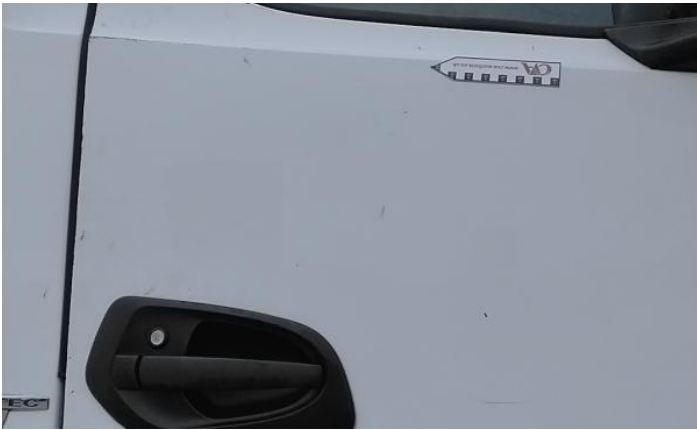
15: Door osf  
Scratched  
Over 25mm Thru Paint

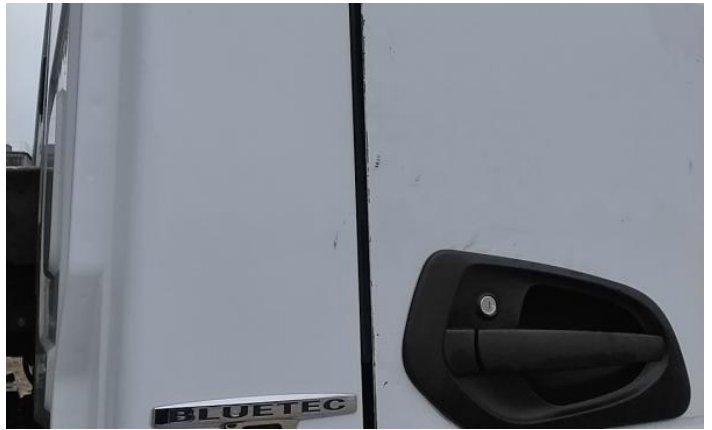
16: Door osf  
Chipped  
Edge Chip

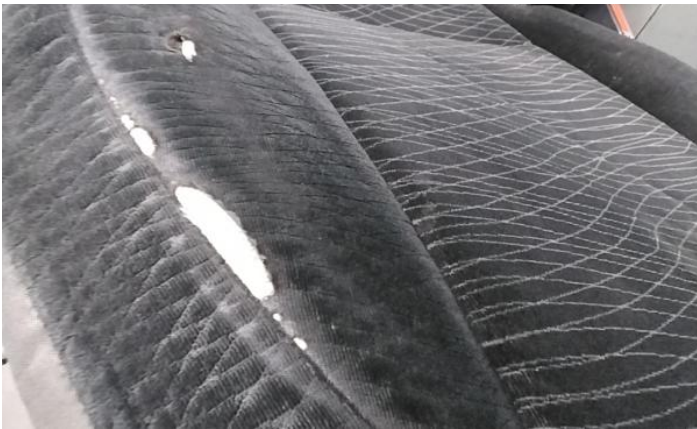
17: Seat Base Cover osf  
Holed  
Over 3mm
