# VEHICLE INSPECTION REPORT

**PK67VFW**

## Daf CF 450

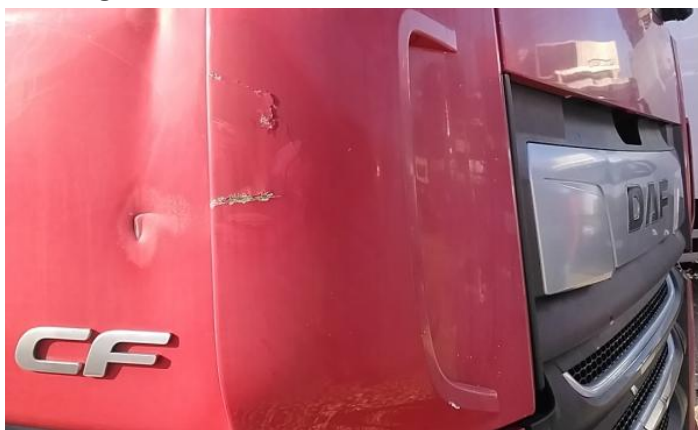
1: Wing of  
Cracked  
Replace

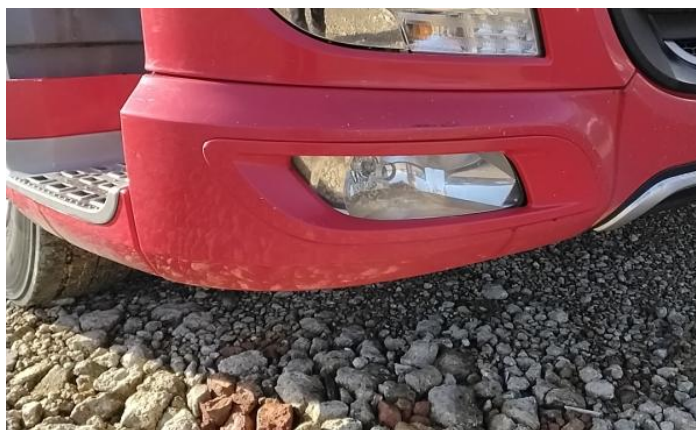
2: Bumper Front  
Scratched  
Over 25mm Not Thru Paint

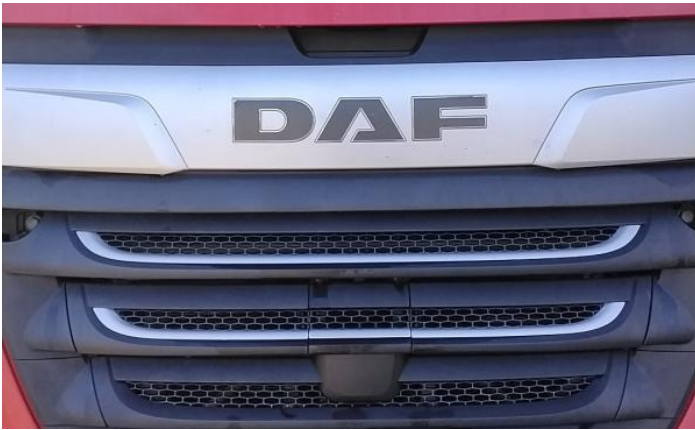
3: Bonnet  
Chipped  
Multiple Chips

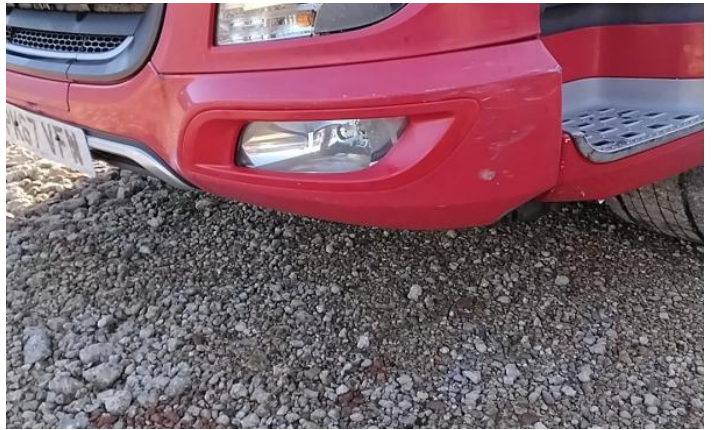
4: Bumper Front  
Scratched  
25 to 100mm Thru Paint

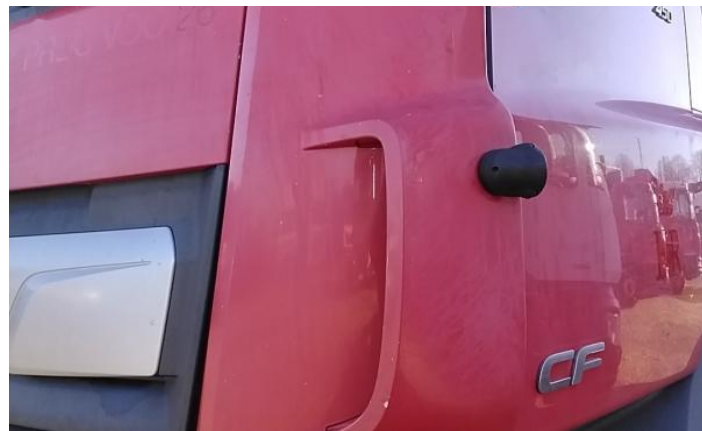
5: Wing nsf  
Chipped  
Multiple Chips

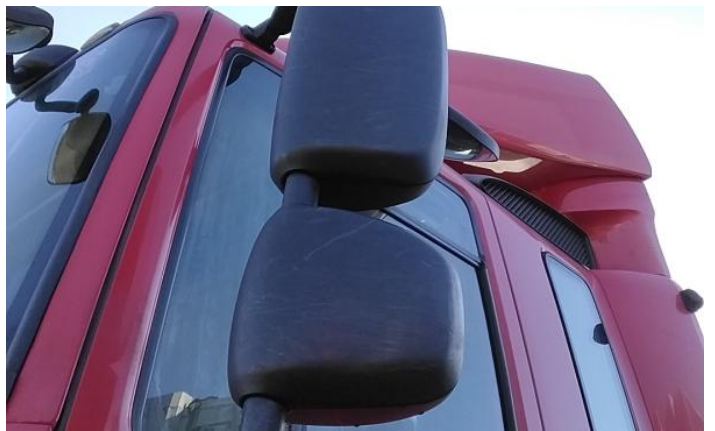
6: Door Mirror Assy nsf  
Scuffed (Unpainted)  
Over 100mm

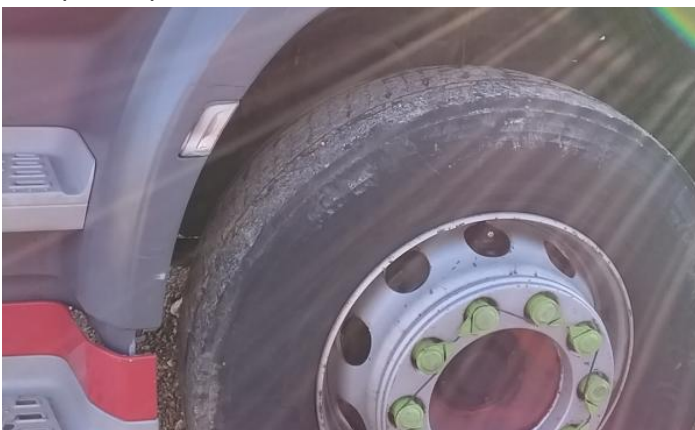
7: Wing Front Arch Extension ns  
Scratched (Painted)  
Over 25mm Not Thru Paint

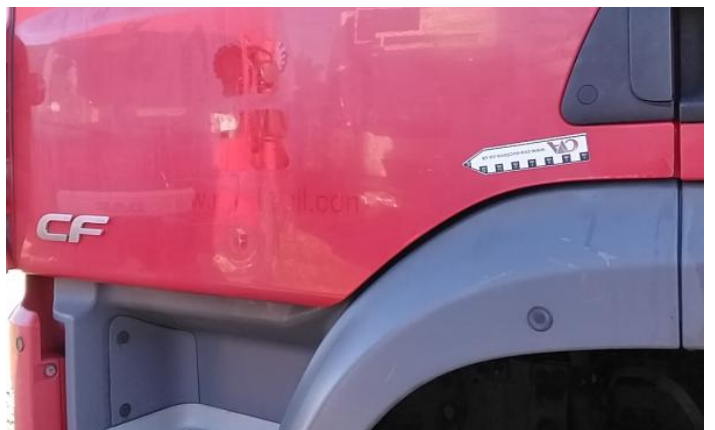
8: Door nsf  
Scratched  
Over 25mm Thru Paint

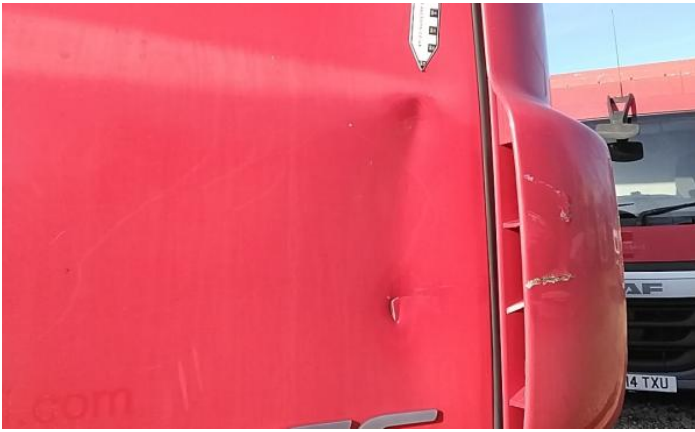
9: Door osf  
Dented  
With Paint Damage

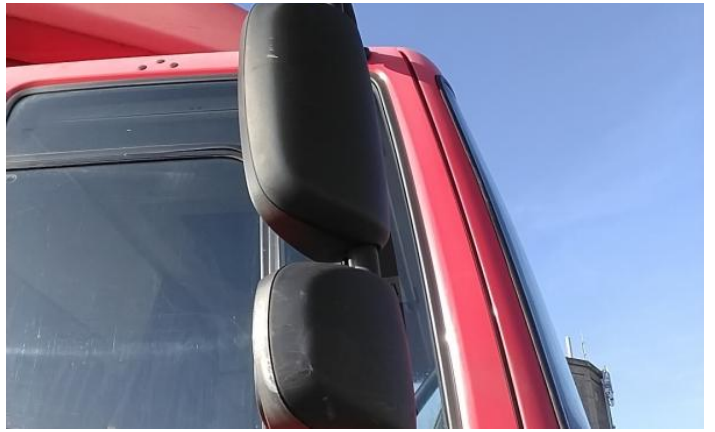
10: Door Mirror Assy osf  
Scuffed (Unpainted)  
Over 100mm

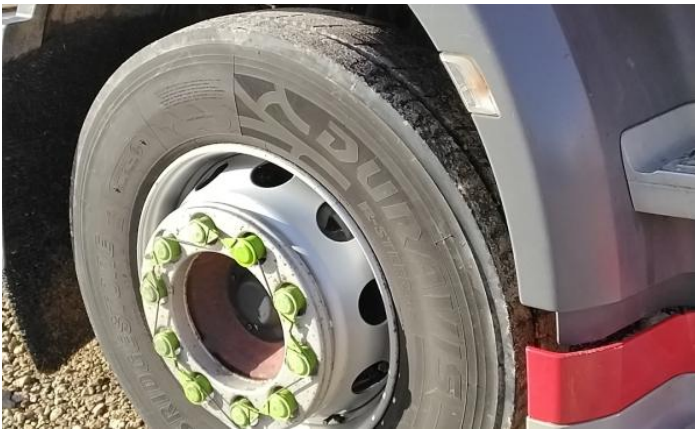
11: Wing Front Arch Extension os  
Scratched (Painted)  
Over 25mm Not Thru Paint

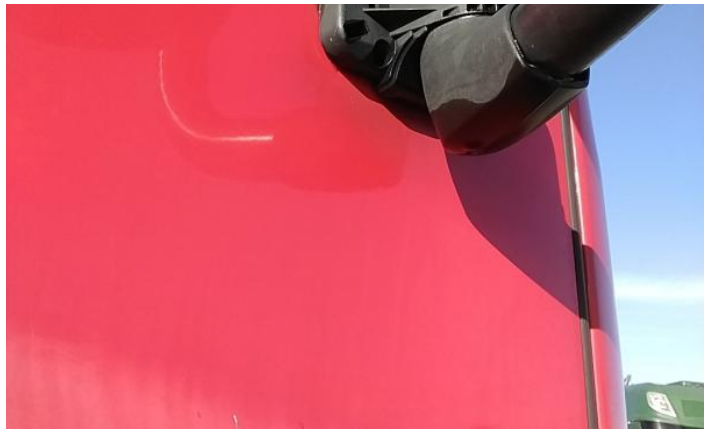
12: Door Mirror Assy osf  
Broken  
Replace

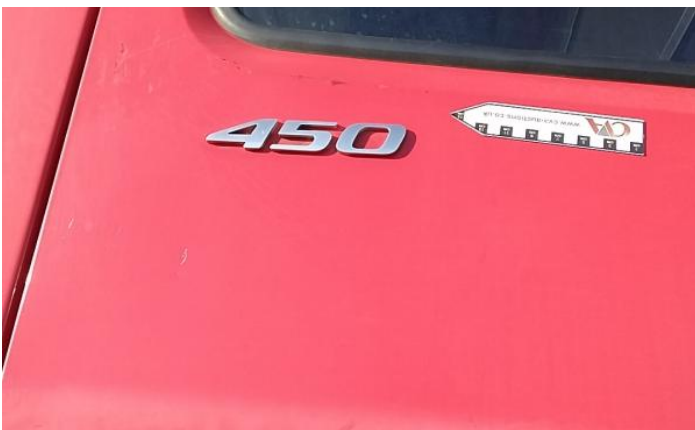
13: Door osf  
Scratched  
Over 25mm Not Thru Paint

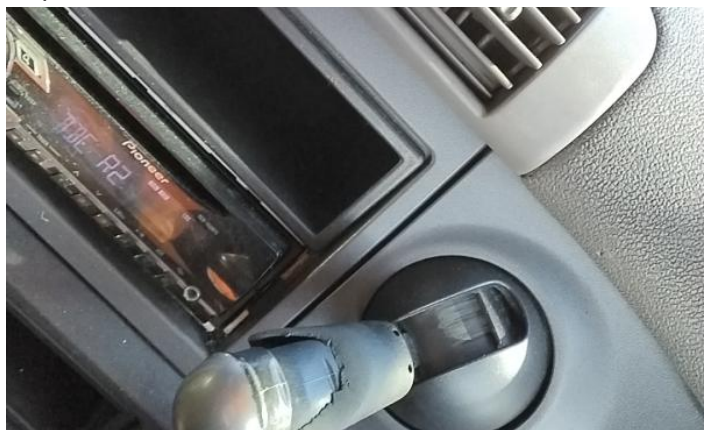
14: Switches And Controls  
Broken  
Replace
