# VEHICLE INSPECTION REPORT

**BK14AOP**

## Iveco Eurocargo 75E16

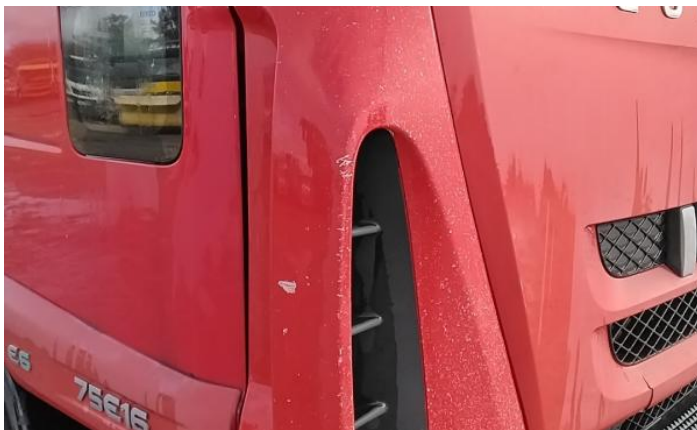
1: Wing osf  
Chipped  
Multiple Chips

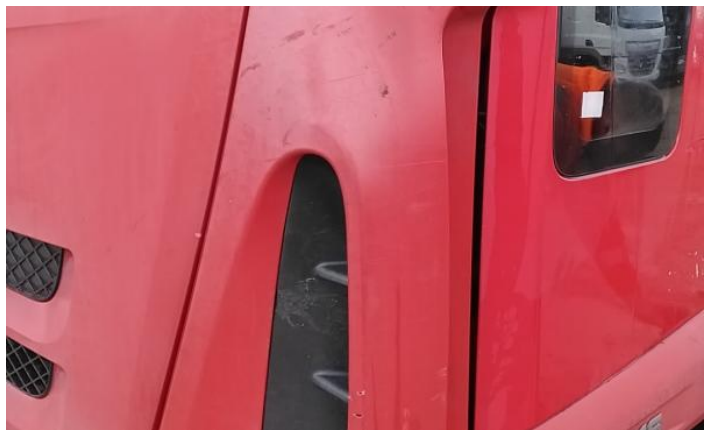
2: Wing nsf  
Scratched  
Over 25mm Not Thru Paint

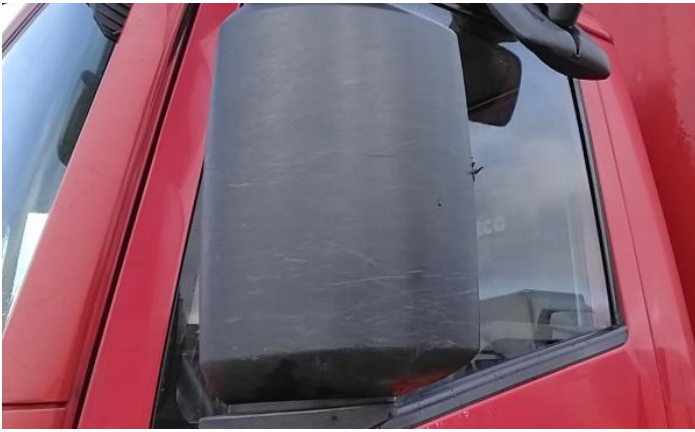
3: Door Mirror Assy nsf  
Scuffed (Unpainted)  
Over 100mm

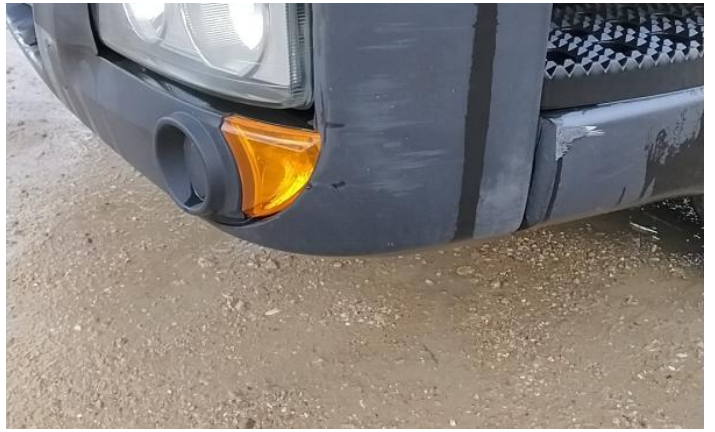
4: Bumper Front Moulding  
Scuffed (Unpainted)  
Over 100mm

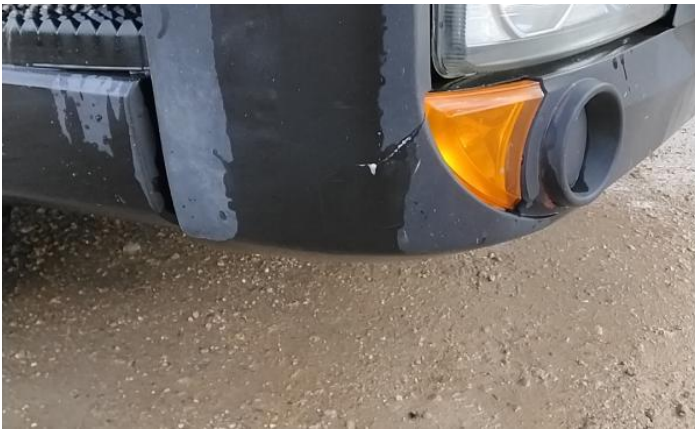
5: Bumper Front  
Cracked  
Over 25mm

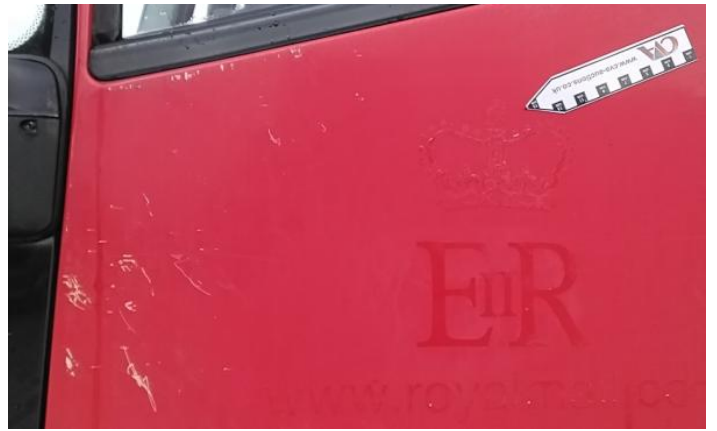
6: Door nsf  
Scratched  
Over 25mm Thru Paint

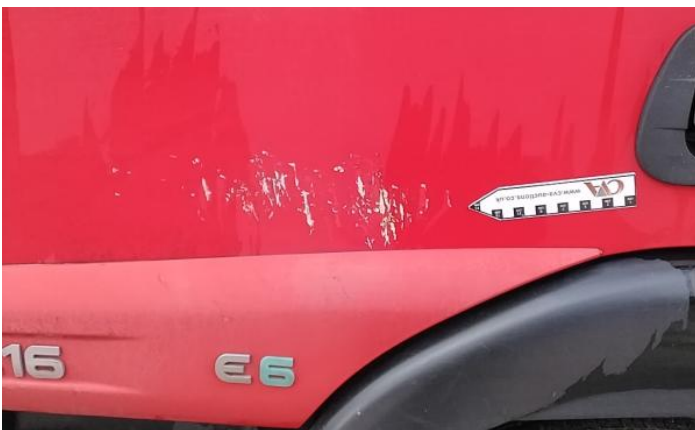
7: Door nsf  
Scratched  
Over 25mm Thru Paint

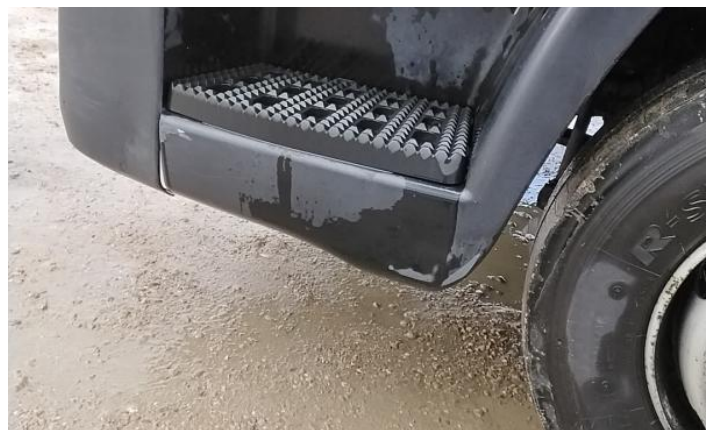
8: Wing Front Arch Extension ns  
Scuffed (Unpainted)  
Over 100mm

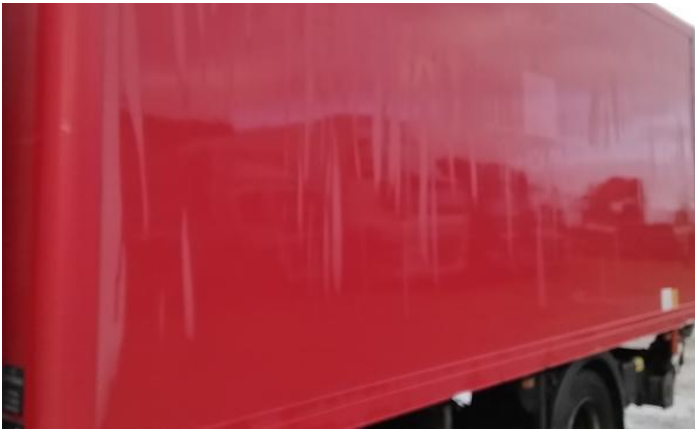
9: Qtr Panel nsr  
Scratched  
Over 25mm Not Thru Paint

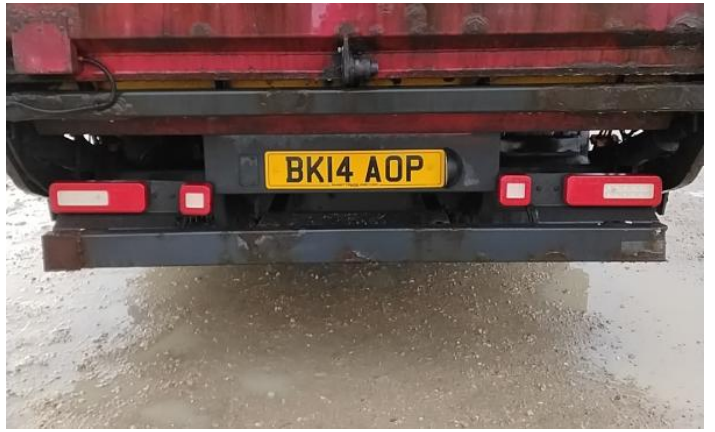
10: Bumper Rear  
Rusted  
Over 5mm

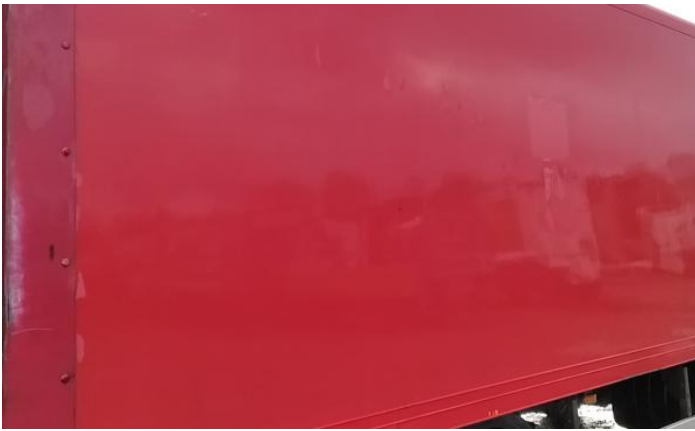
11: Qtr Panel osr  
Scratched  
Over 25mm Not Thru Paint

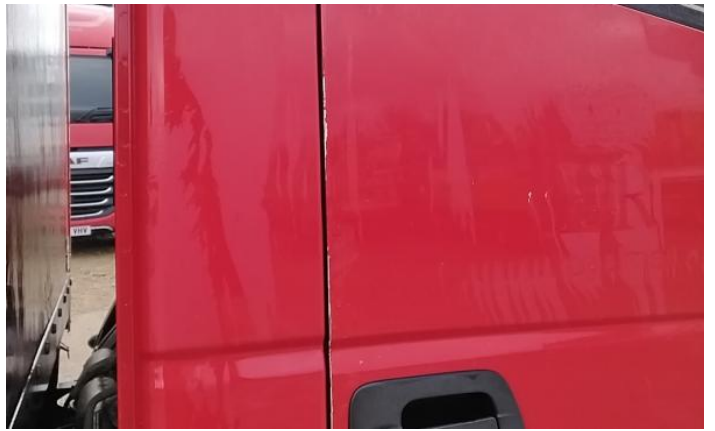
12: Door osf  
Chipped  
Edge Chip

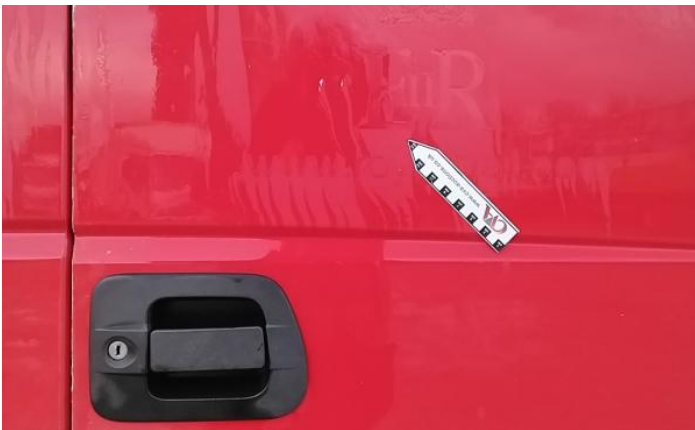
13: Door osf  
Scratched  
UpTo 25mm Thru Paint

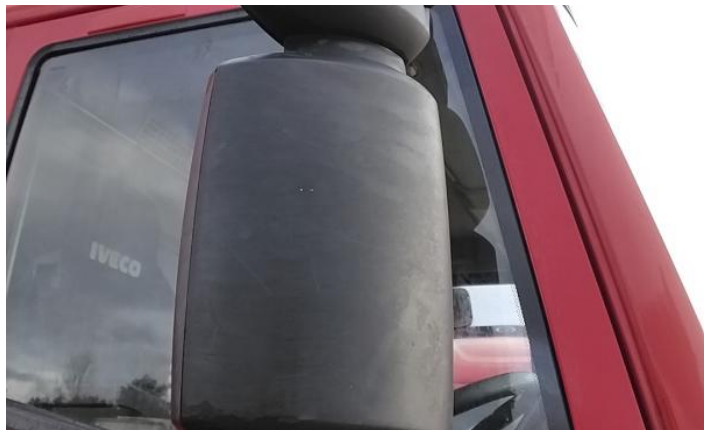
14: Door Mirror Assy osf  
Scuffed (Unpainted)  
Over 100mm

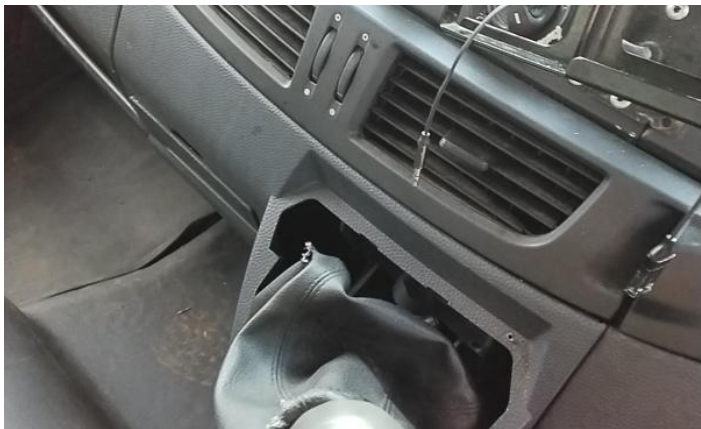
15: Switches And Controls  
Broken  
Replace

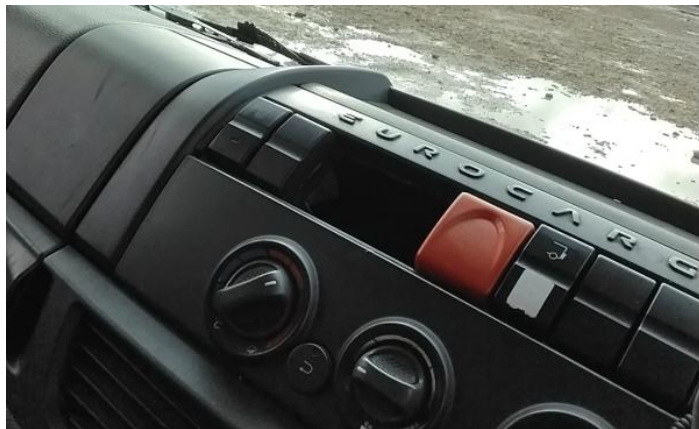
16: Switches And Controls  
Missing  
Replace

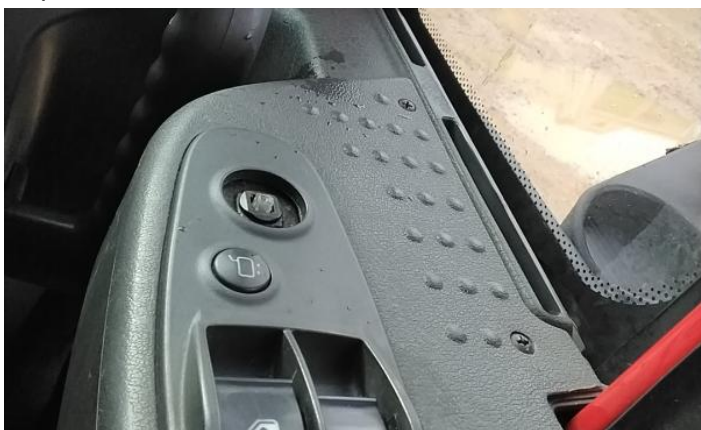
17: Fascia Trim  
Damaged  
Replace
