## VEHICLE INSPECTION REPORT

**SH71GHZ**

### Fiat Doblo Work Up 1.6 MULTIJET 16V II

**Non Runner**

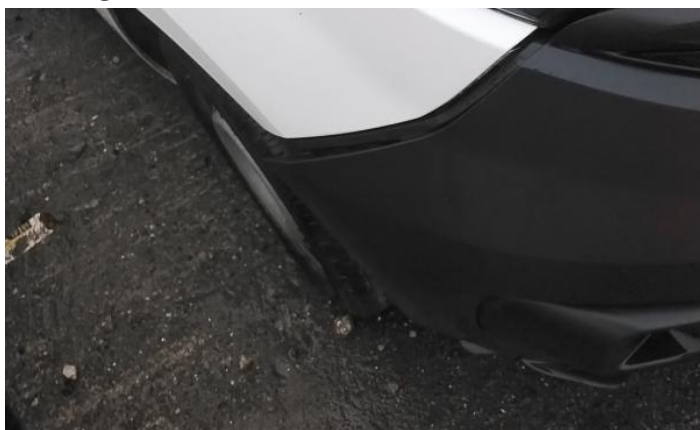
1: Bumper Front  
Cracked  
Over 25mm

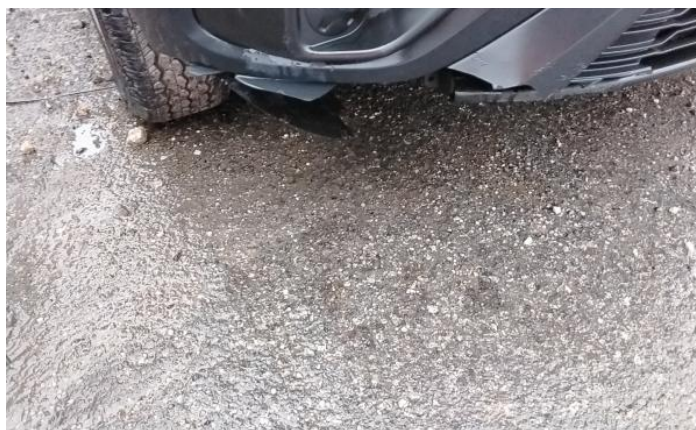
2: Bumper Front Moulding  
Broken  
Replace

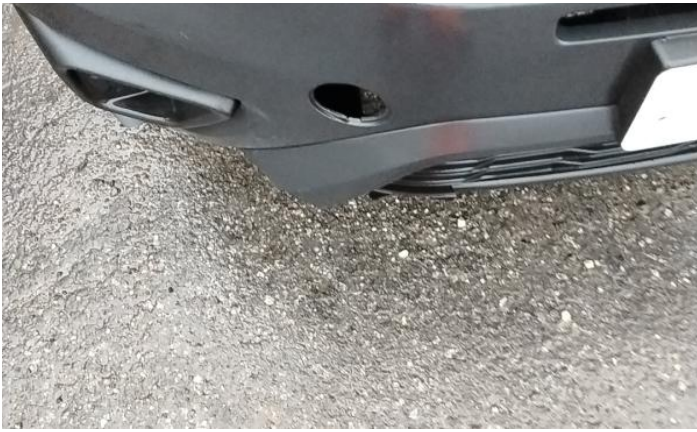
3: Bumper Front Moulding  
Missing  
Replace

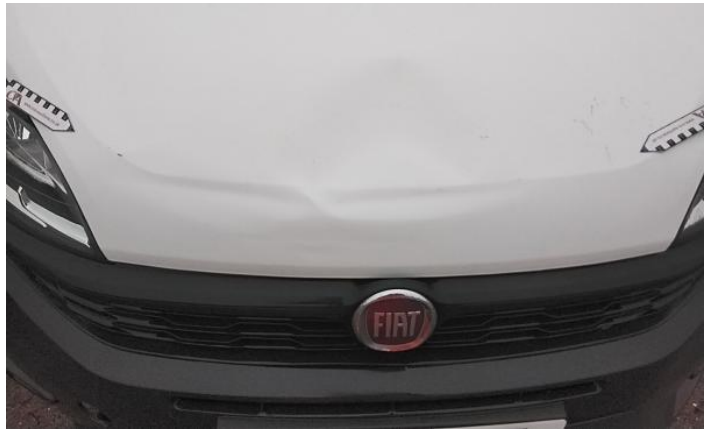
4: Bonnet  
Dented  
With Paint Damage

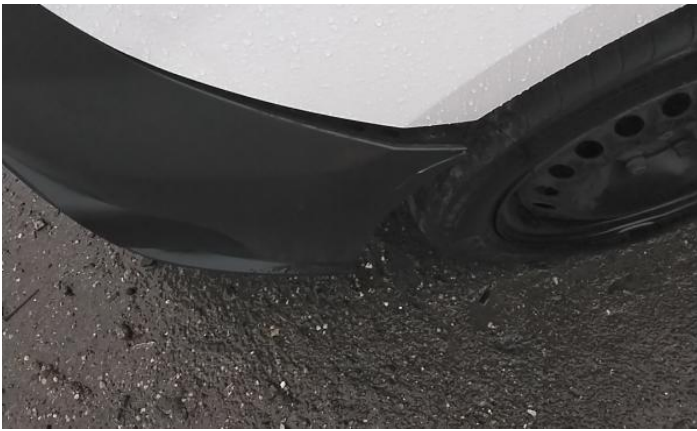
5: Bumper Front  
Insecure  
Action Required

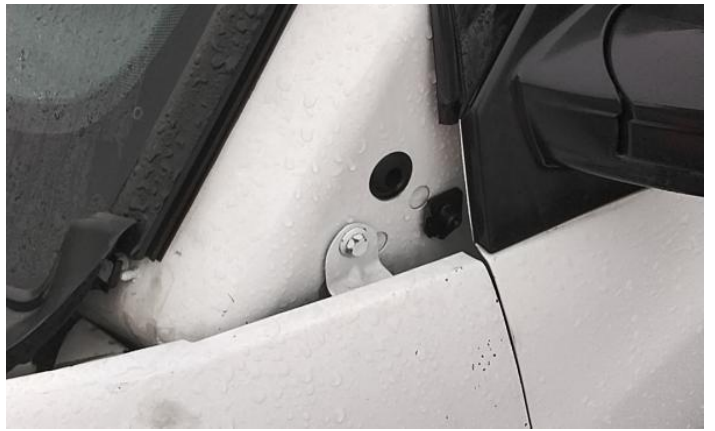
6: Door Moulding nsf  
Missing  
Replace

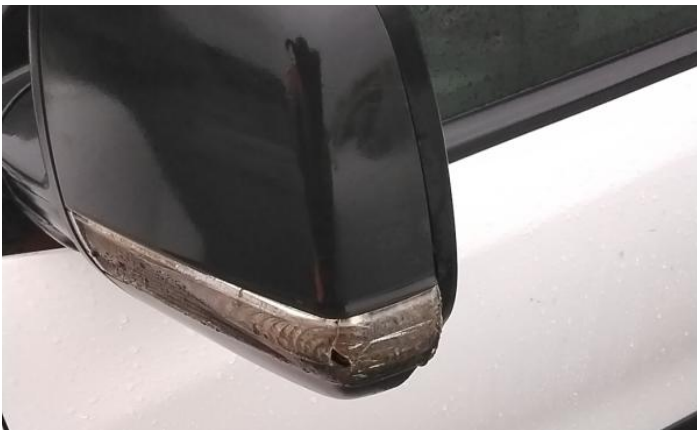
7: Door Mirror Assy nsf  
Broken  
Replace

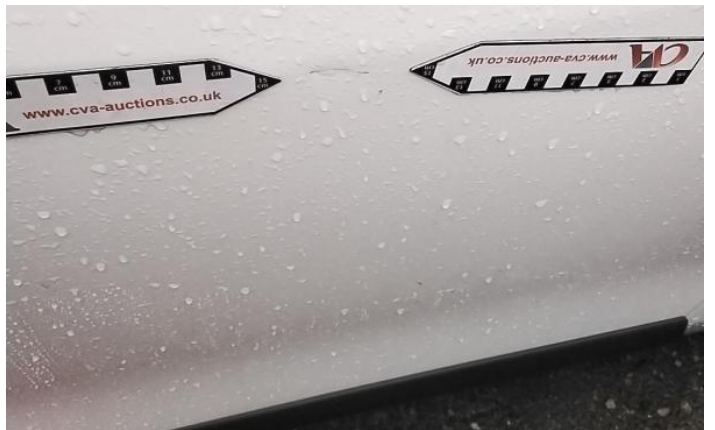
8: Door nsf  
Dented  
With Paint Damage

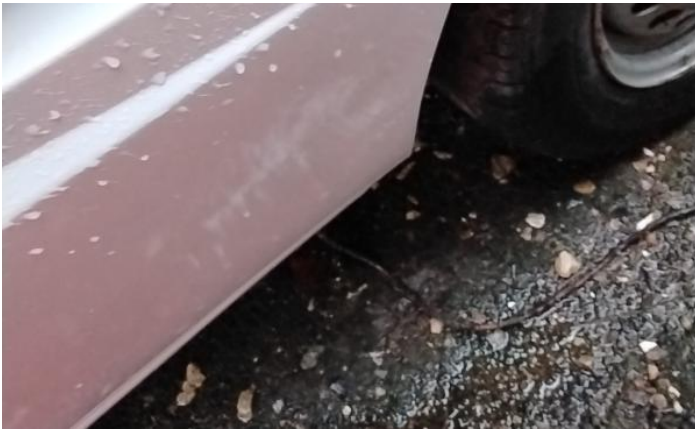
9: Qtr Panel nsr  
Dented  
Over 30mm

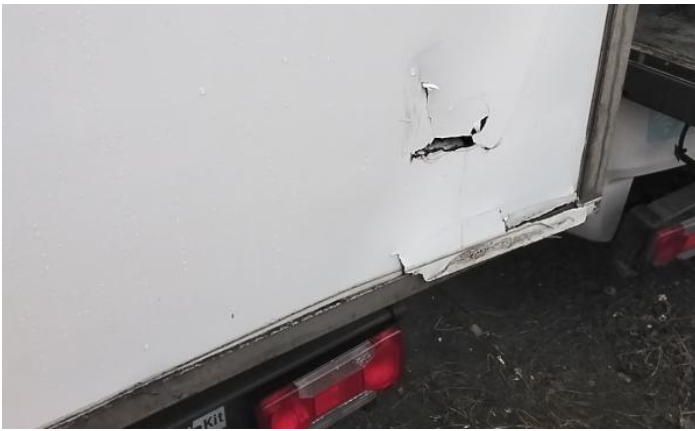
11: Panel Rear  
Cracked  
Replace

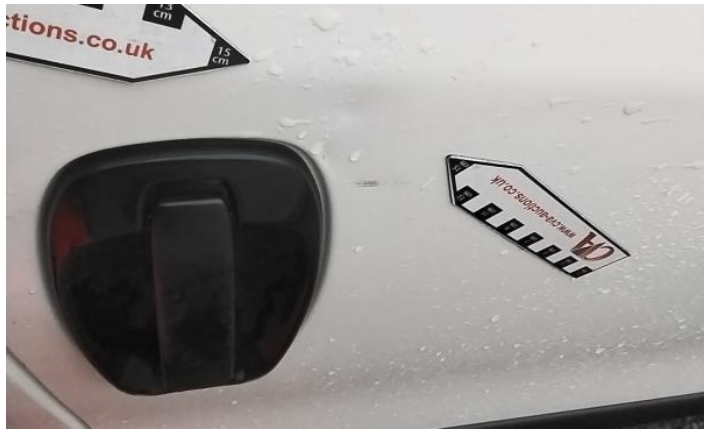
12: Door osf  
Dented  
Over 30mm

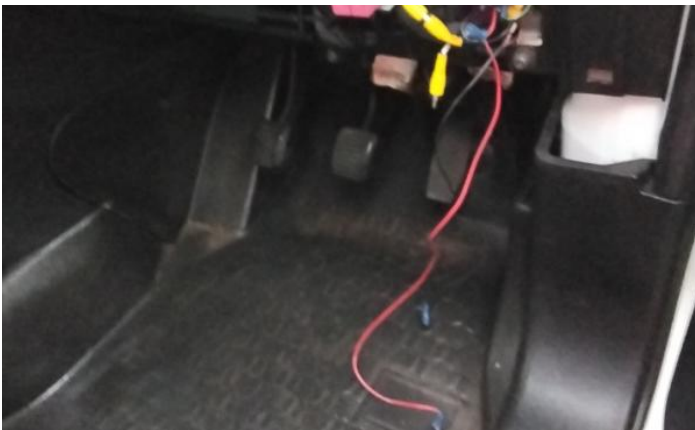
13: Fascia Panel  
Missing  
Replace

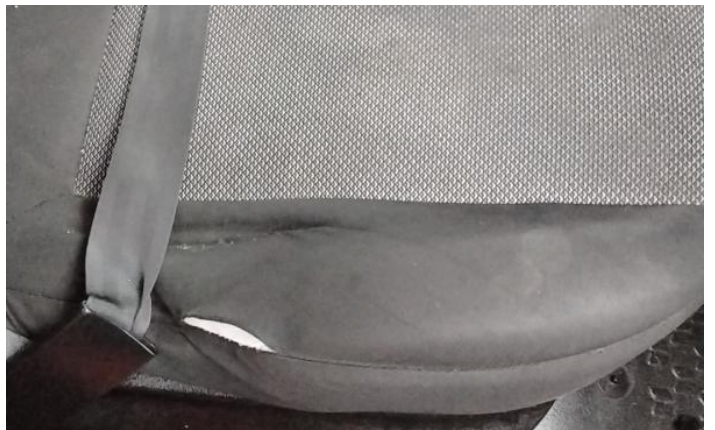
14: Seat Base Cover osf  
Holed  
Over 3mm

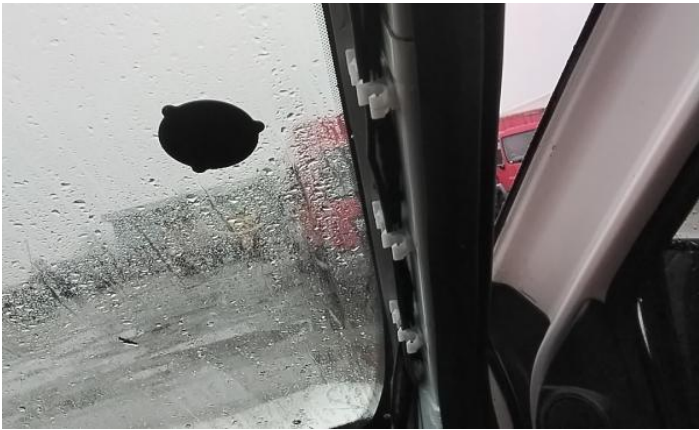
15: Fascia Panel  
Missing  
Replace

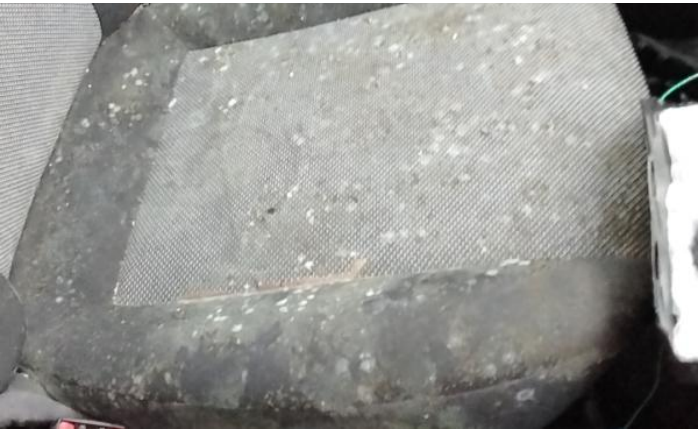
16: Seat Base Cover nsf  
Soiled  
Heavy

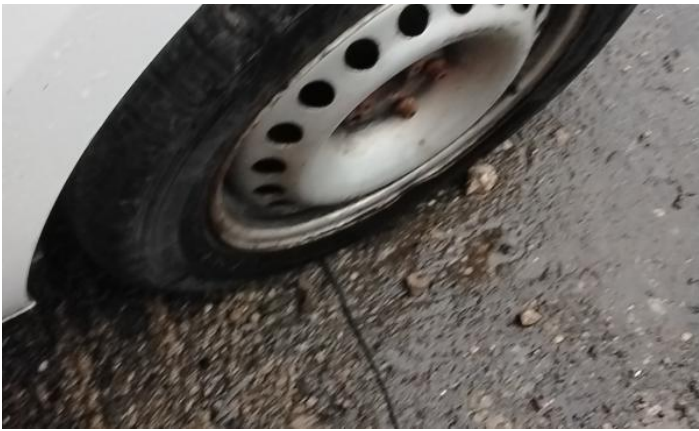
17: Wheel osf  
Dented  
Over 30mm (Steel)

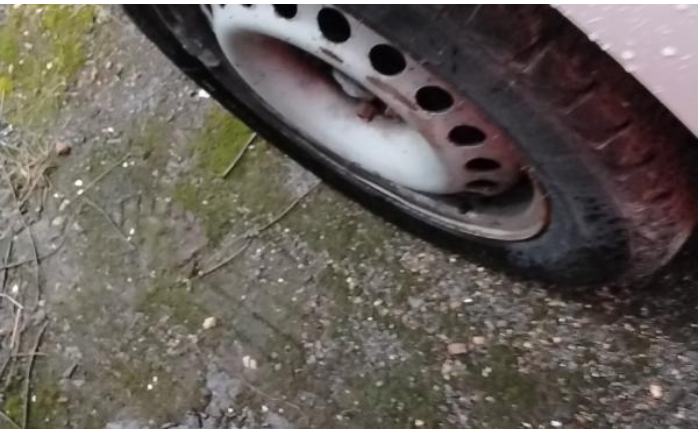
18: Wheel osr  
Dented  
Over 30mm (Steel)
