# VEHICLE INSPECTION REPORT

**SA71KKE**

## Fiat Doblo Work Up 1.6 MULTIJET 16V II

**Non Runner**

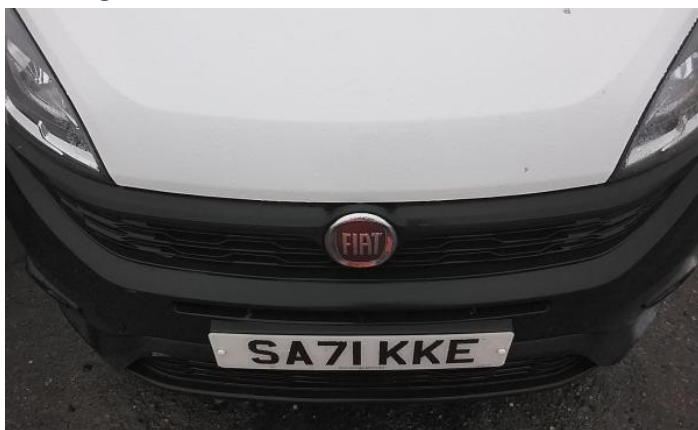
1: Bonnet  
Chipped  
Multiple Chips

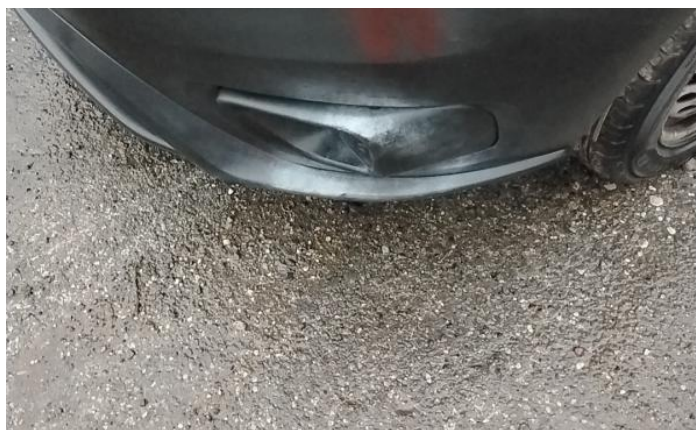
2: Bumper Front  
Poor Previous Repair  
Poor Colour

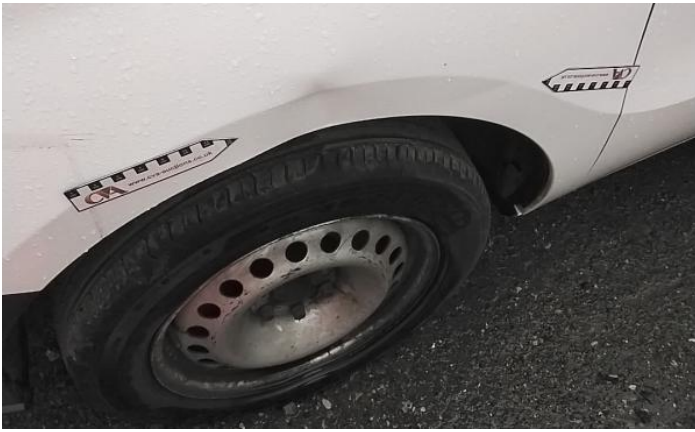
3: Wing nsf  
Dented  
Over 30mm

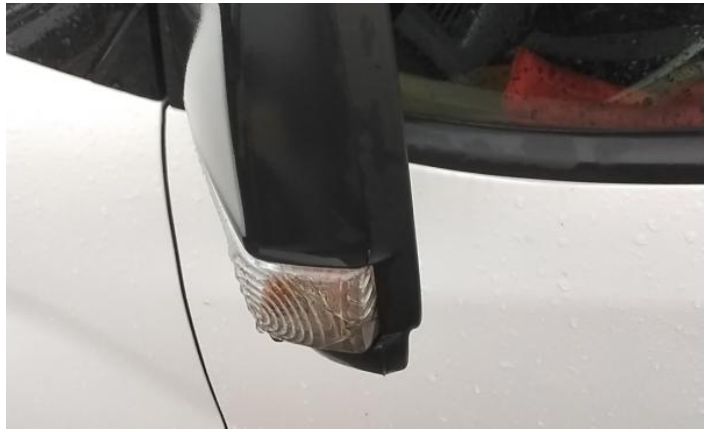
4: Door Mirror Assy nsf  
Broken  
Replace

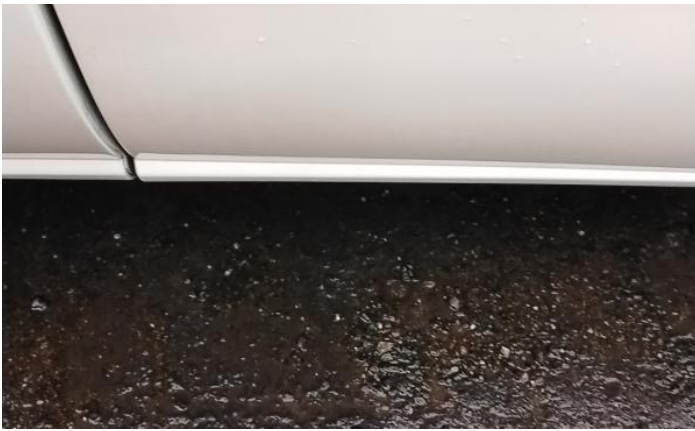
5: Qtr Panel nsr  
Dented  
Over 30mm

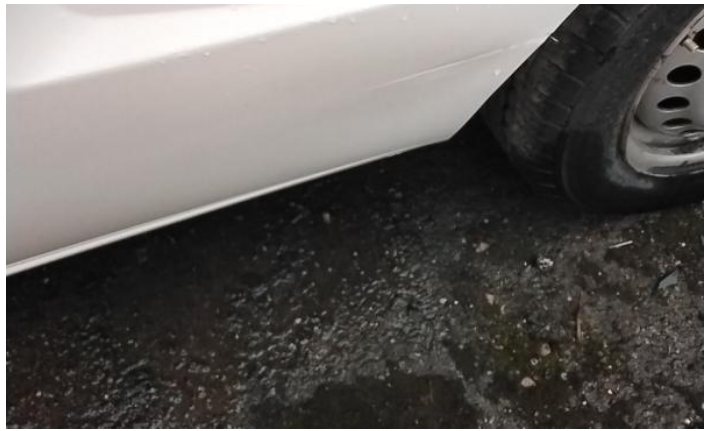
6: Qtr Panel nsr  
Dented  
Over 30mm

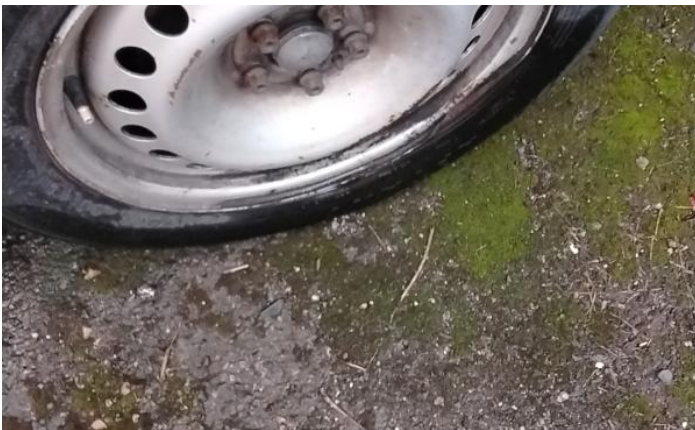
7: Wheel nsr  
Damaged  
Replace

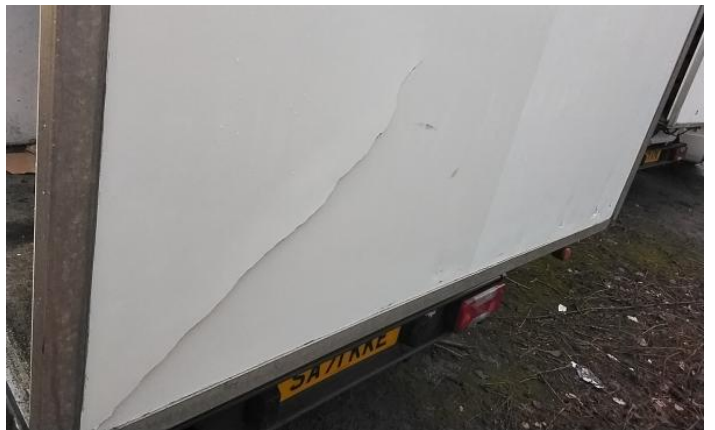
8: Panel Rear  
Cracked  
Replace

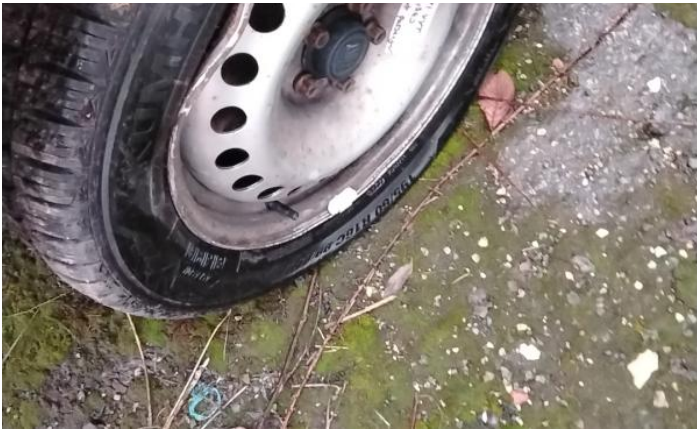
9: Wheel osr  
Damaged  
Replace

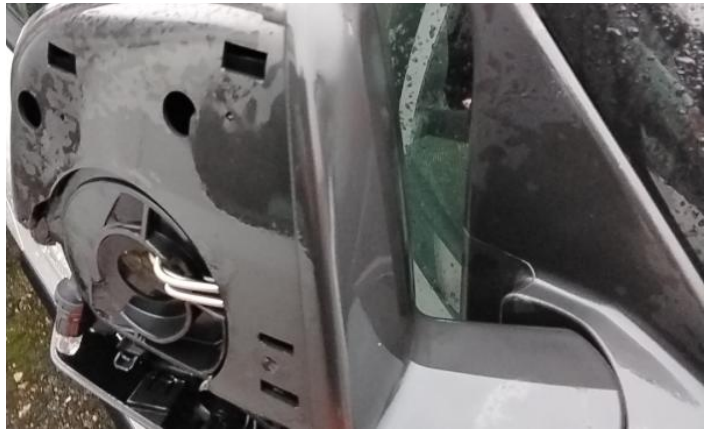
10: Door Mirror Assy osf  
Broken  
Replace

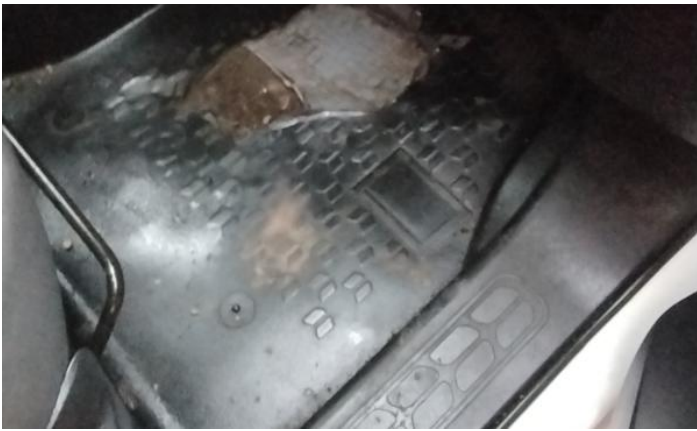
11: Carpets Front  
Holed  
Over 3mm

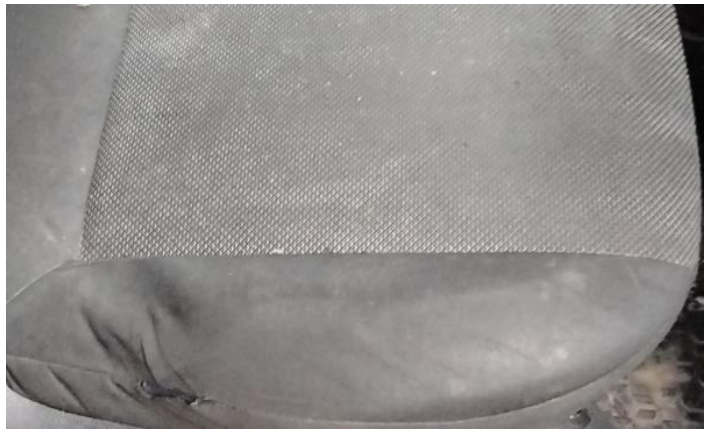
12: Seat Base Cover osf  
Soiled  
Heavy

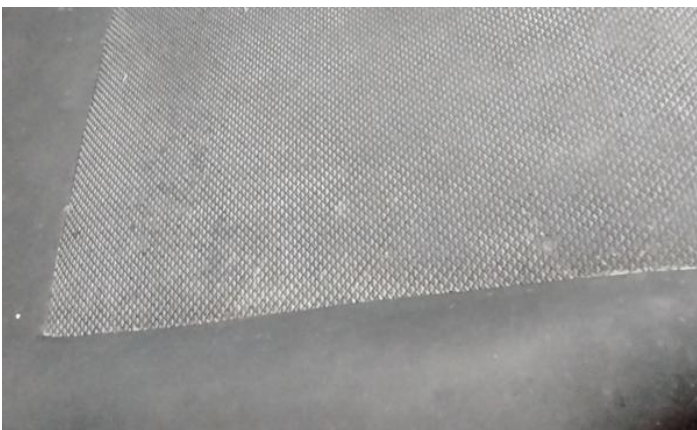
13: Seat Base Cover nsf  
Soiled  
Heavy

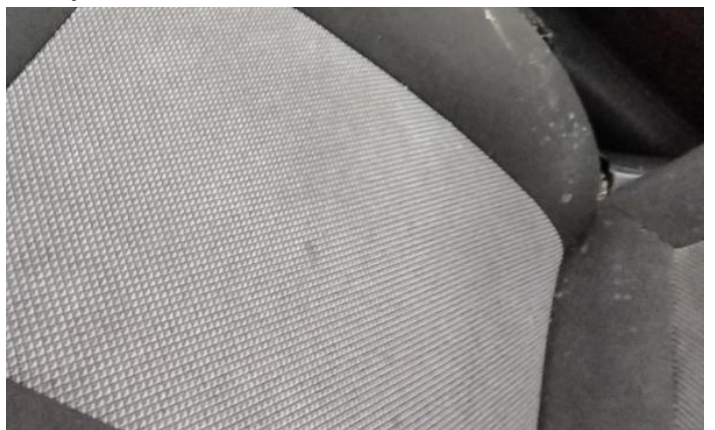
14: Seat Back Cover nsf  
Soiled  
Heavy

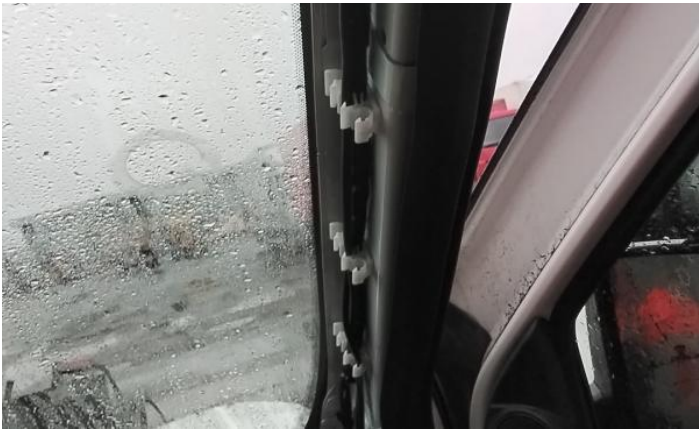
15: Fascia Panel  
Missing  
Replace

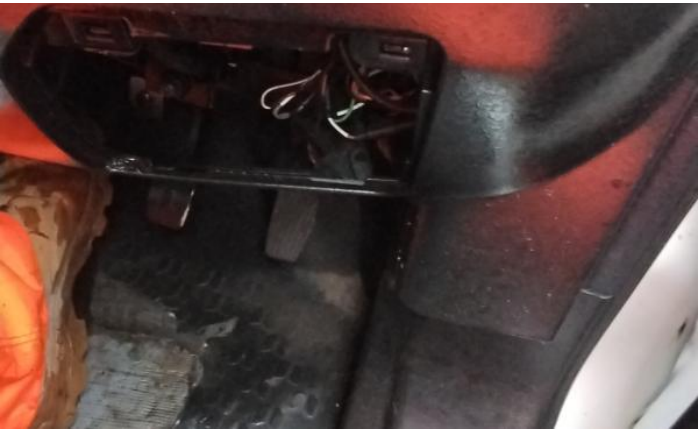
16: Fascia Panel  
Missing  
Replace
