# VEHICLE INSPECTION REPORT

**SJ71HTK**

## Fiat Doblo Work Up 1.6 MULTIJET 16V II

\*NON-RUNNER, SUSPECTED ENGINE FAILURE\* AD-BLUE

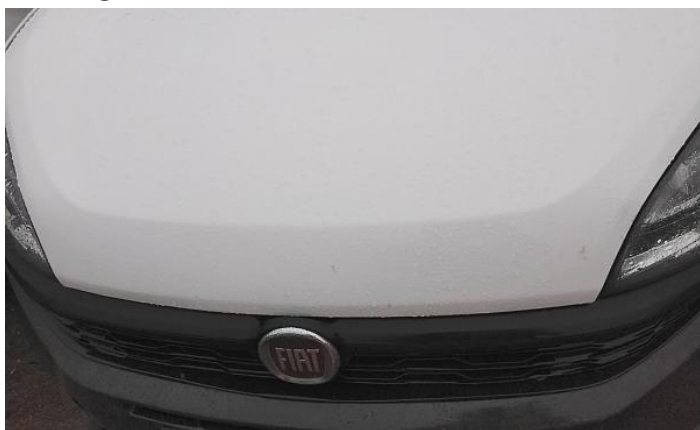
1: Bonnet  
Chipped  
Multiple Chips

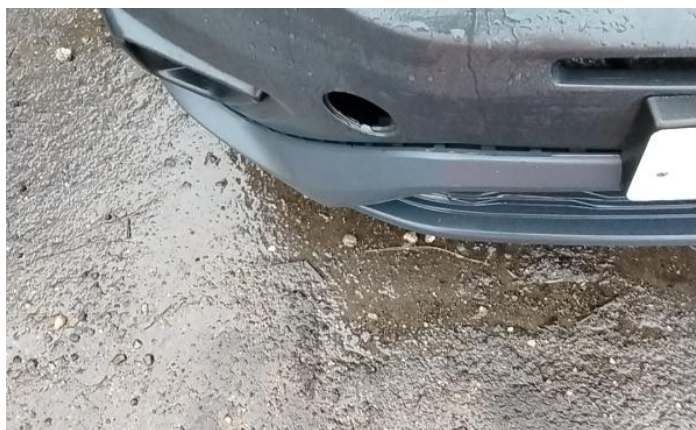
2: Bumper Front Moulding  
Missing  
Replace

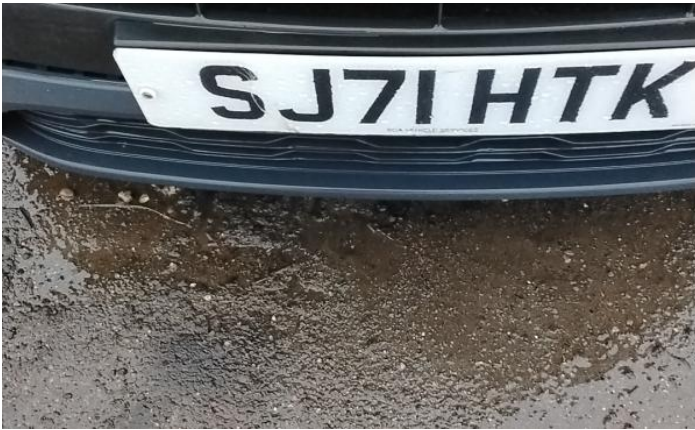
3: Number Plate Front  
Broken  
Replace

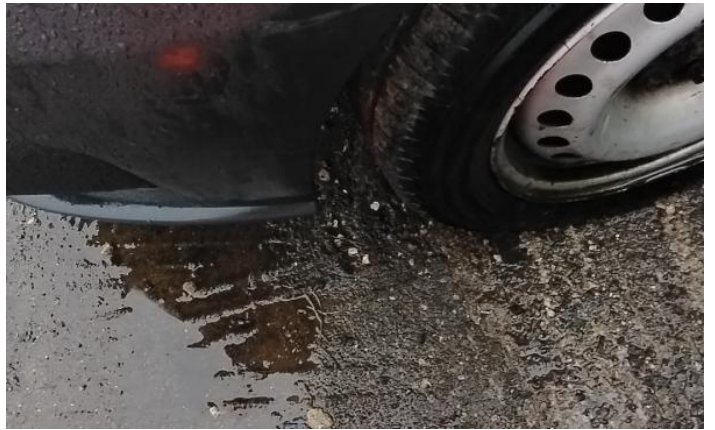
4: Bumper Front  
Scratched  
25 to 100mm Thru Paint

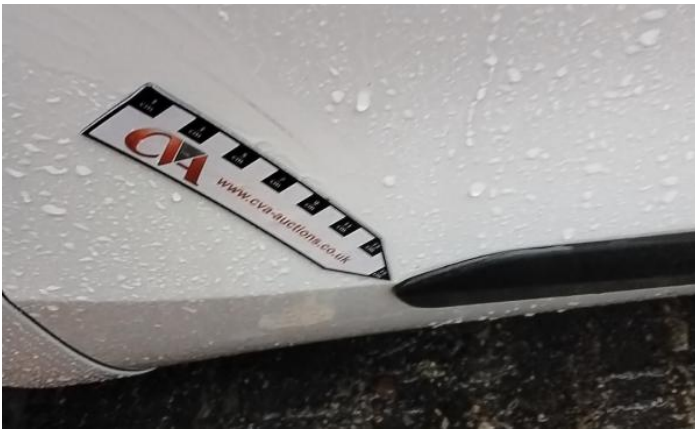
5: Door nsf  
Scratched  
Over 25mm Thru Paint

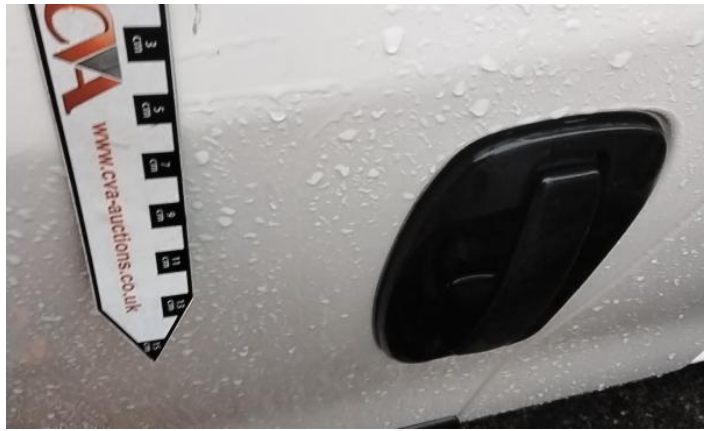
6: Door nsf  
Scratched  
Over 25mm Thru Paint

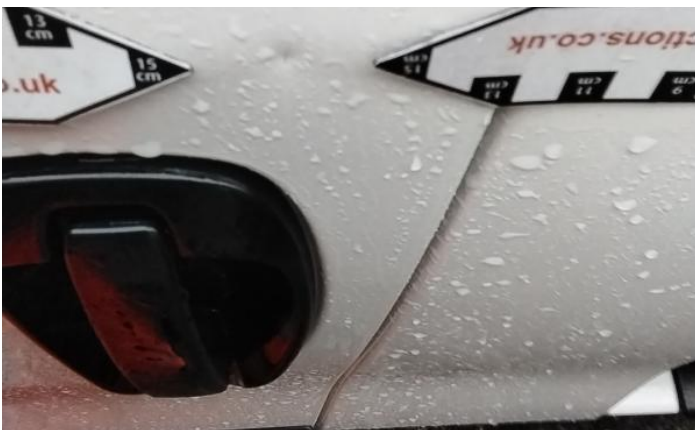
7: Door nsf  
Dented  
Over 30mm

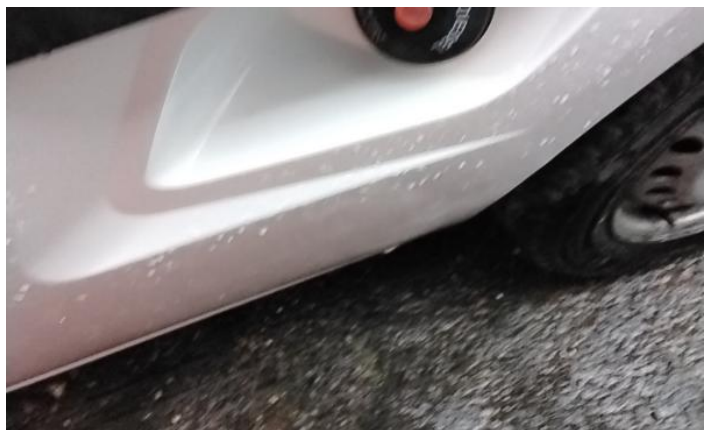
8: Qtr Panel nsr  
Dented  
Over 30mm

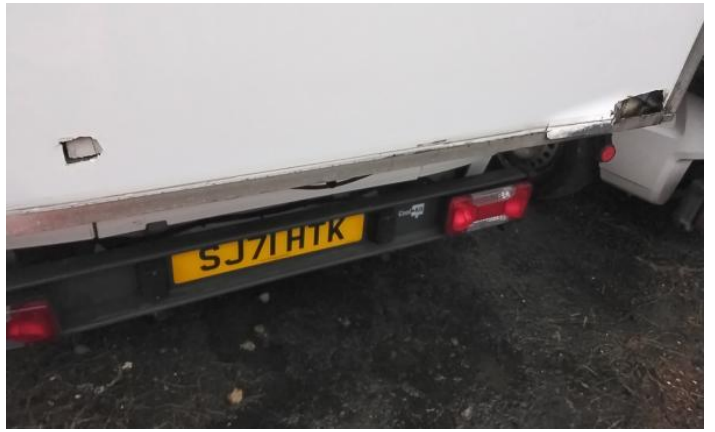
10: Panel Rear  
Cracked  
Replace

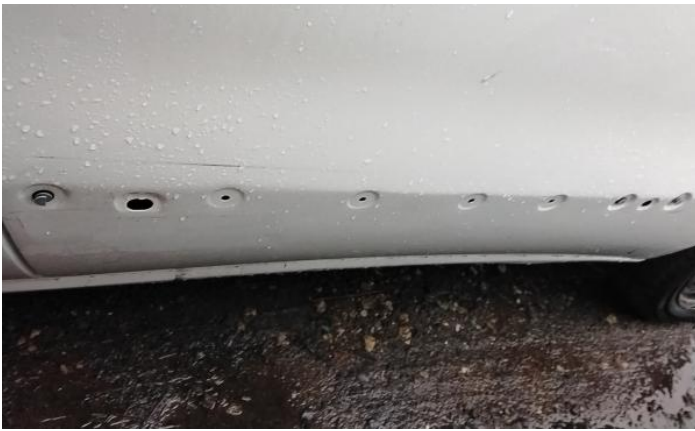
11: Door Moulding osf  
Missing  
Replace

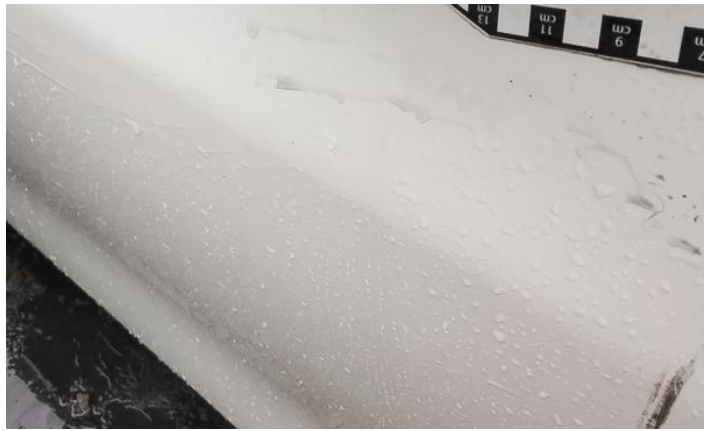
12: Door osf  
Dented  
With Paint Damage

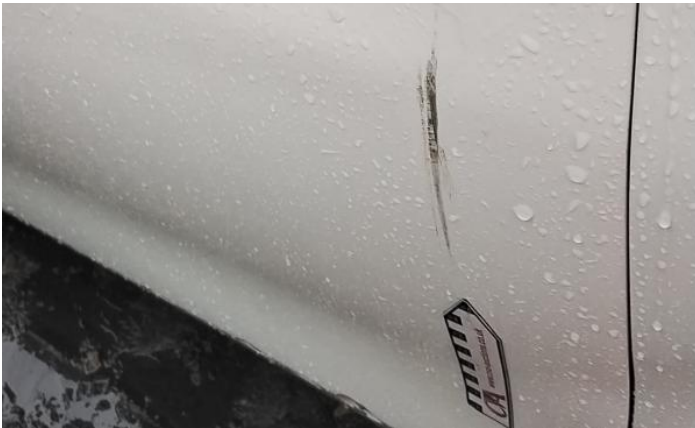
13: Door osf  
Dented  
With Paint Damage

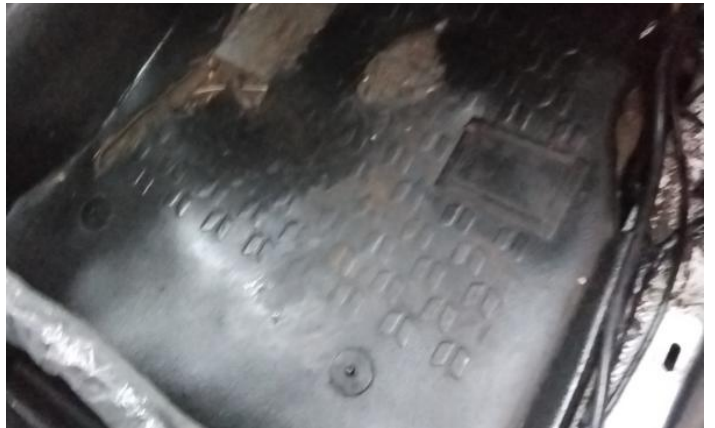
14: Carpets Front  
Holed  
Over 3mm

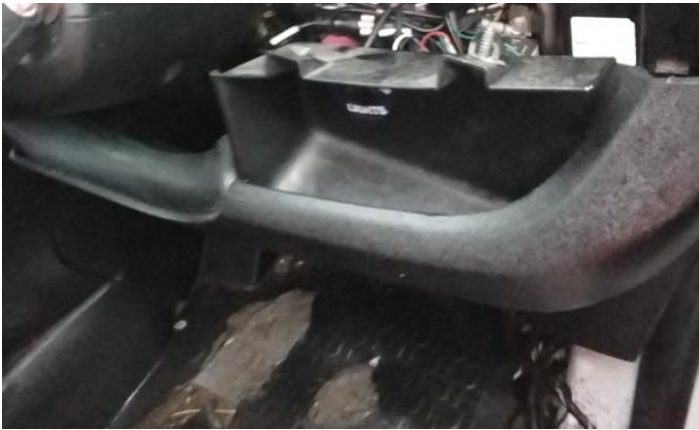
15: Fascia Panel  
Broken  
Replace

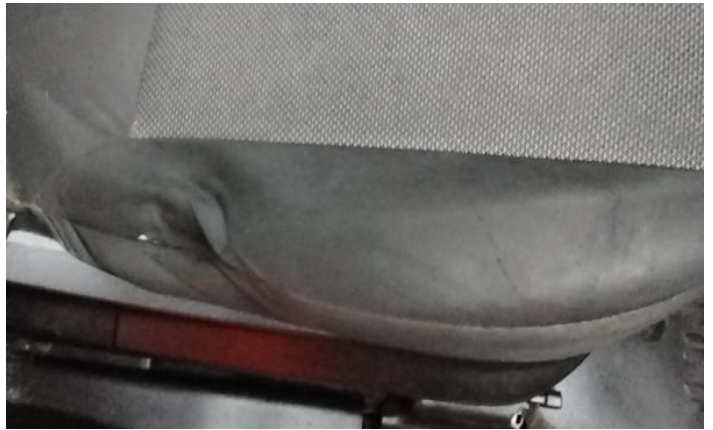
16: Seat Base Cover osf  
Holed  
Over 3mm

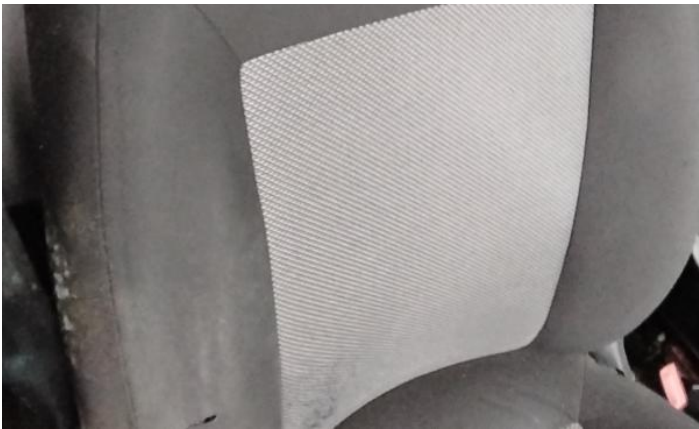
17: Seat Back Cover osf  
Holed  
Over 3mm

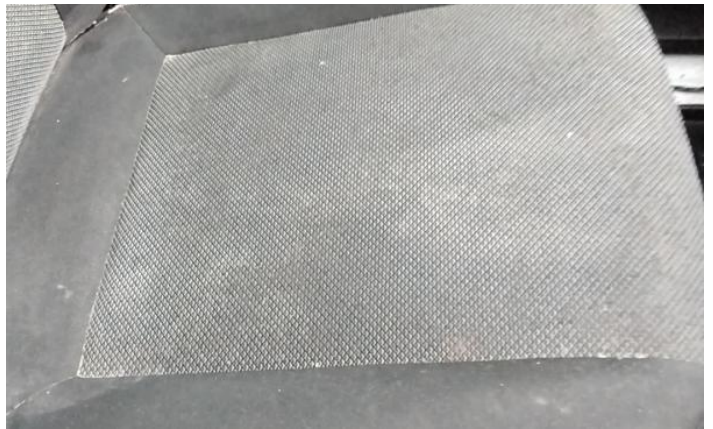
18: Seat Base Cover nsf  
Soiled  
Heavy
