# VEHICLE INSPECTION REPORT

**SA71KKH**

## Fiat Doblo Work Up 1.6 MULTIJET 16V II

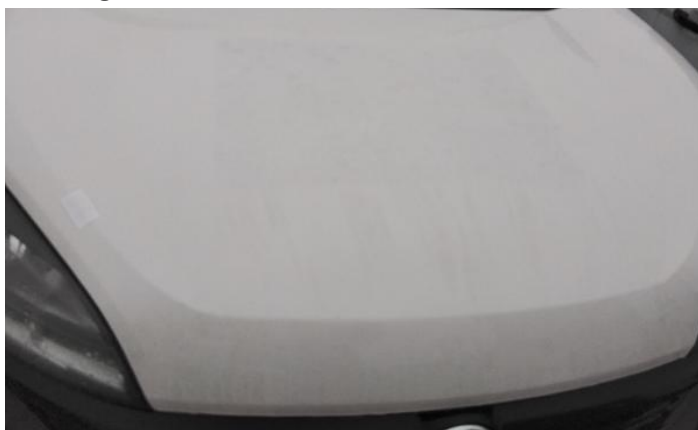
1: Bonnet  
Chipped  
Multiple Chips

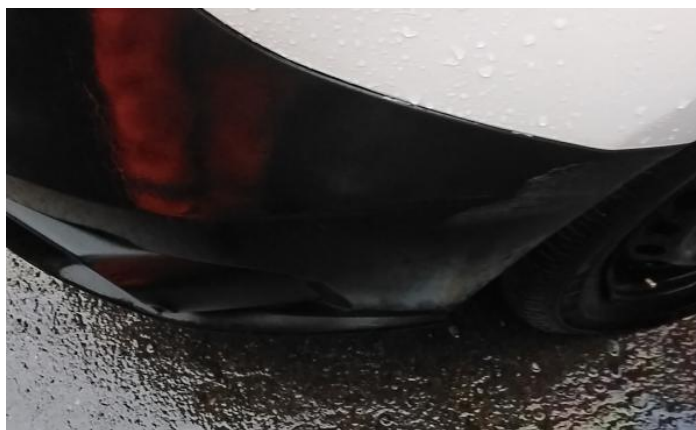
2: Bumper Front  
Scratched  
Over 100mm Thru Paint

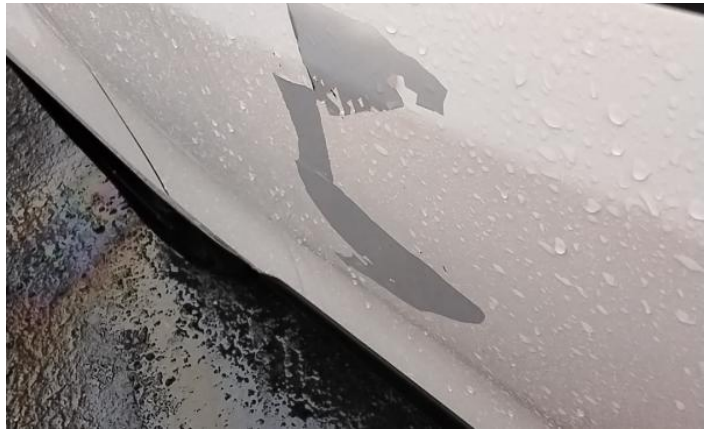
4: Door nsf  
Scratched  
Over 25mm Thru Paint

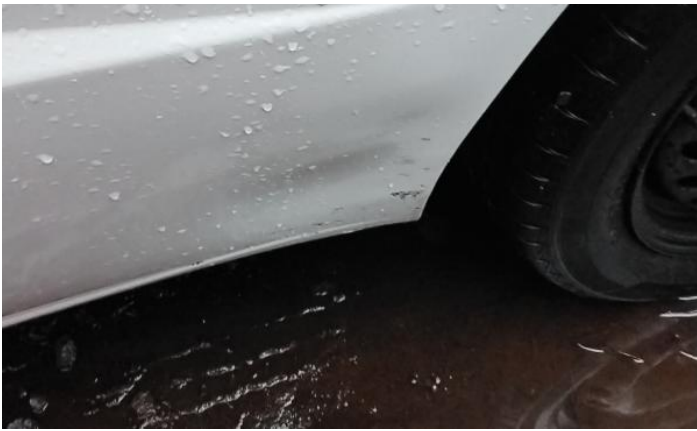
5: Qtr Panel nsr  
Dented  
With Paint Damage

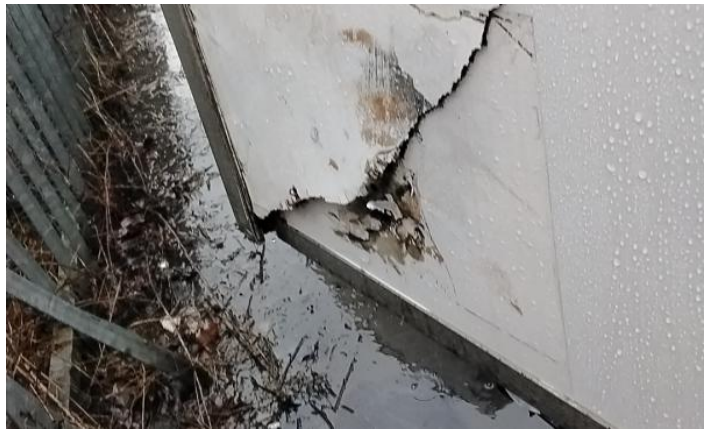
6: Panel Rear  
Cracked  
Replace

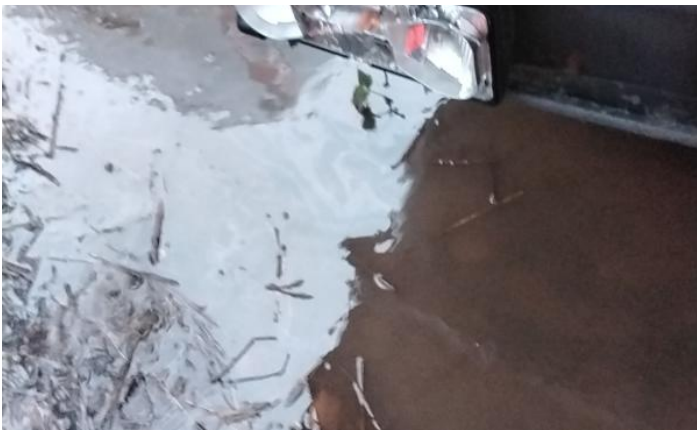
7: Lamp nsr  
Broken  
Replace

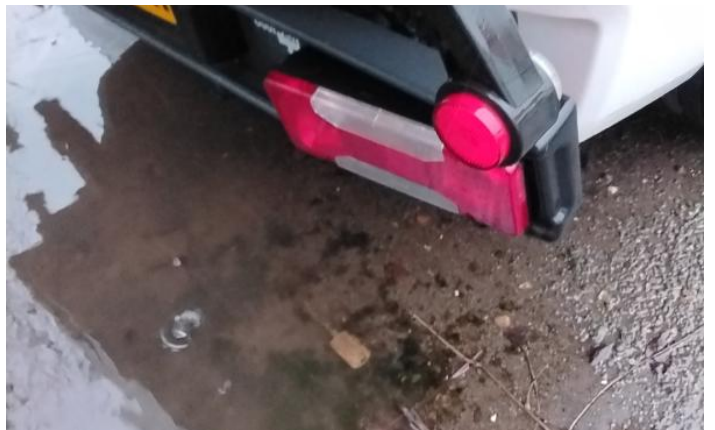
8: Bumper Rear  
Dented  
Over 30mm

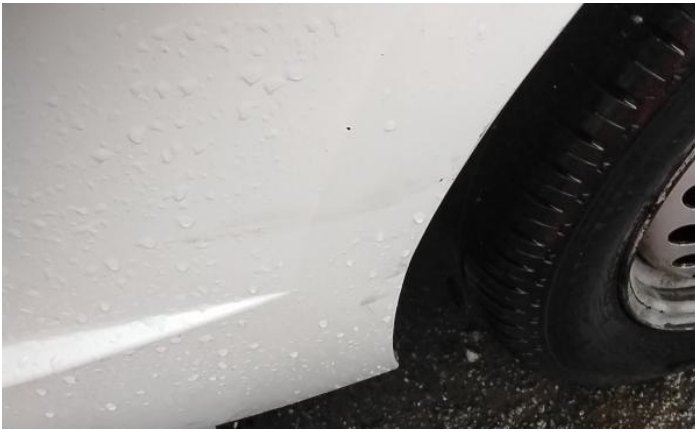
9: Qtr Panel osr  
Dented  
With Paint Damage

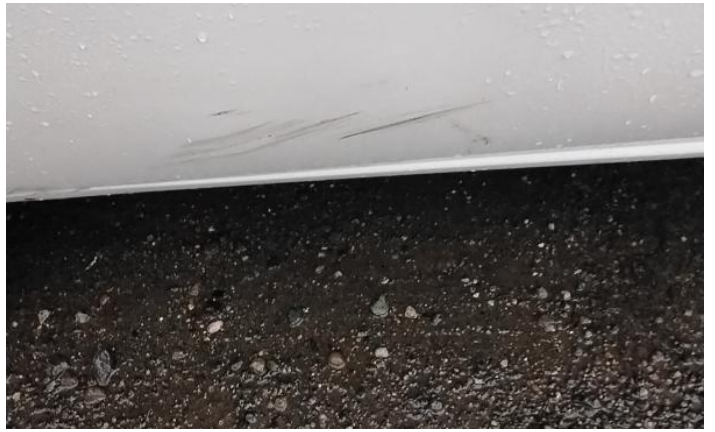
10: Qtr Panel osr  
Scratched  
Over 25mm Thru Paint

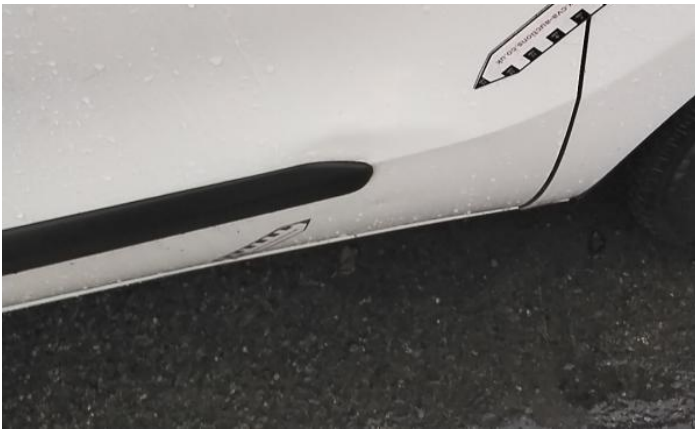
11: Door osf  
Dented  
With Paint Damage

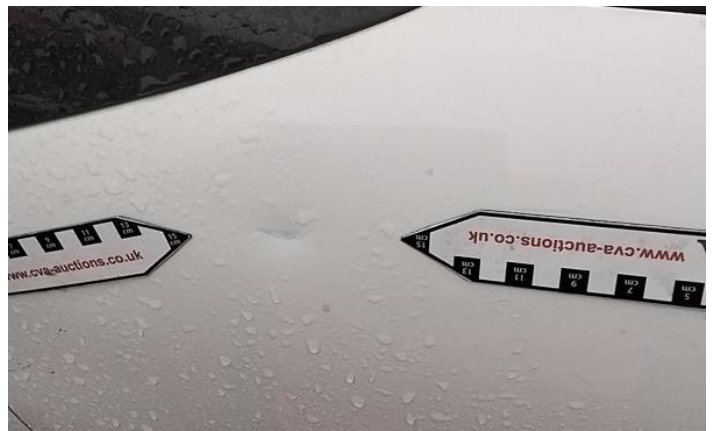
12: Wing osf  
Dented  
With Paint Damage

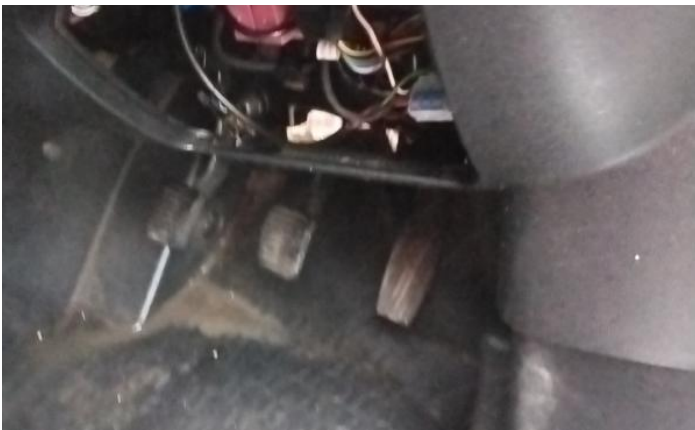
13: Fascia Panel  
Missing  
Replace

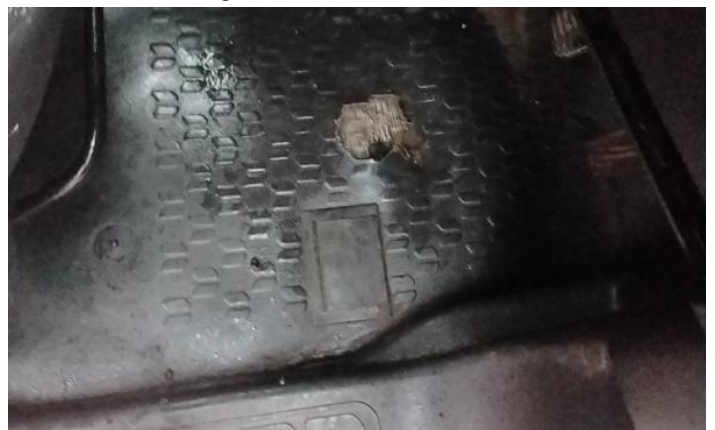
14: Carpets Front  
Holed  
Over 3mm

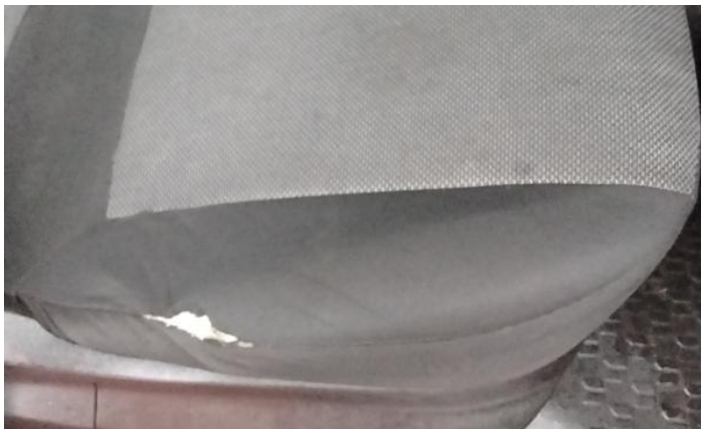
15: Seat Base Cover osf  
Holed  
Over 3mm

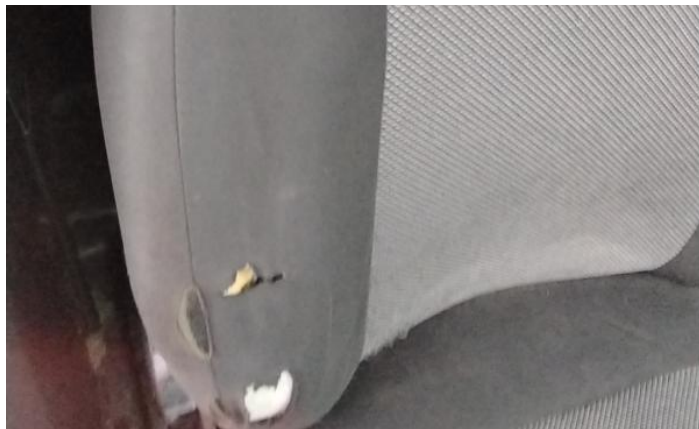
16: Seat Back Cover osf  
Holed  
Over 3mm

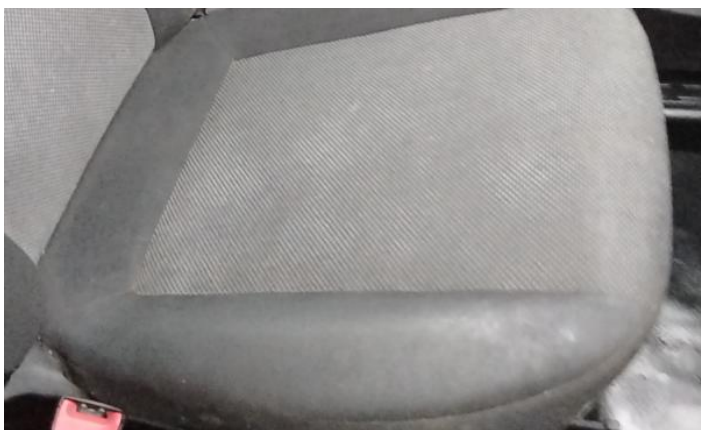
17: Seat Base Cover nsf  
Soiled  
Heavy
