# VEHICLE INSPECTION REPORT

**SA71KJK**

## Fiat Doblo Work Up 1.6 MULTIJET 16V II

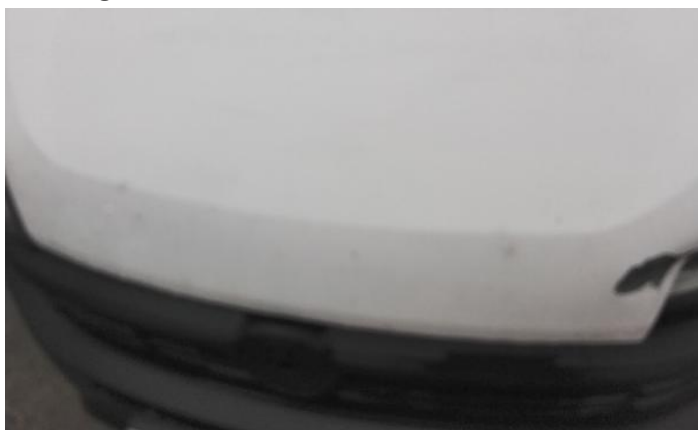
1: Bonnet  
Dented  
With Paint Damage

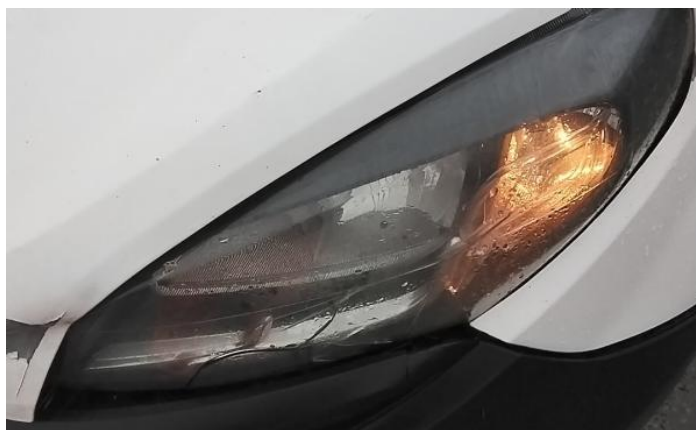
2: Headlamps  
Broken  
Replace

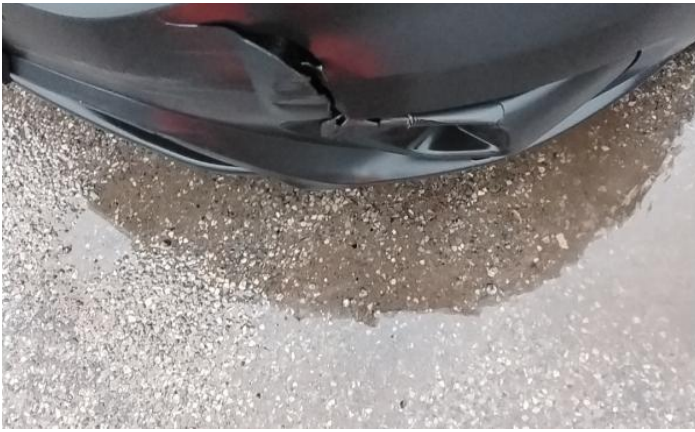
3: Bumper Front  
Cracked  
Over 25mm

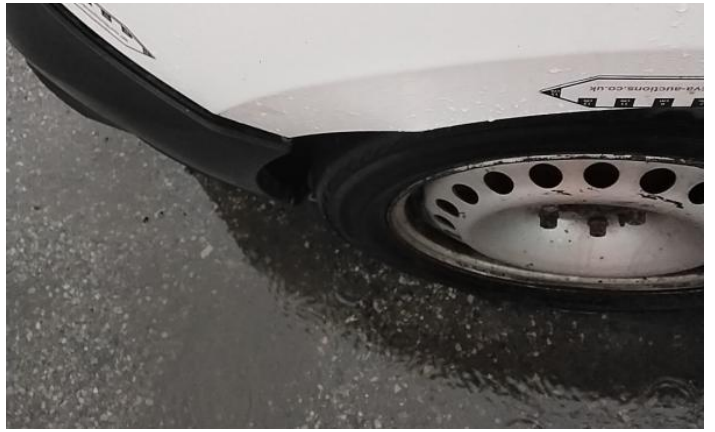
4: Wing nsf  
Dented  
With Paint Damage

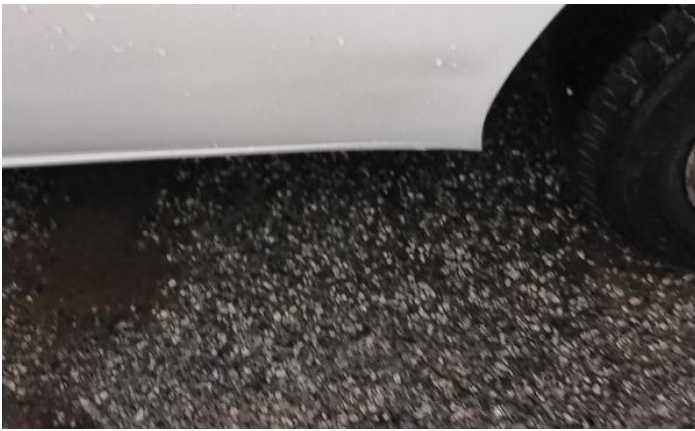
5: Qtr Panel nsr  
Dented  
Over 30mm

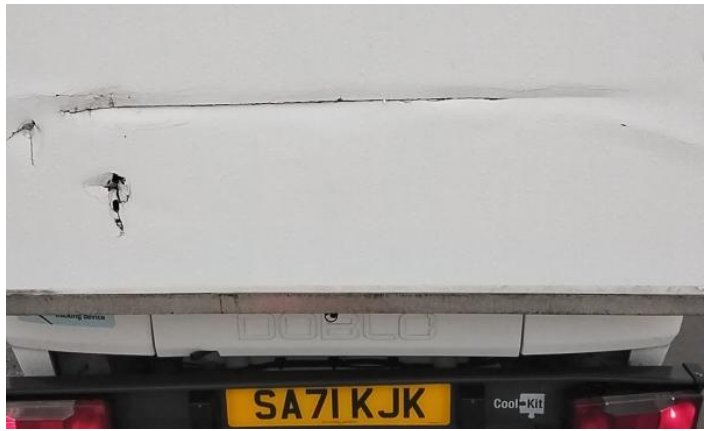
6: Panel Rear  
Cracked  
Replace

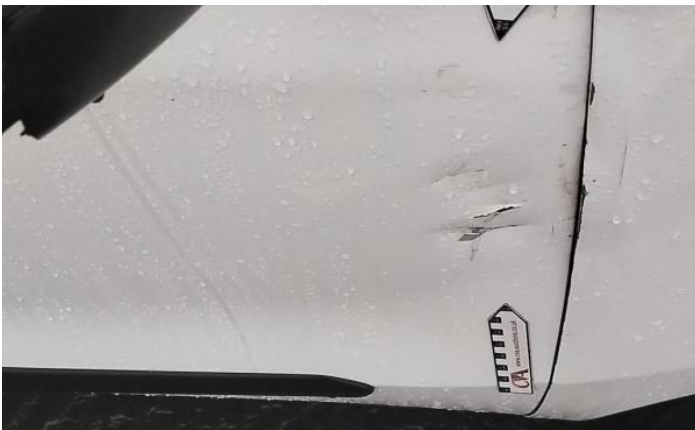
7: Door osf  
Dented  
With Paint Damage

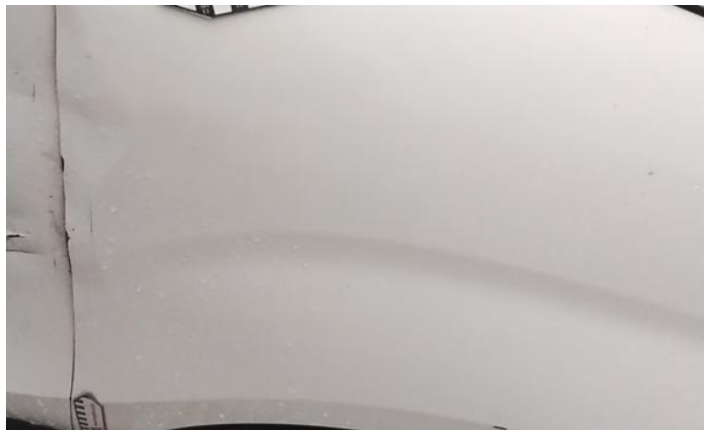
8: Wing osf  
Dented  
With Paint Damage

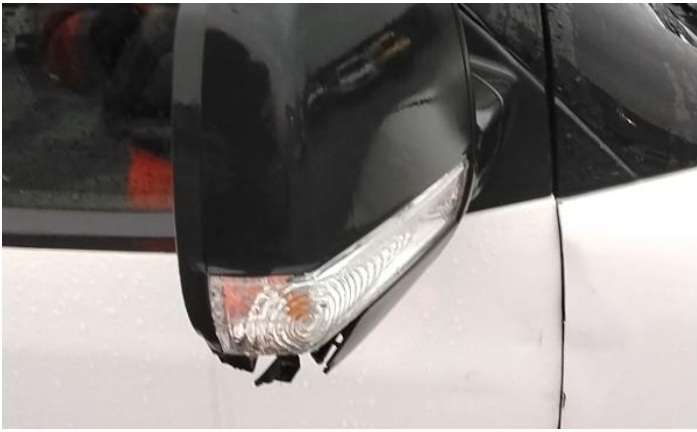
9: Door Mirror Assy osf  
Broken  
Replace

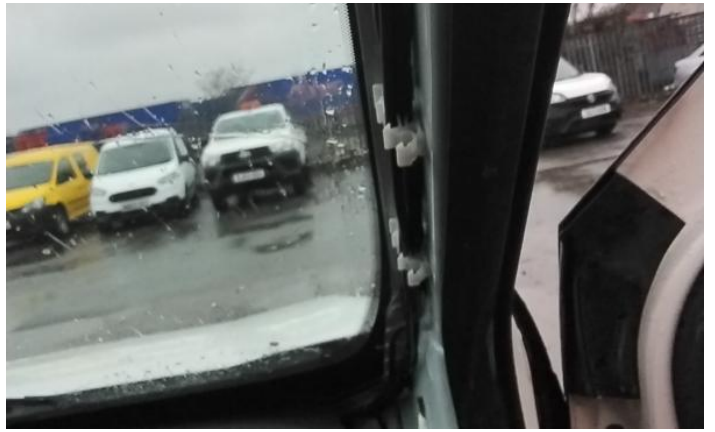
10: Fascia Panel  
Missing  
Replace

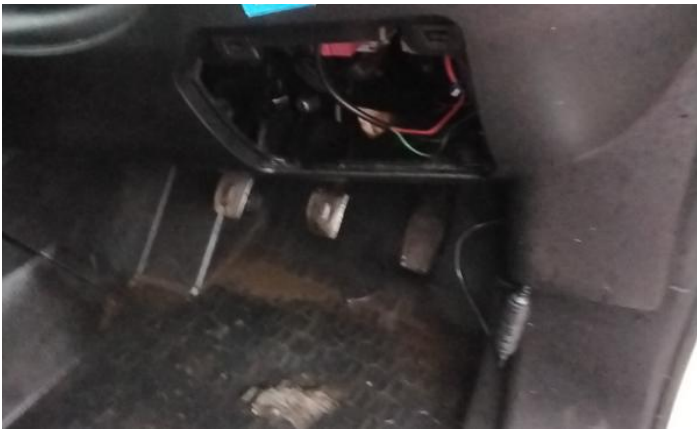
11: Fascia Panel  
Missing  
Replace

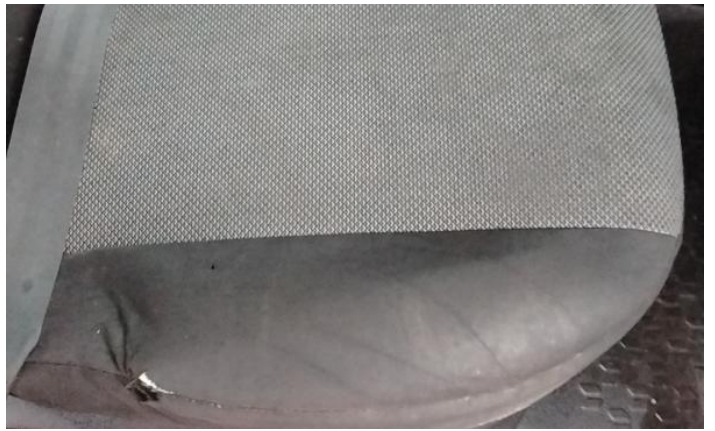
12: Seat Base Cover osf  
Holed  
Over 3mm

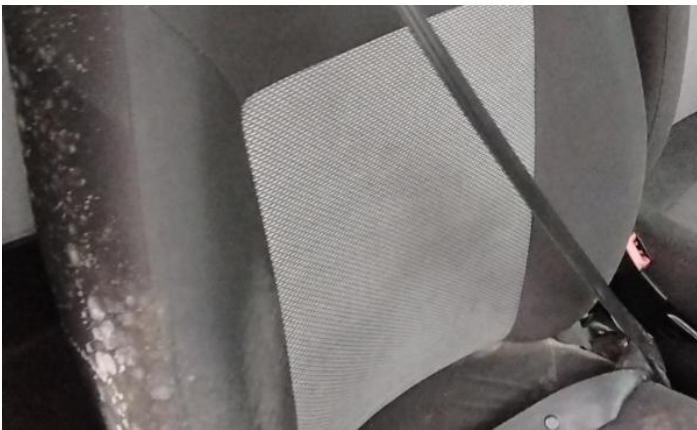
13: Seat Back Cover osf  
Soiled  
Heavy

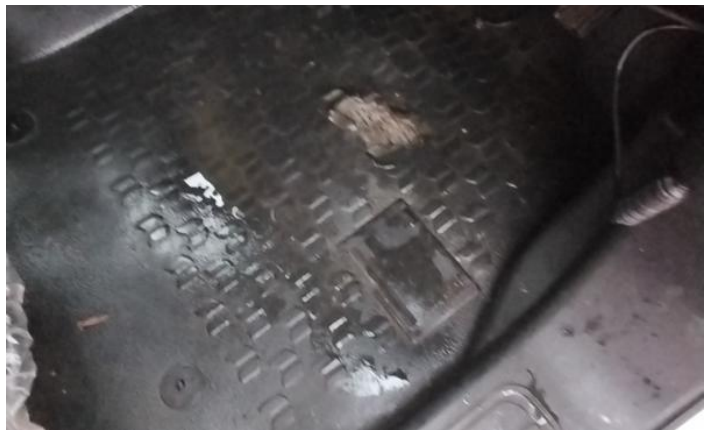
14: Carpets Front  
Holed  
Over 3mm

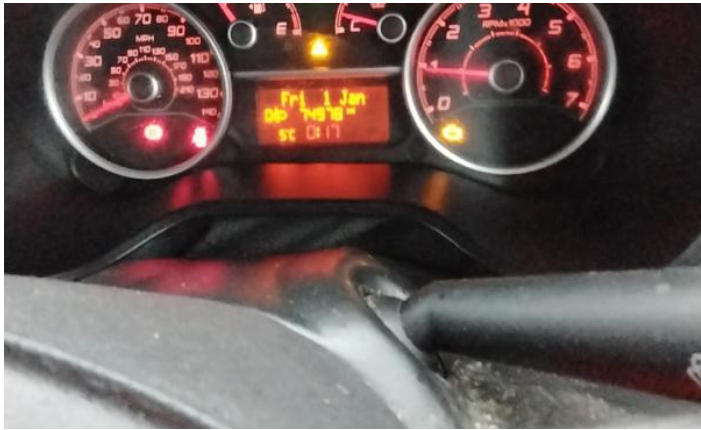
15: Dash Warning Lights  
 Displayed  
 No Action

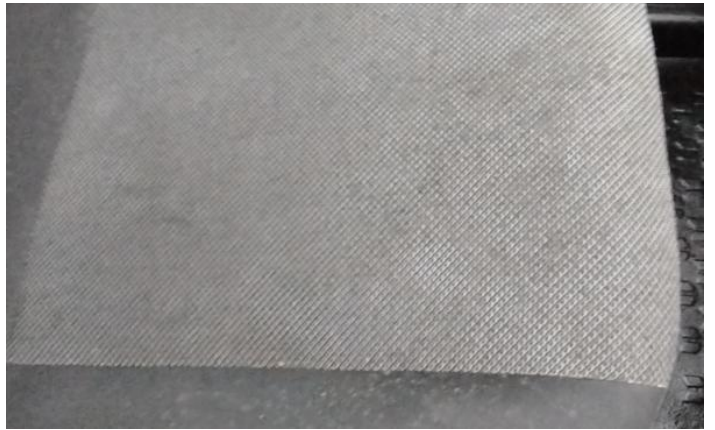
16: Seat Base Cover nsf  
 Soiled  
 Heavy
