# VEHICLE INSPECTION REPORT

**YD67FEF**

## Daf LF 230

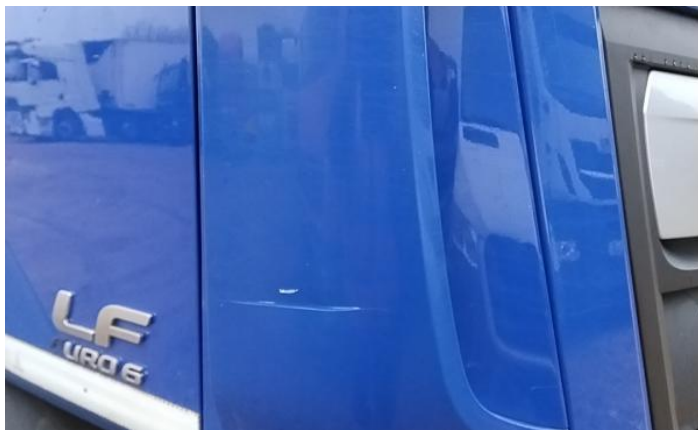
1: Wing osf  
Scratched  
Over 25mm Thru Paint

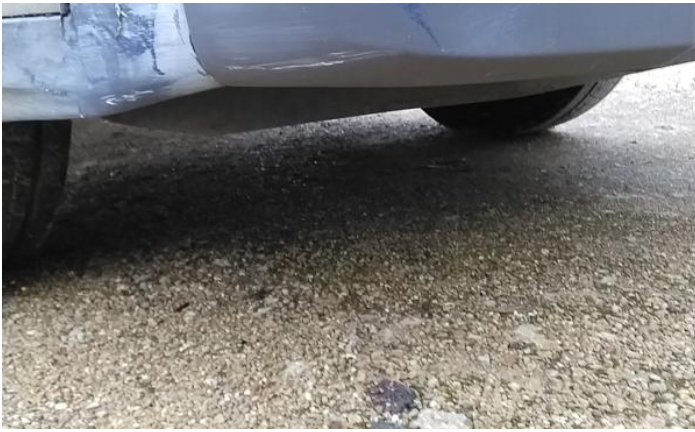
3: Bumper Front Moulding  
Scratched (Painted)  
Over 25mm Not Thru Paint

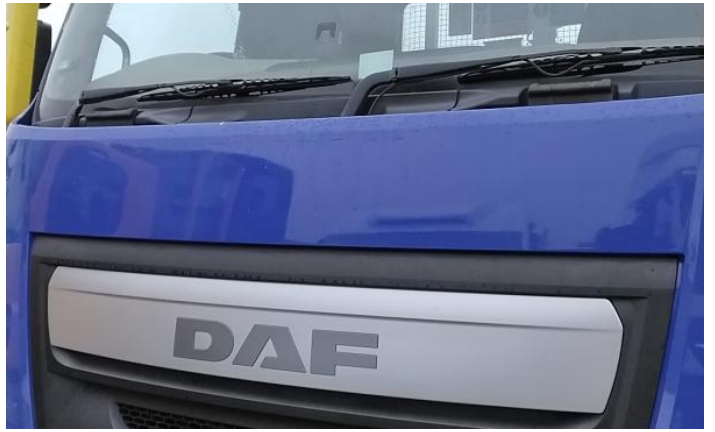
4: Bonnet  
Scratched  
Over 25mm Not Thru Paint

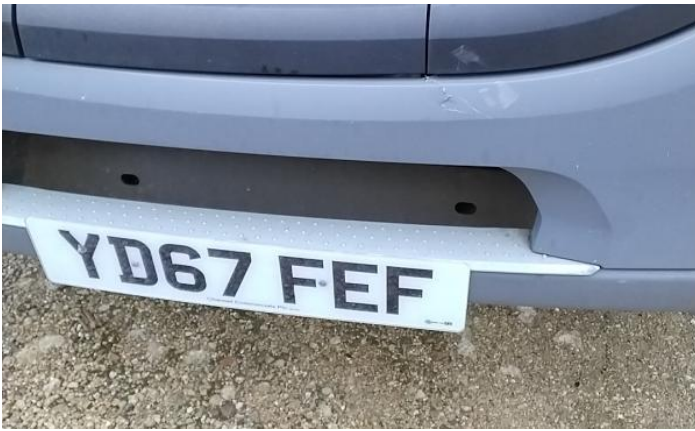
5: Bumper Front  
Cracked  
Over 25mm

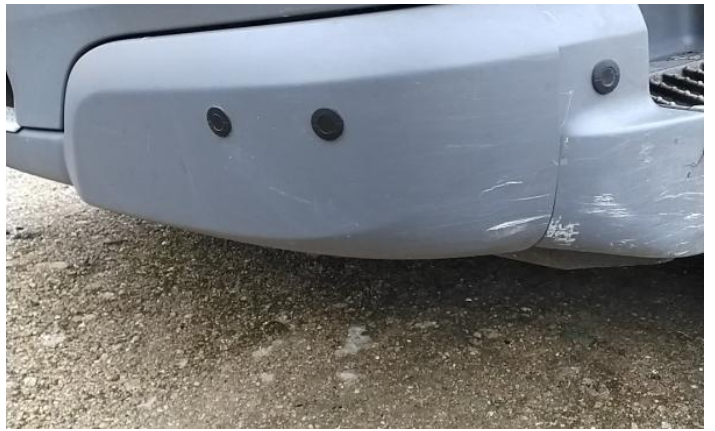
6: Bumper Front Moulding  
Scratched (Painted)  
Over 25mm Thru Paint

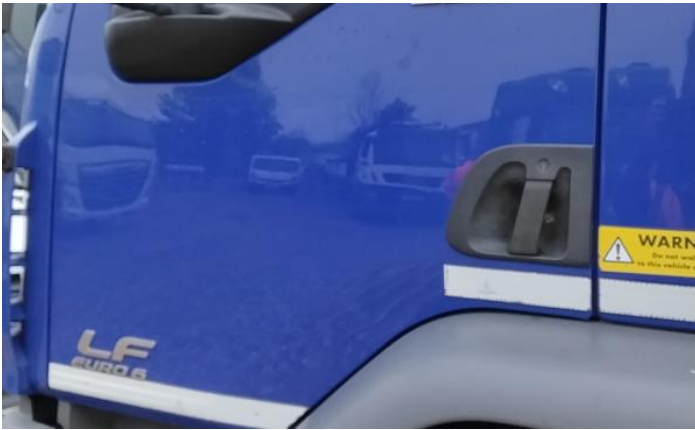
9: Door nsf  
Scratched  
Over 25mm Not Thru Paint

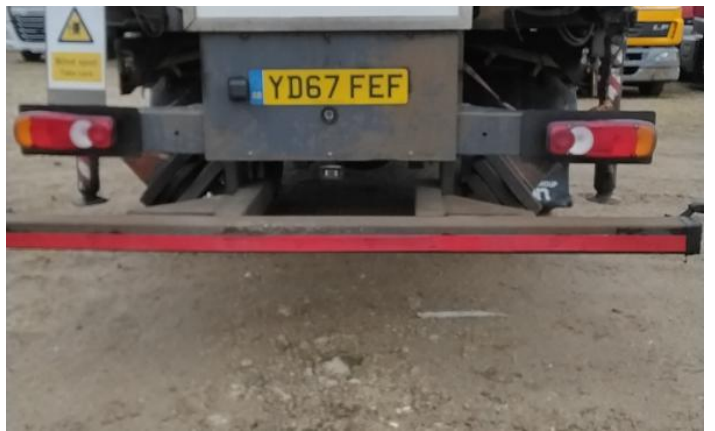
12: Bumper Rear  
Rusted  
Over 5mm

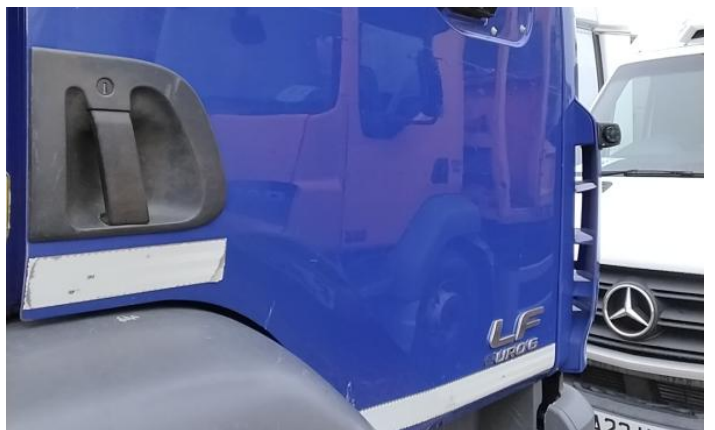
14: Door osf  
Scratched  
Over 25mm Not Thru Paint

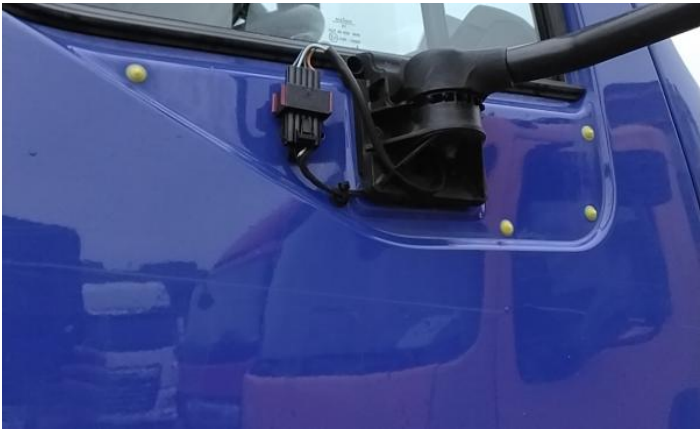
15: Door Moulding osf  
Missing  
Replace

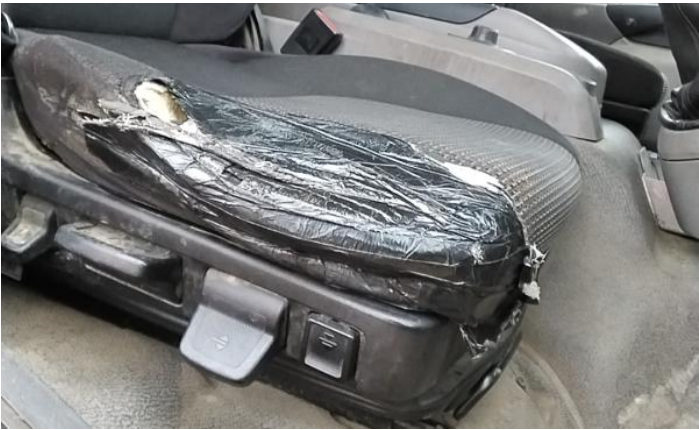
16: Seat Base Cover osf  
Holed  
Over 3mm
