# VEHICLE INSPECTION REPORT

**KU68EUY**

## Mercedes-Benz Sprinter 314 CDI

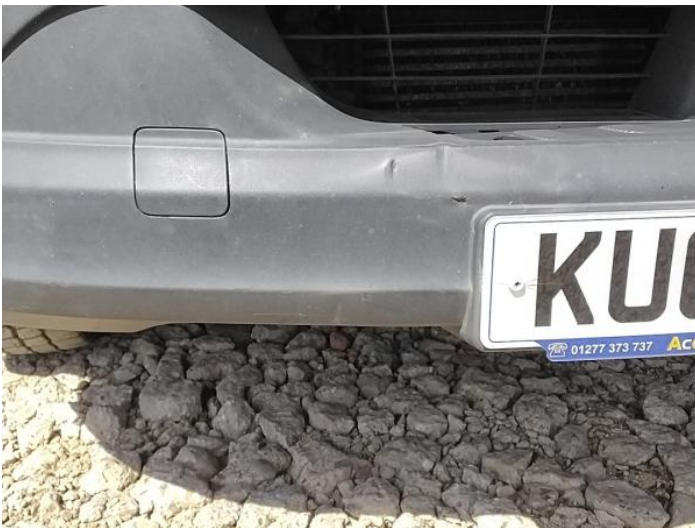
1: Bumper Front  
Dented  
Between 10mm + 30mm

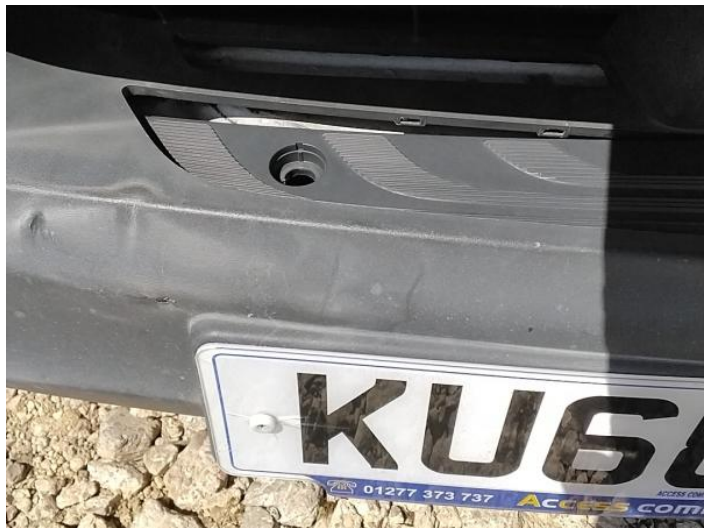
2: Bumper Front Moulding  
Broken  
Replace

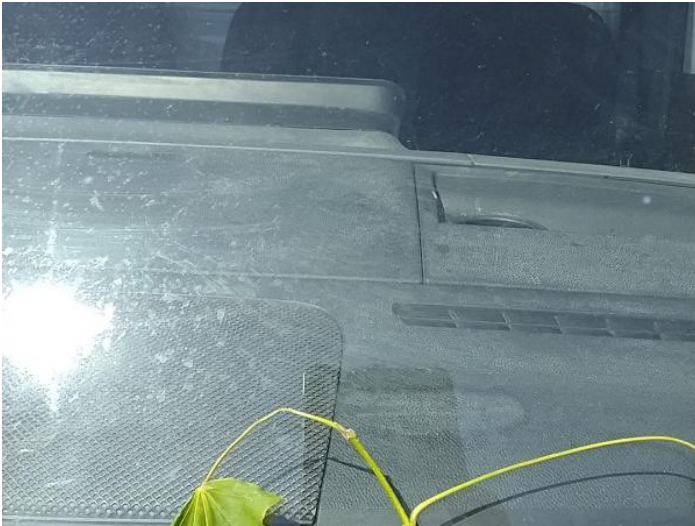
3: Screen Front  
Chipped  
UpTo 10mm

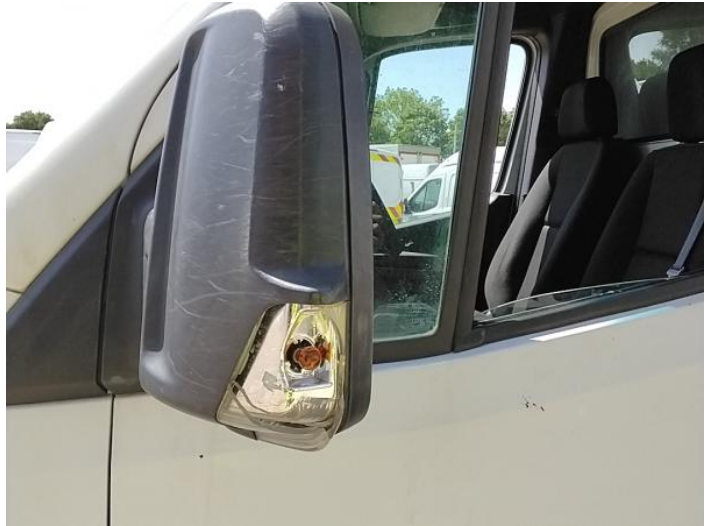
4: Door Mirror Glass ns  
Broken  
Replace

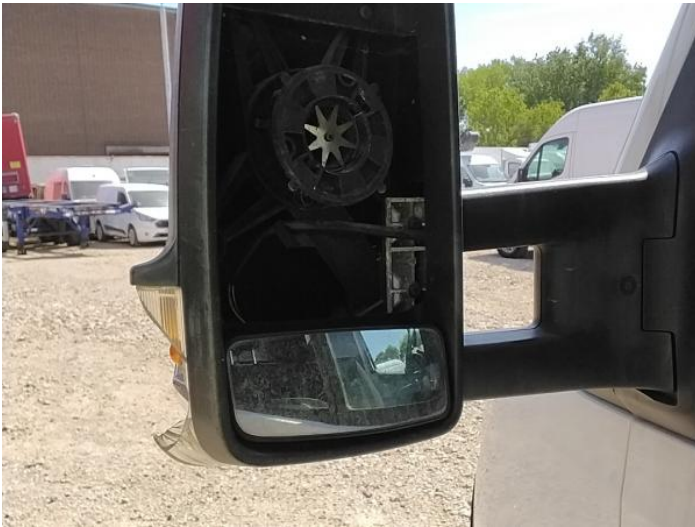
5: Door Mirror Glass ns  
Missing  
Replace

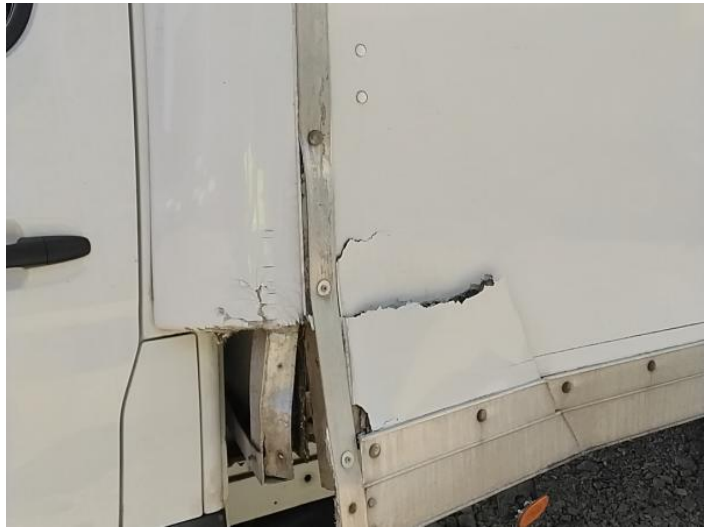
6: C Post ns  
Hole  
Over 10mm

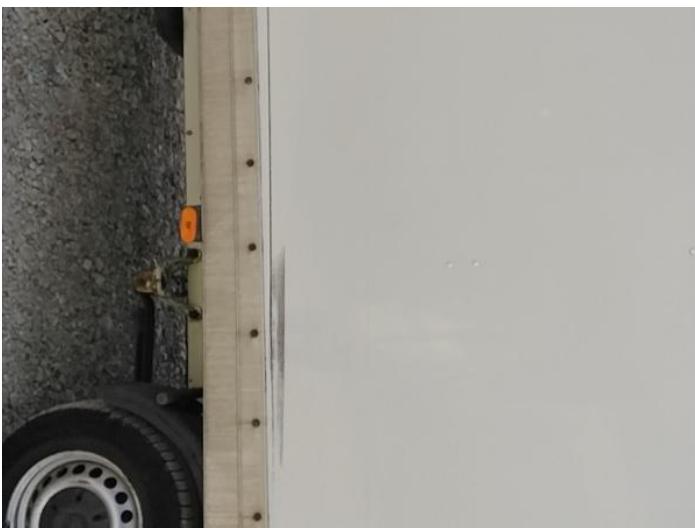
7: General Exterior  
Soiled  
Light

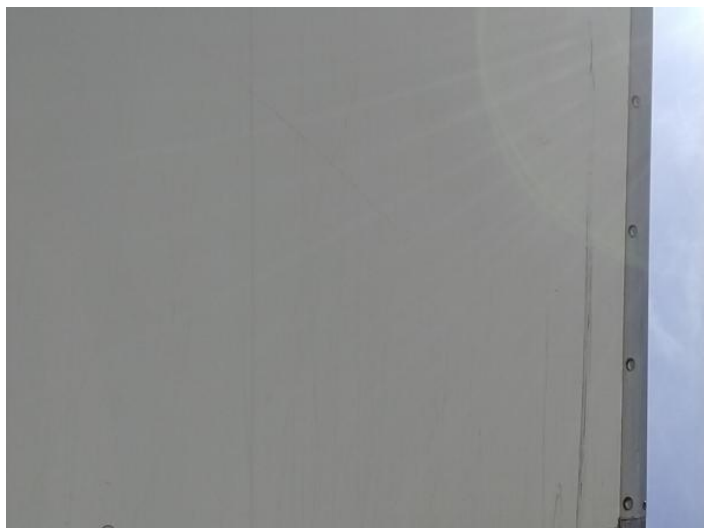
8: General Exterior  
Soiled  
Light

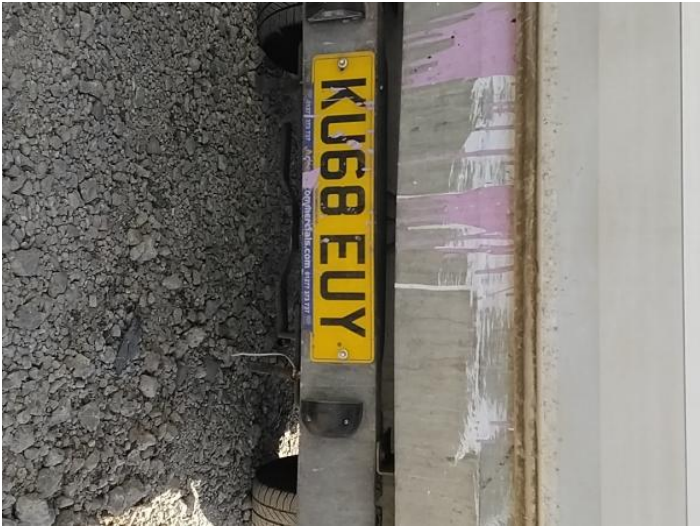
9: General Exterior  
Soiled  
Light

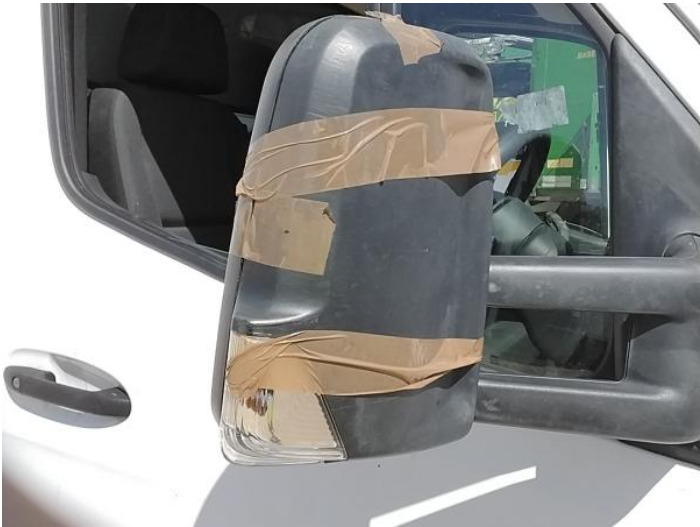
11: Door Mirror Assy osf  
Broken  
Replace

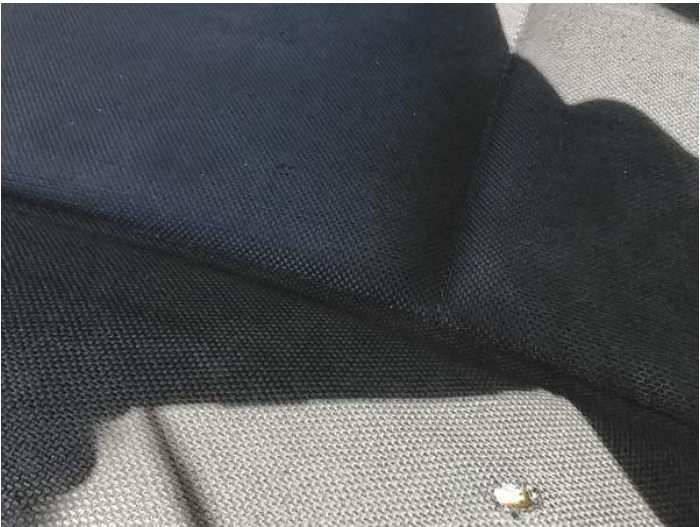
12: Seat Base Cover nsf  
Holed  
Over 3mm
