# VEHICLE INSPECTION REPORT

**DE24KOA**

## Volkswagen Crafter CR35 2.0 TDI 140PS

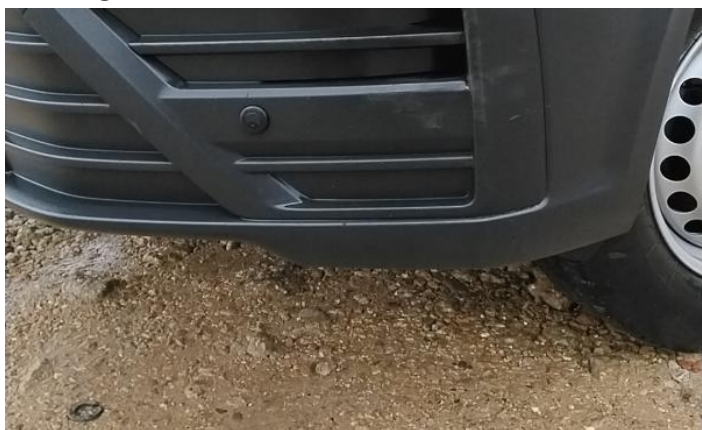
1: Bumper Front Moulding  
Scuffed (Unpainted)  
Over 100mm

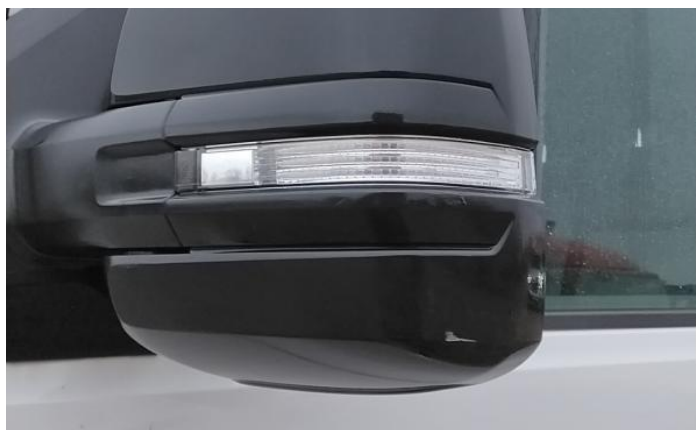
2: Door Mirror Assy nsf  
Scuffed (Unpainted)  
Over 100mm

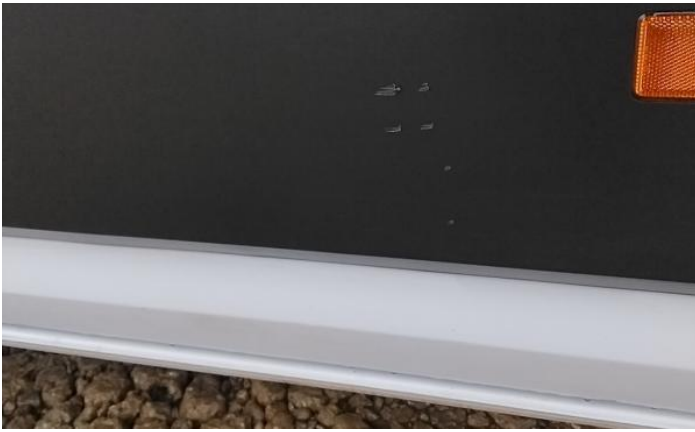
3: Door Moulding nsf  
Scuffed (Unpainted)  
UpTo 100mm

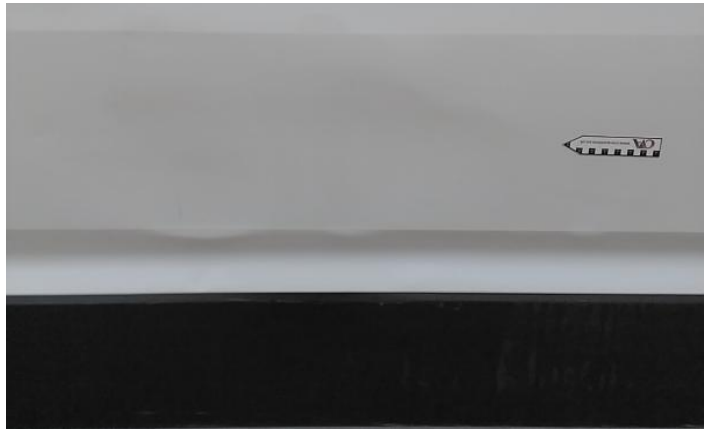
4: Door nsr  
Dented  
Over 30mm

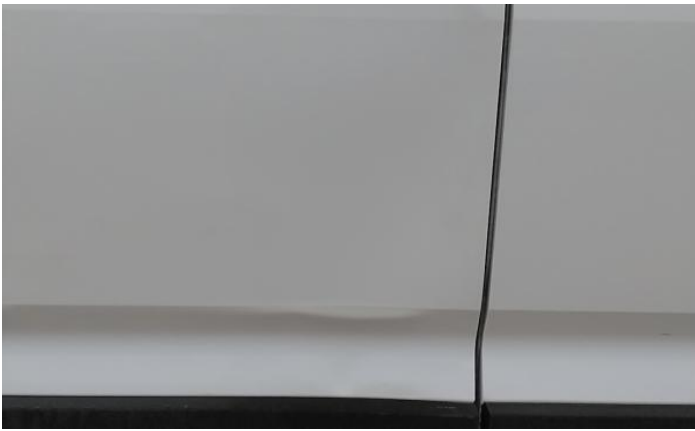
5: Door nsr  
Dented  
Over 30mm

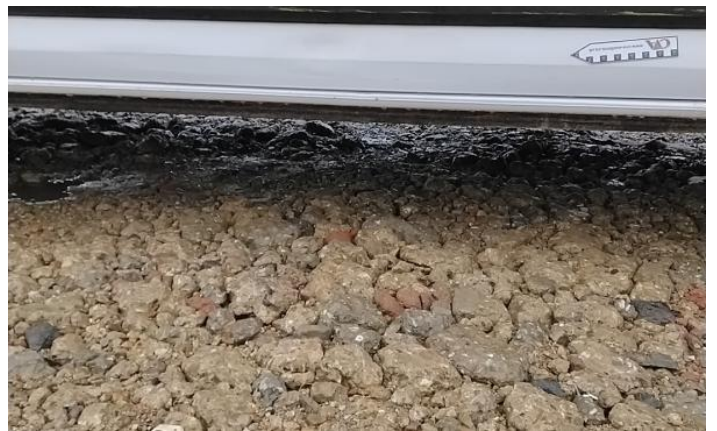
6: Door nsr  
Dented  
With Paint Damage

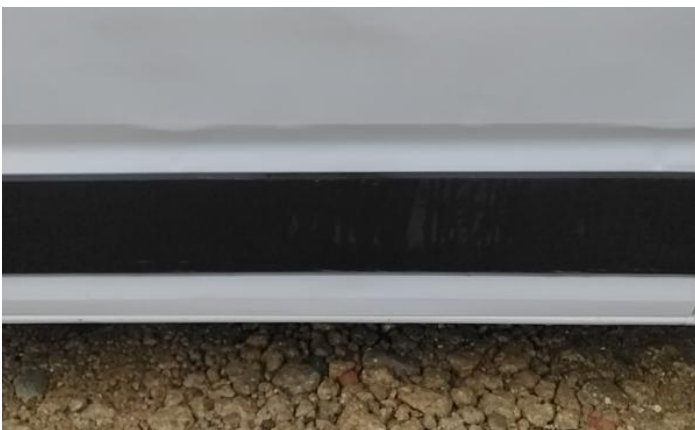
7: Door Moulding nsr  
Scratched (Painted)  
Over 25mm Not Thru Paint

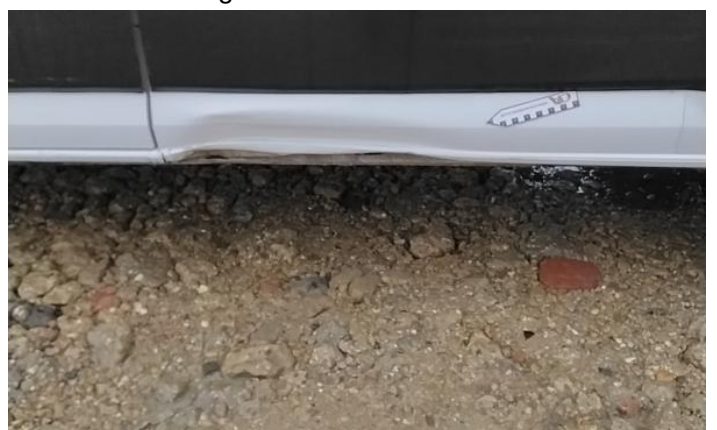
8: Sill ns  
Dented  
With Paint Damage

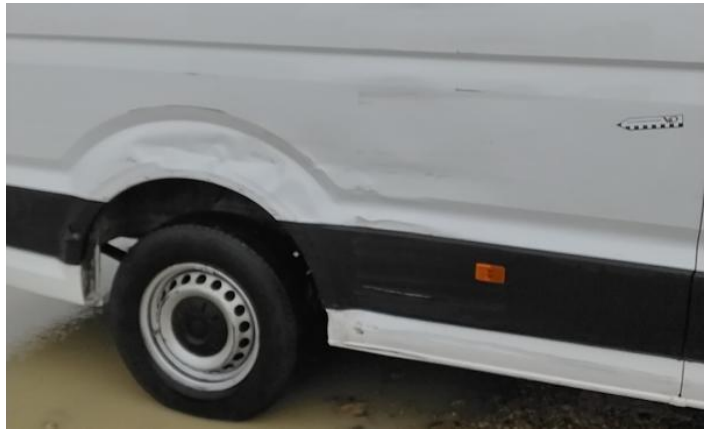
10: Qtr Panel osr  
Dented  
Over 30% Of Panel

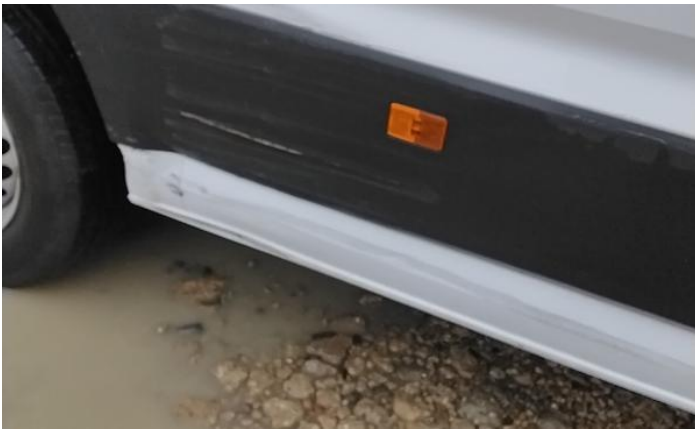
11: Qtr Panel Moulding os  
Broken  
Replace

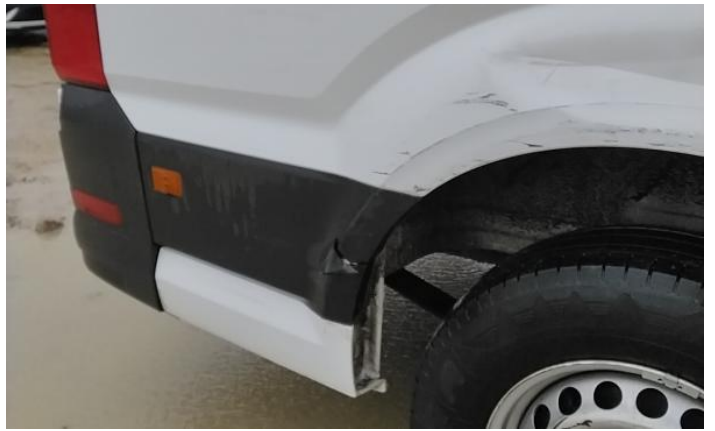
12: Qtr Panel Moulding os  
Broken  
Replace

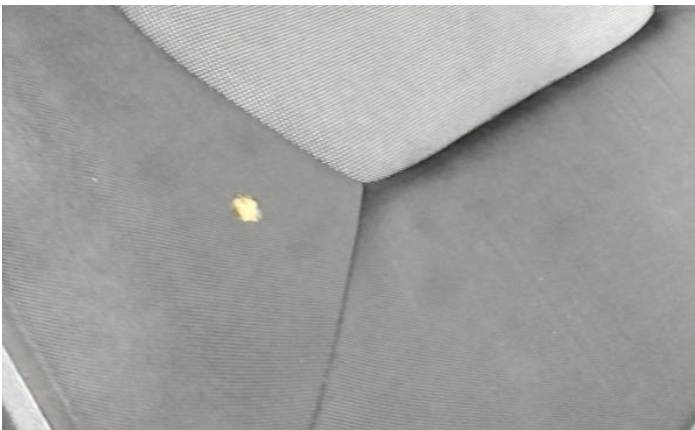
13: Seat Base Cover osf  
Burn  
Over 3mm
