# VEHICLE INSPECTION REPORT

**DA23BVR**

## Volkswagen Crafter CR35 2.0 TDI 140PS

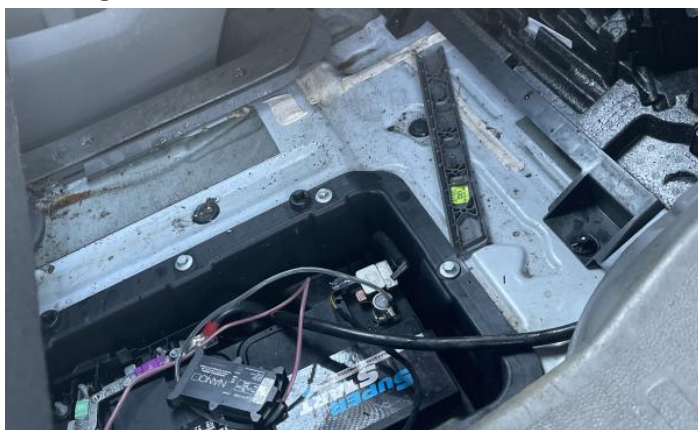
1: Carpets Front  
Missing  
Replace

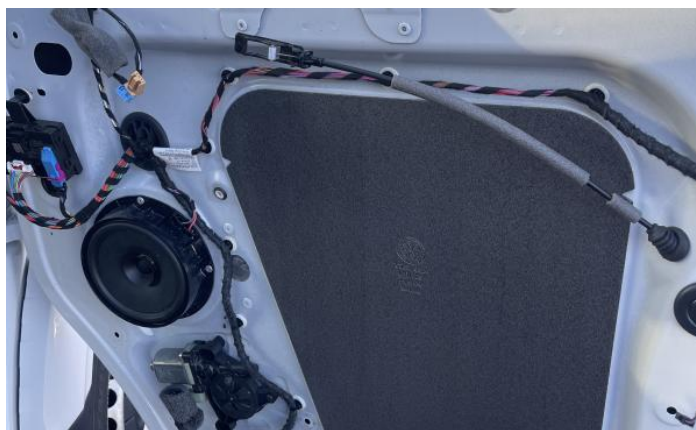
2: Door Pad osf  
Missing  
Replace

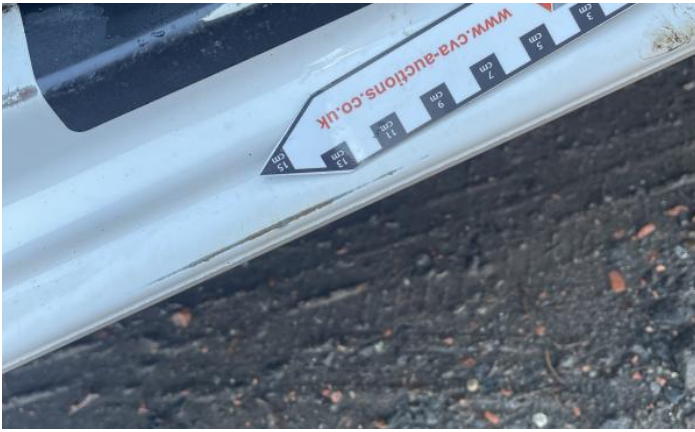
3: Sill os  
Scratched  
Over 25mm Thru Paint

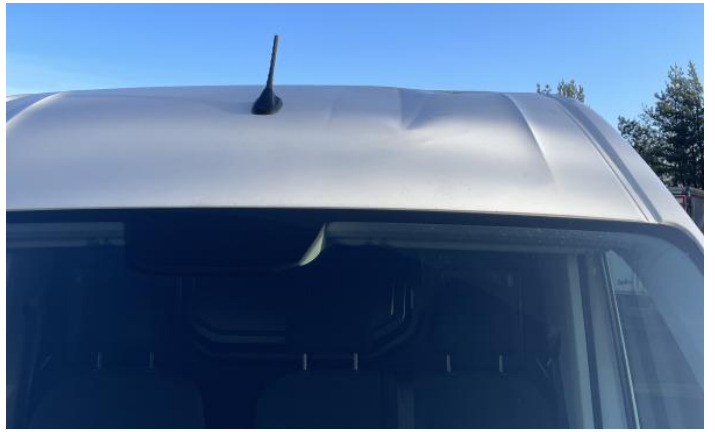
4: Roof  
Dented  
With Paint Damage

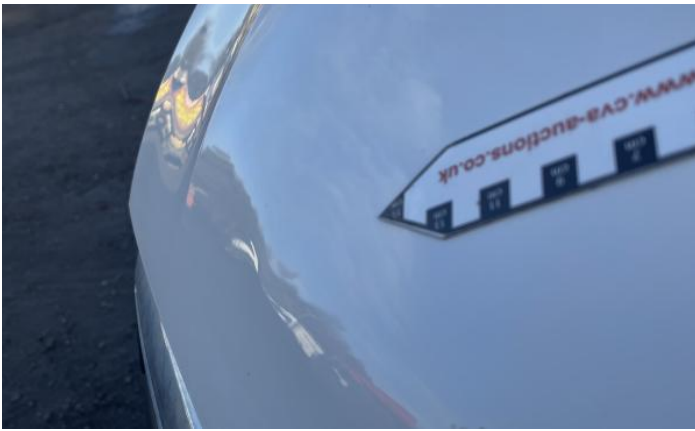
5: Bonnet  
Dented  
With Paint Damage

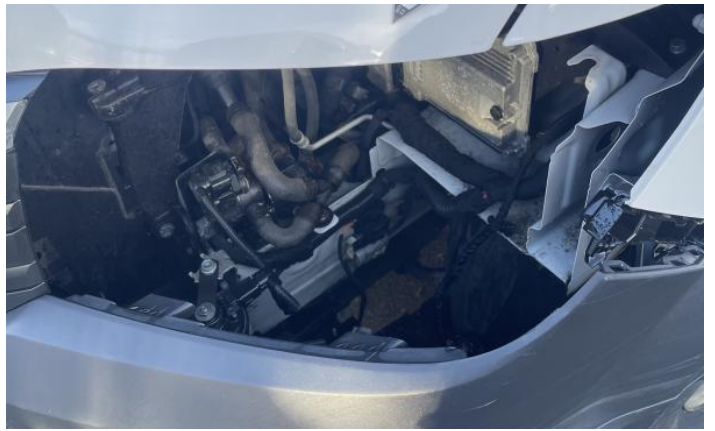
6: Headlamp ns  
Missing  
Replace

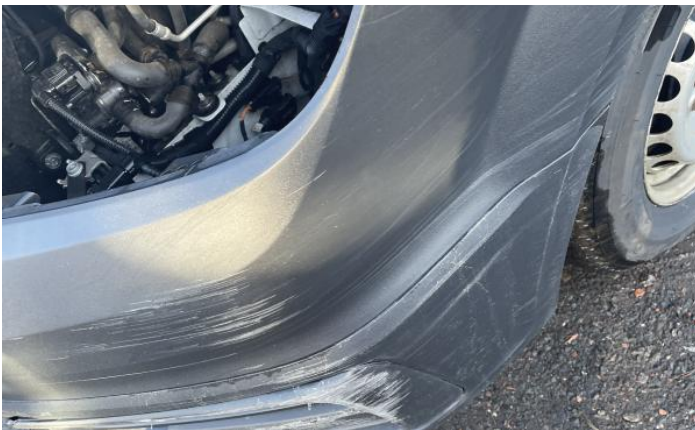
7: Bumper Front Moulding  
Broken  
Replace

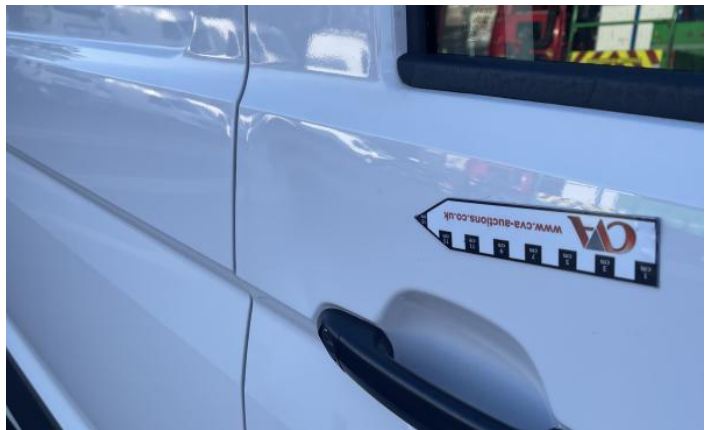
8: Door osf  
Dented  
With Paint Damage

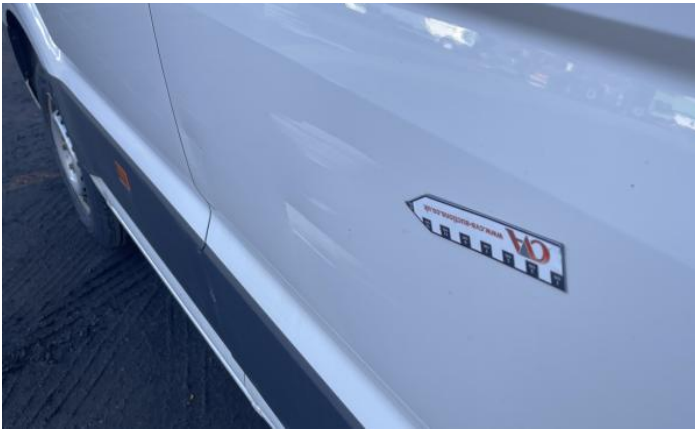
9: Qtr Panel osr  
Dented  
With Paint Damage

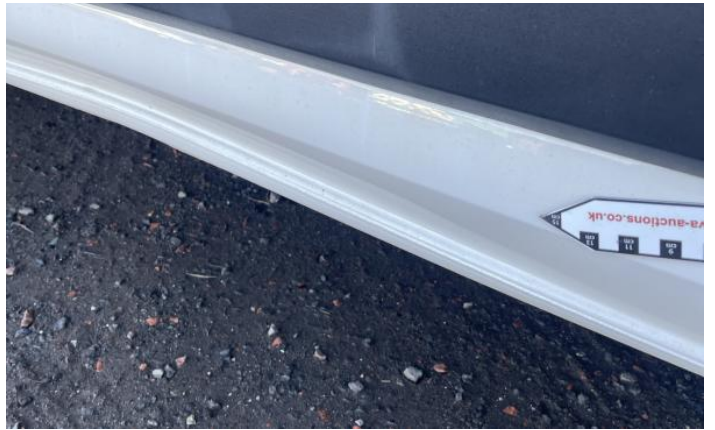
10: Sill os  
Dented  
With Paint Damage

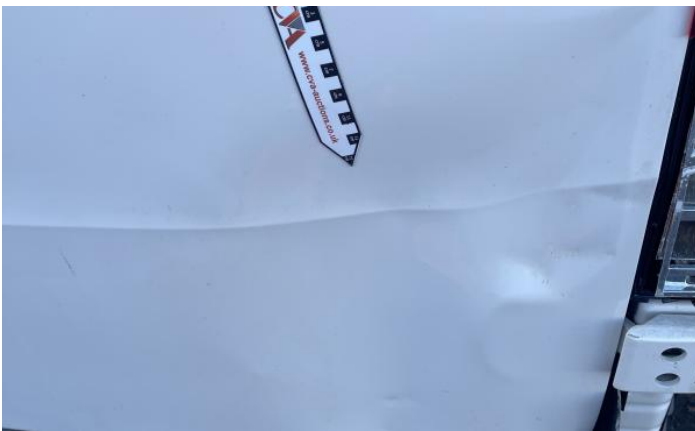
11: Tailgate  
Dented  
With Paint Damage

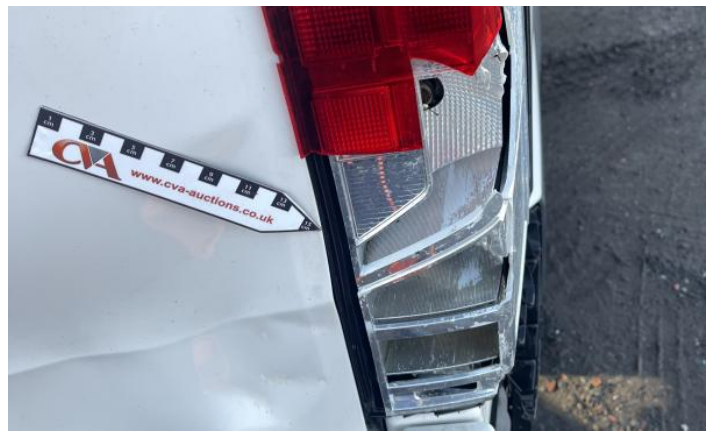
12: Fog Lamp osr  
Broken  
Replace

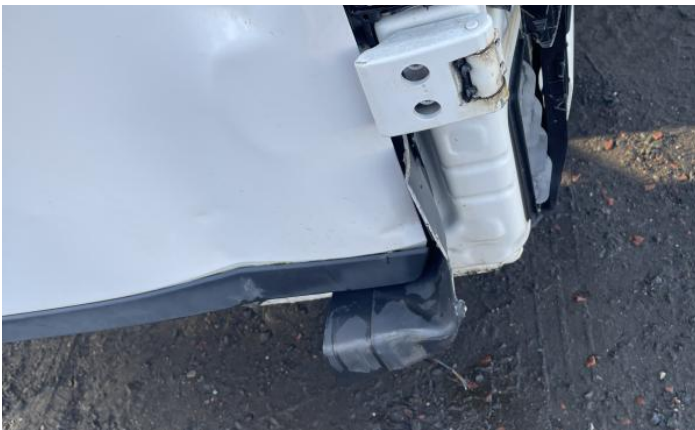
13: Bumper Rear Moulding  
Broken  
Replace

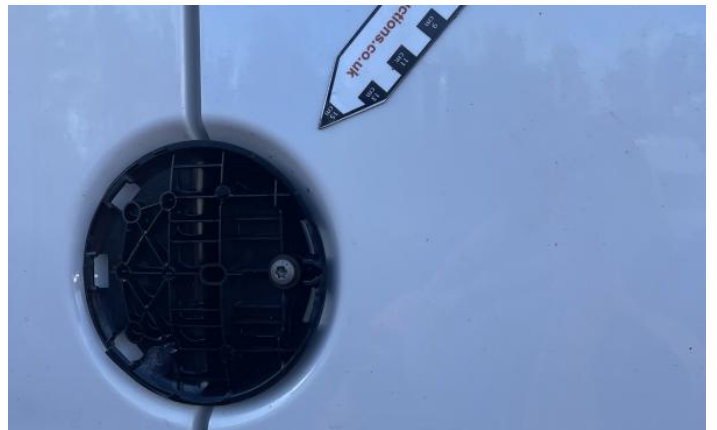
14: Badgedecal Rear  
Broken  
Replace

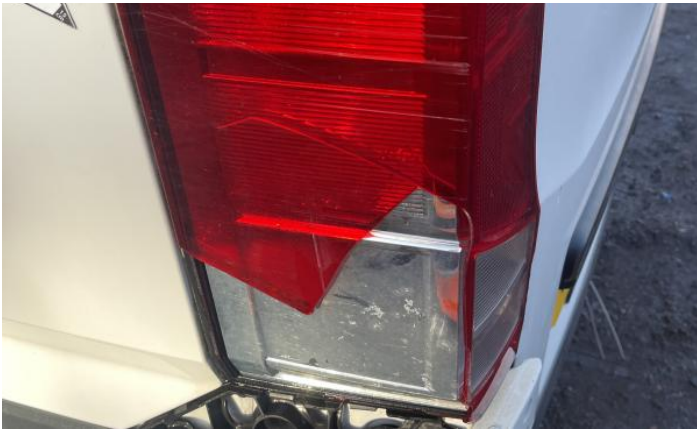
15: Fog Lamp nsr  
Broken  
Replace

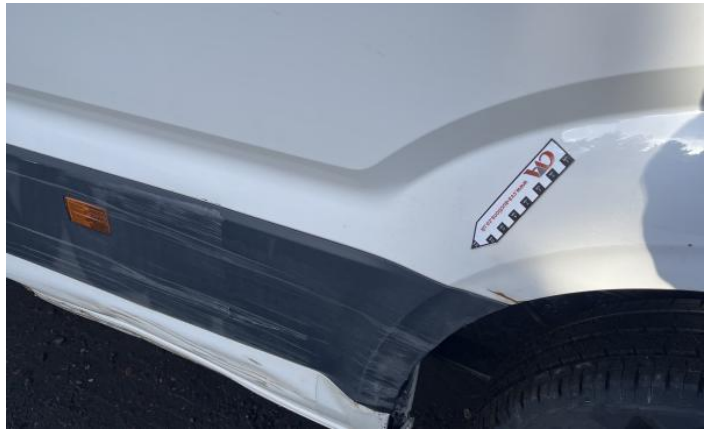
16: Qtr Panel nsr  
Dented  
With Paint Damage

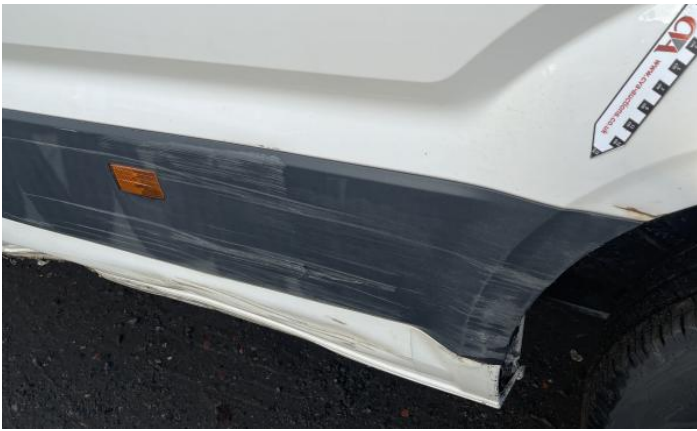
17: Qtr Panel Moulding ns  
Scuffed (Unpainted)  
Over 100mm

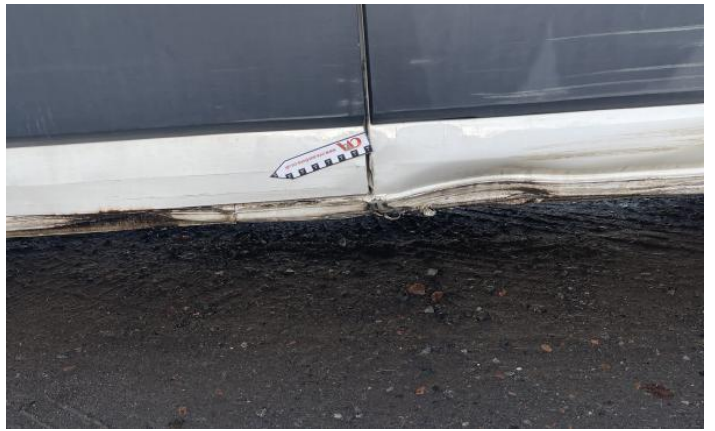
18: Sill ns  
Dented  
With Paint Damage

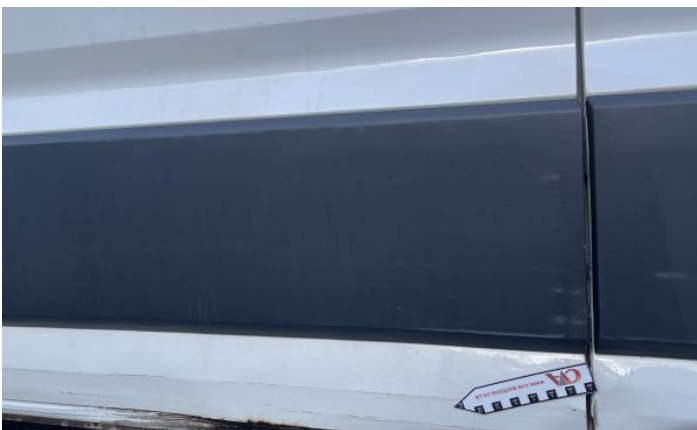
19: Door nsr  
Dented  
With Paint Damage

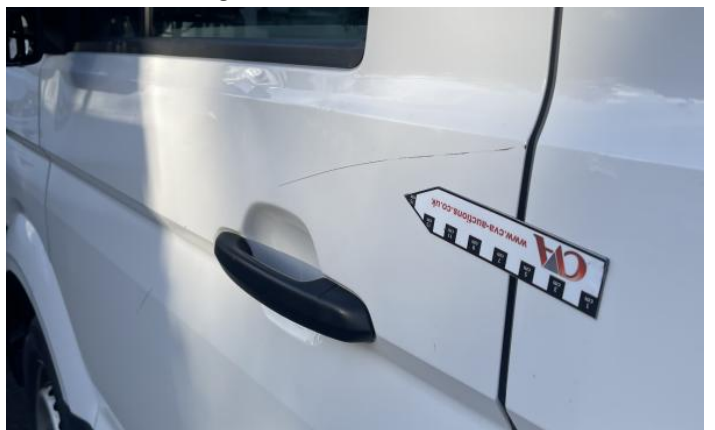
20: Door nsf  
Dented  
With Paint Damage

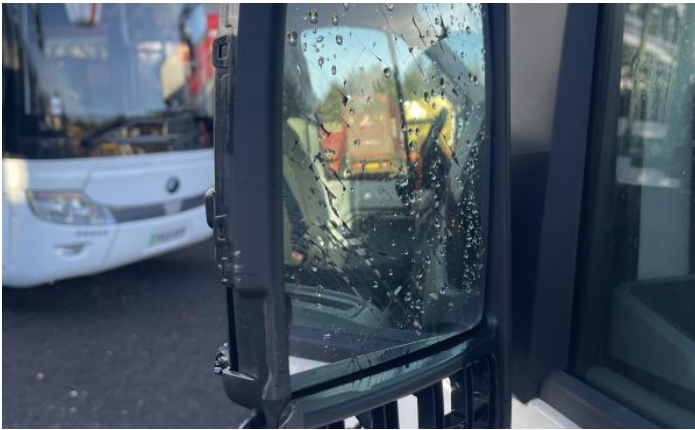
21: Door Mirror Glass ns  
Broken  
Replace

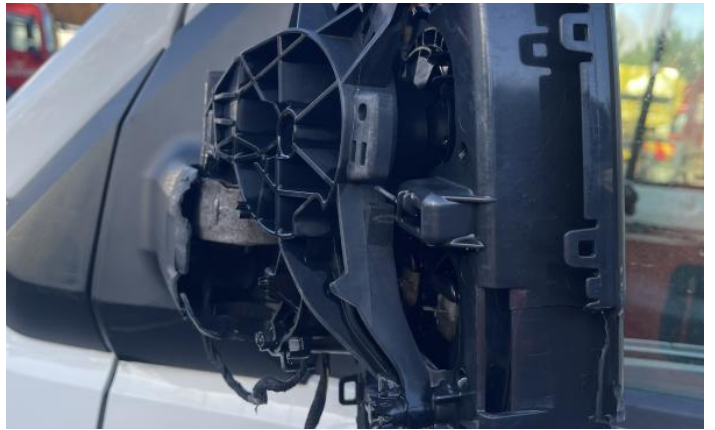
22: Door Mirror Assy nsf  
Broken  
Replace

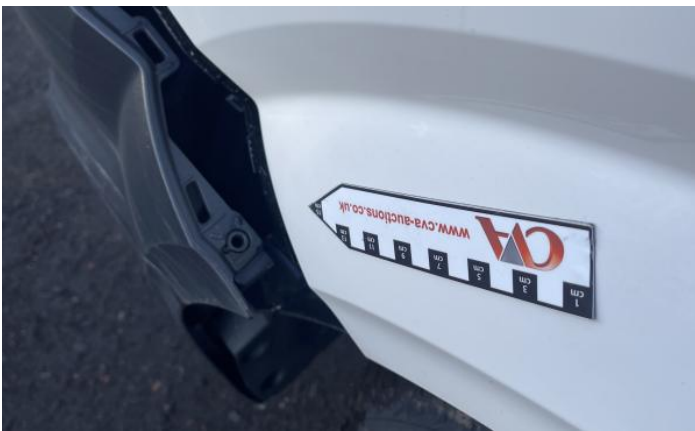
23: Wing nsf  
Dented  
Over 30mm

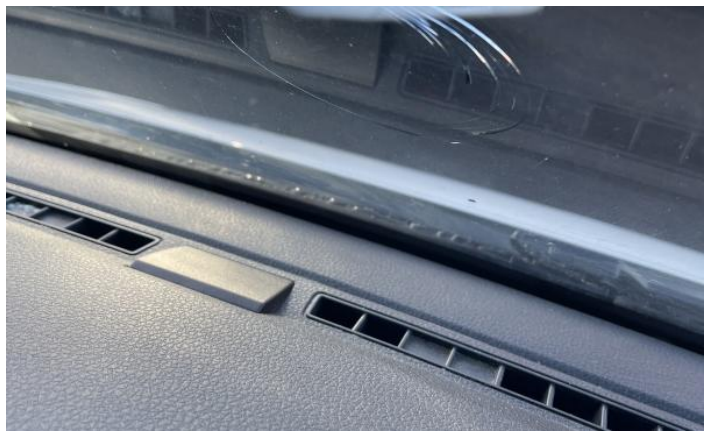
24: Screen Front  
Cracked  
Replace

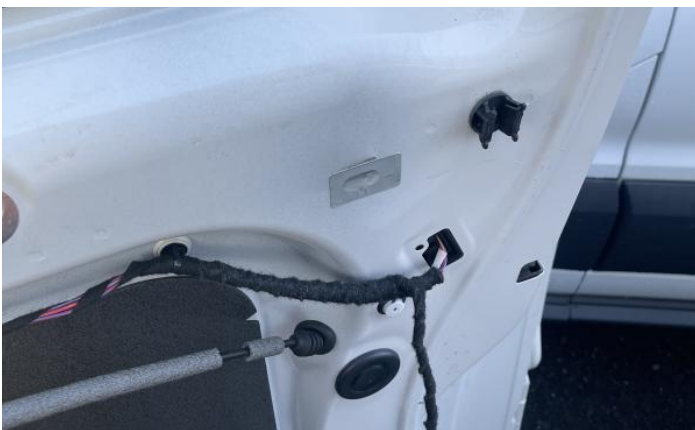
25: Handle Outer osf  
Missing  
Replace
