## VEHICLE INSPECTION REPORT

**PJ73KUW**

### Volkswagen Crafter CR35 2.0 TDI 140PS

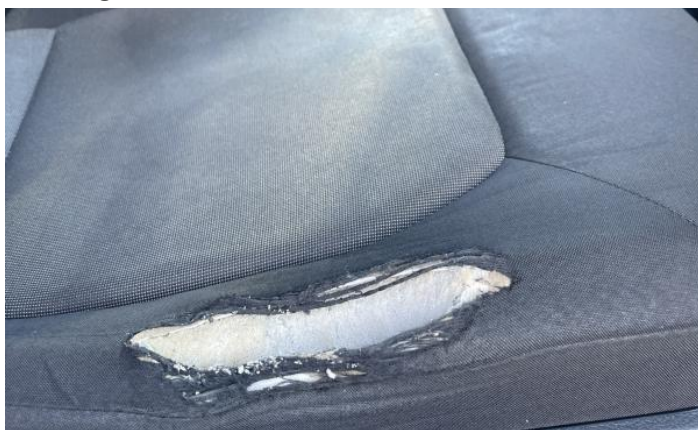
1: Seat Base Cover nsr  
Torn  
Over 3mm

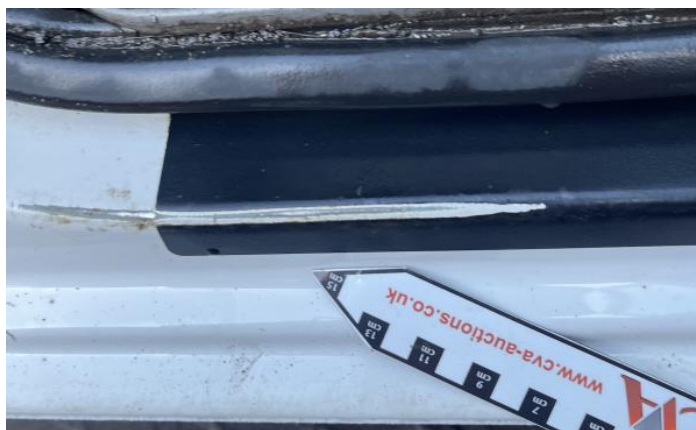
2: Sill os  
Scratched  
Over 25mm Thru Paint

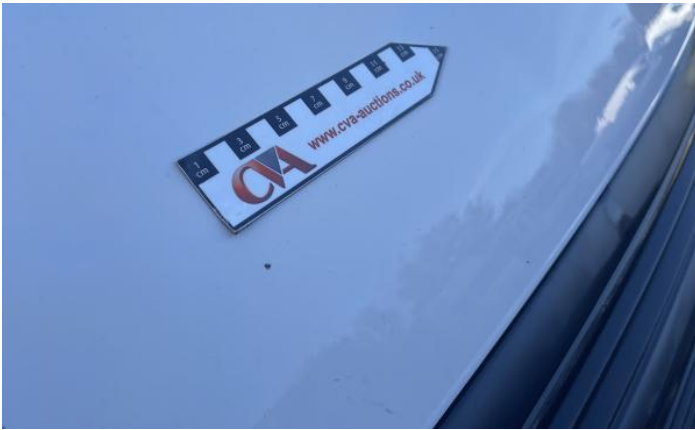
3: Bonnet  
Dented  
Over 30mm

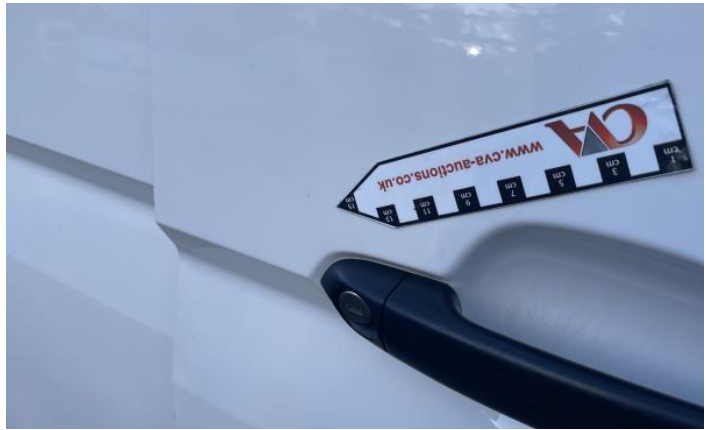
4: Door osf  
Dented  
Over 30mm

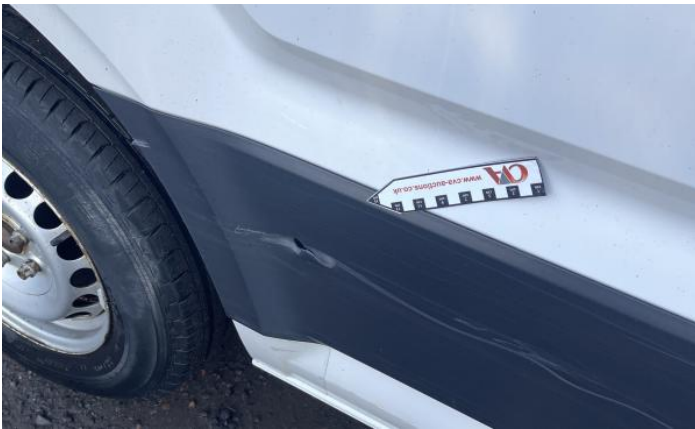
5: Qtr Panel Moulding os  
Broken  
Replace

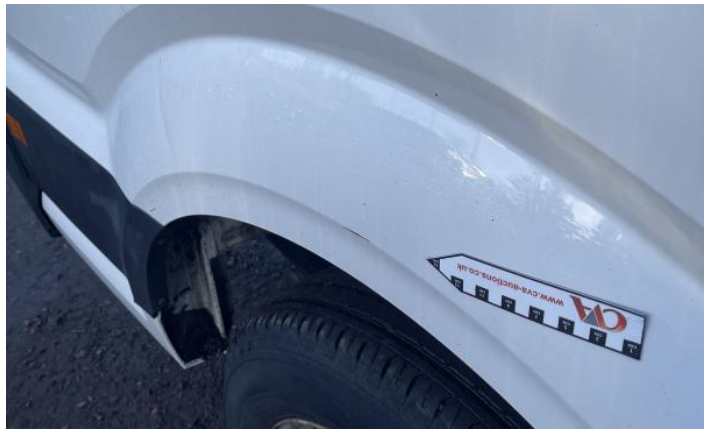
6: Qtr Panel osr  
Dented  
With Paint Damage

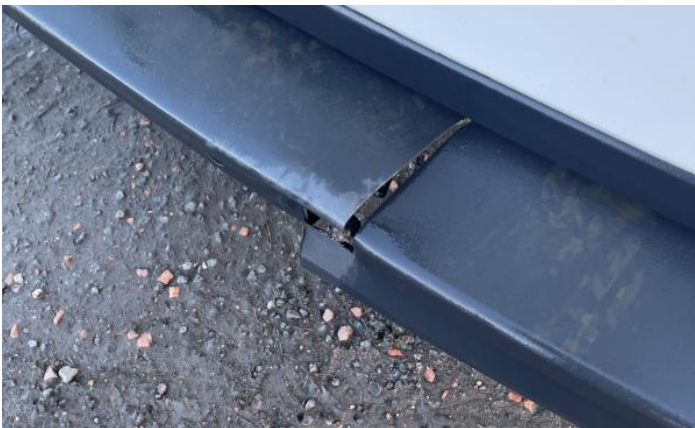
7: Bumper Rear Moulding  
Broken  
Replace

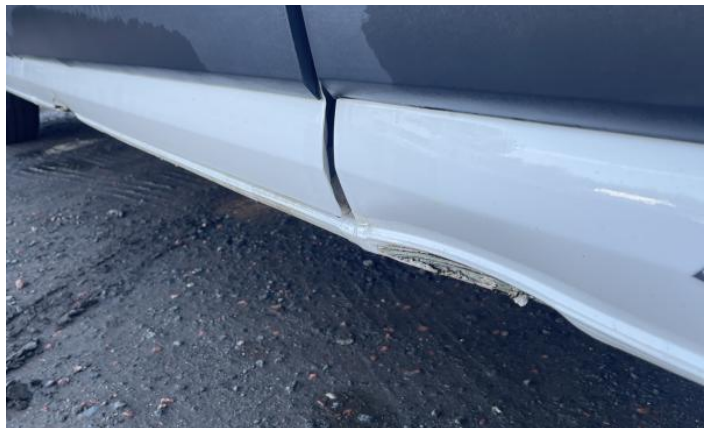
8: Sill ns  
Dented  
With Paint Damage

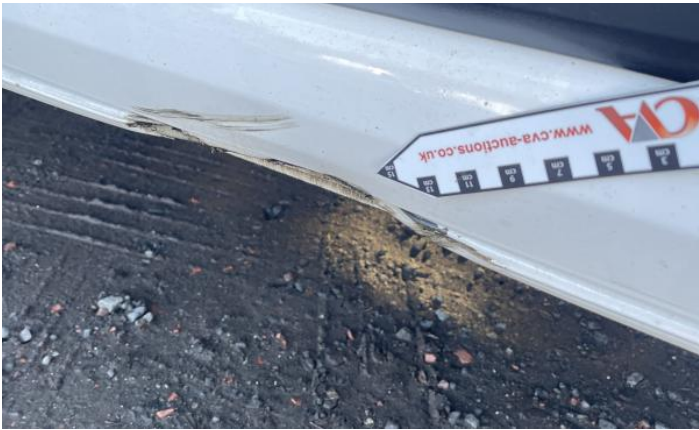
9: Door nsr  
Dented  
Over 30mm

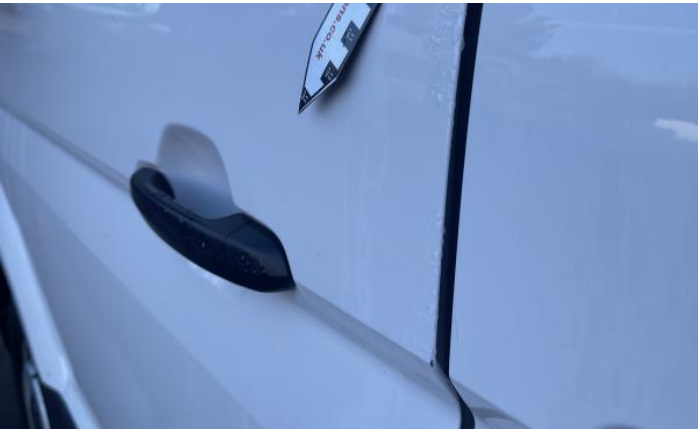
10: Door nsf  
Dented  
Over 2 UpTo 10mm
