## VEHICLE INSPECTION REPORT

**PJ73LSX**

### Volkswagen Crafter CR35 2.0 TDI 140PS

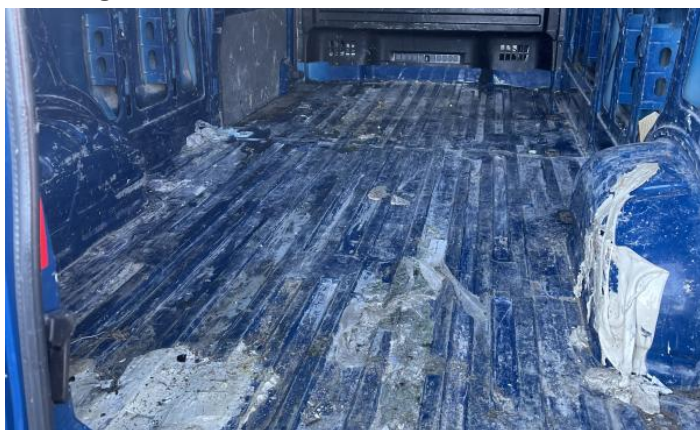
1: Carpets Front  
Missing  
Replace

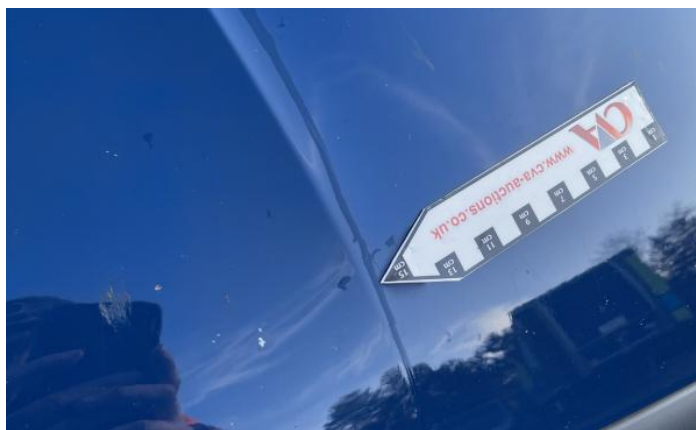
2: Bonnet  
Dented  
With Paint Damage

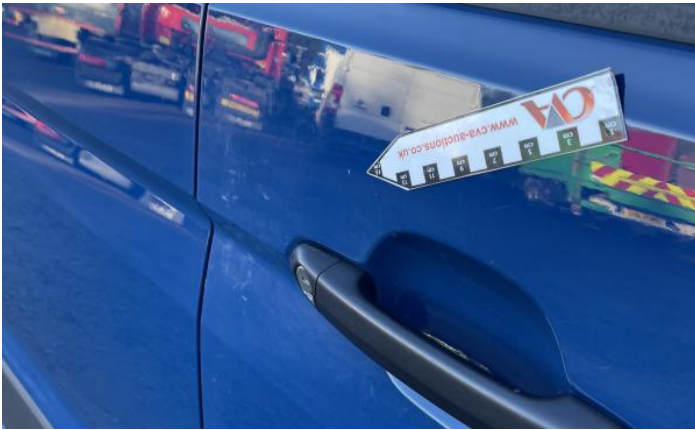
3: Door osf  
Dented  
With Paint Damage

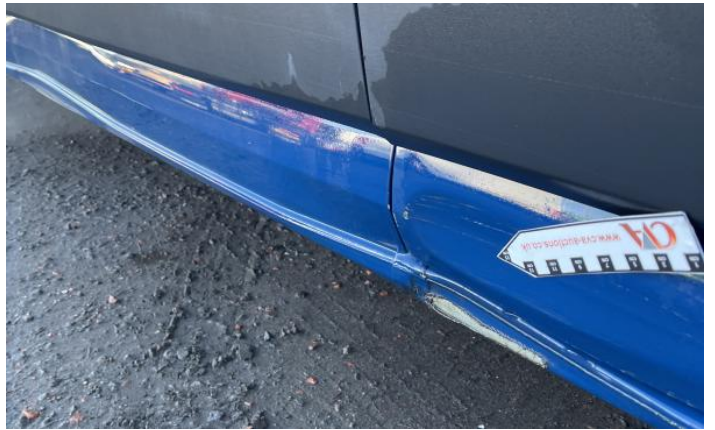
4: Sill os  
Dented  
With Paint Damage

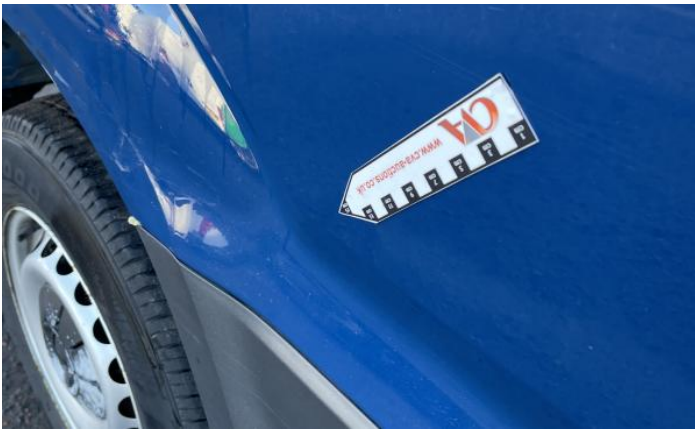
5: Qtr Panel osr  
Dented  
With Paint Damage

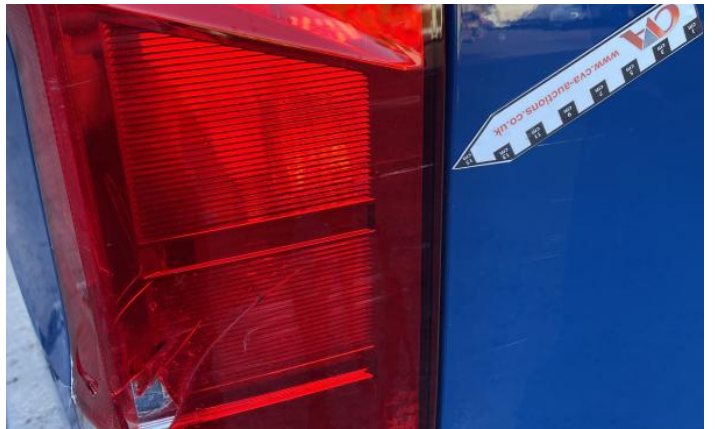
6: Fog Lamp osr  
Broken  
Replace

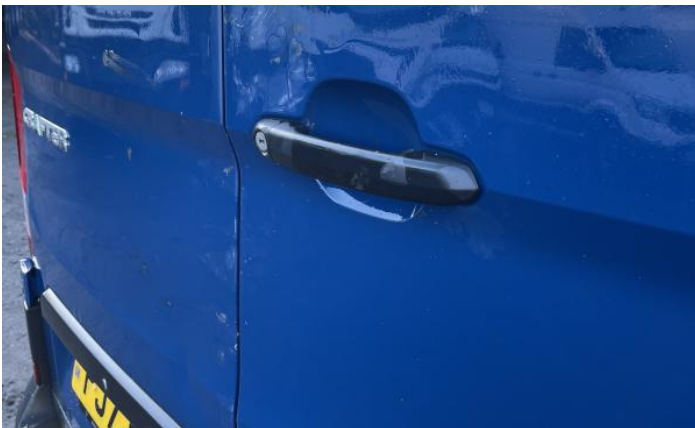
7: Tailgate  
Dented  
Over 30mm

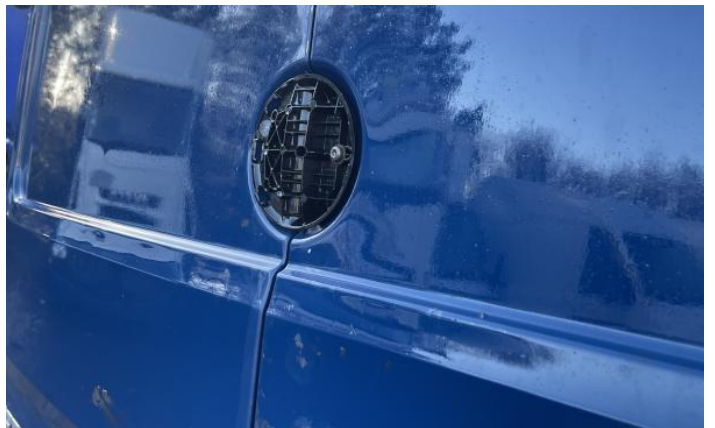
8: Badgedecal Rear  
Missing  
Replace

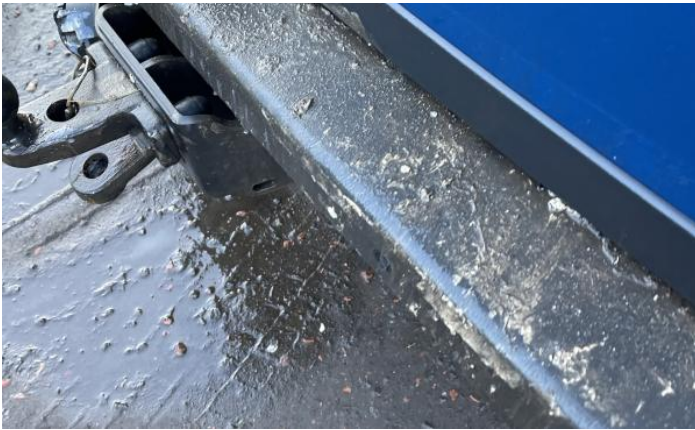
9: Bumper Rear Moulding  
Scuffed (Unpainted)  
Over 100mm

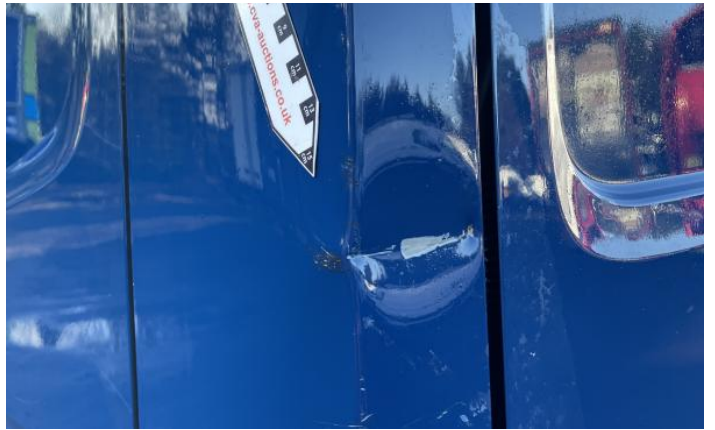
10: D Post ns  
Dented  
With Paint Damage

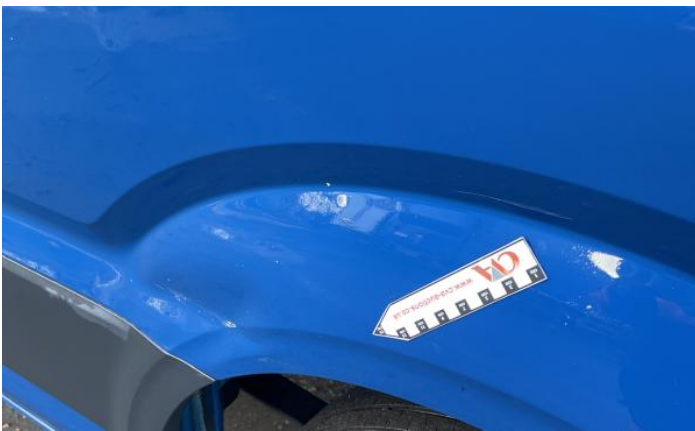
11: Qtr Panel nsr  
Dented  
With Paint Damage

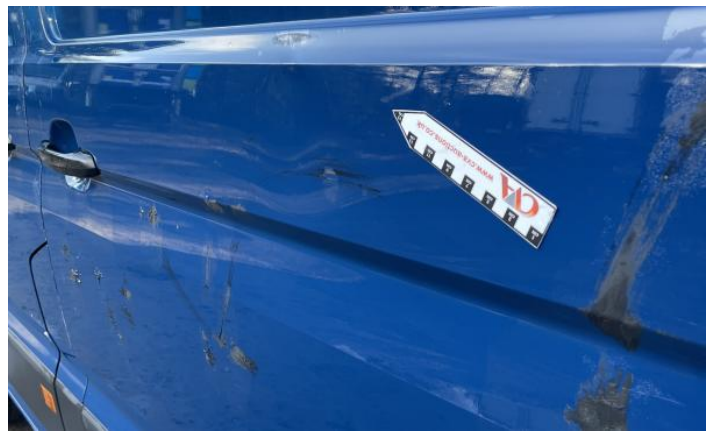
12: Door nsr  
Dented  
With Paint Damage

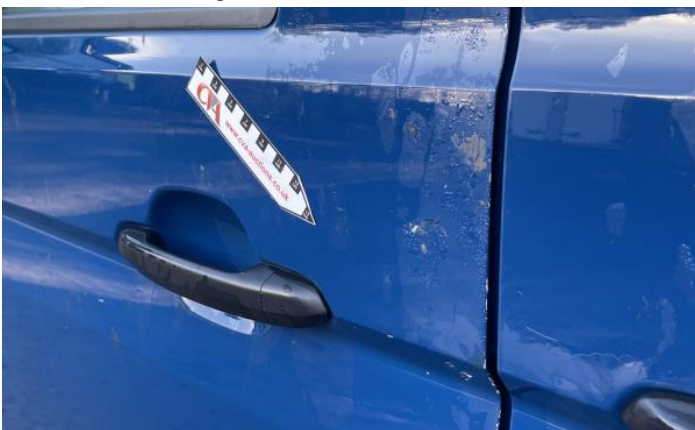
13: Door nsf  
Dented  
With Paint Damage
